ENVIRONMENTAL IMPACT ASSESSMENT

THE SETAI - KAKONA RESORT DEVELOPMENT

LEEWARD HARBOUR, CONCH SOUND POINT, AND HIGH BANK BAY

SOUTH ABACO, BAHAMAS

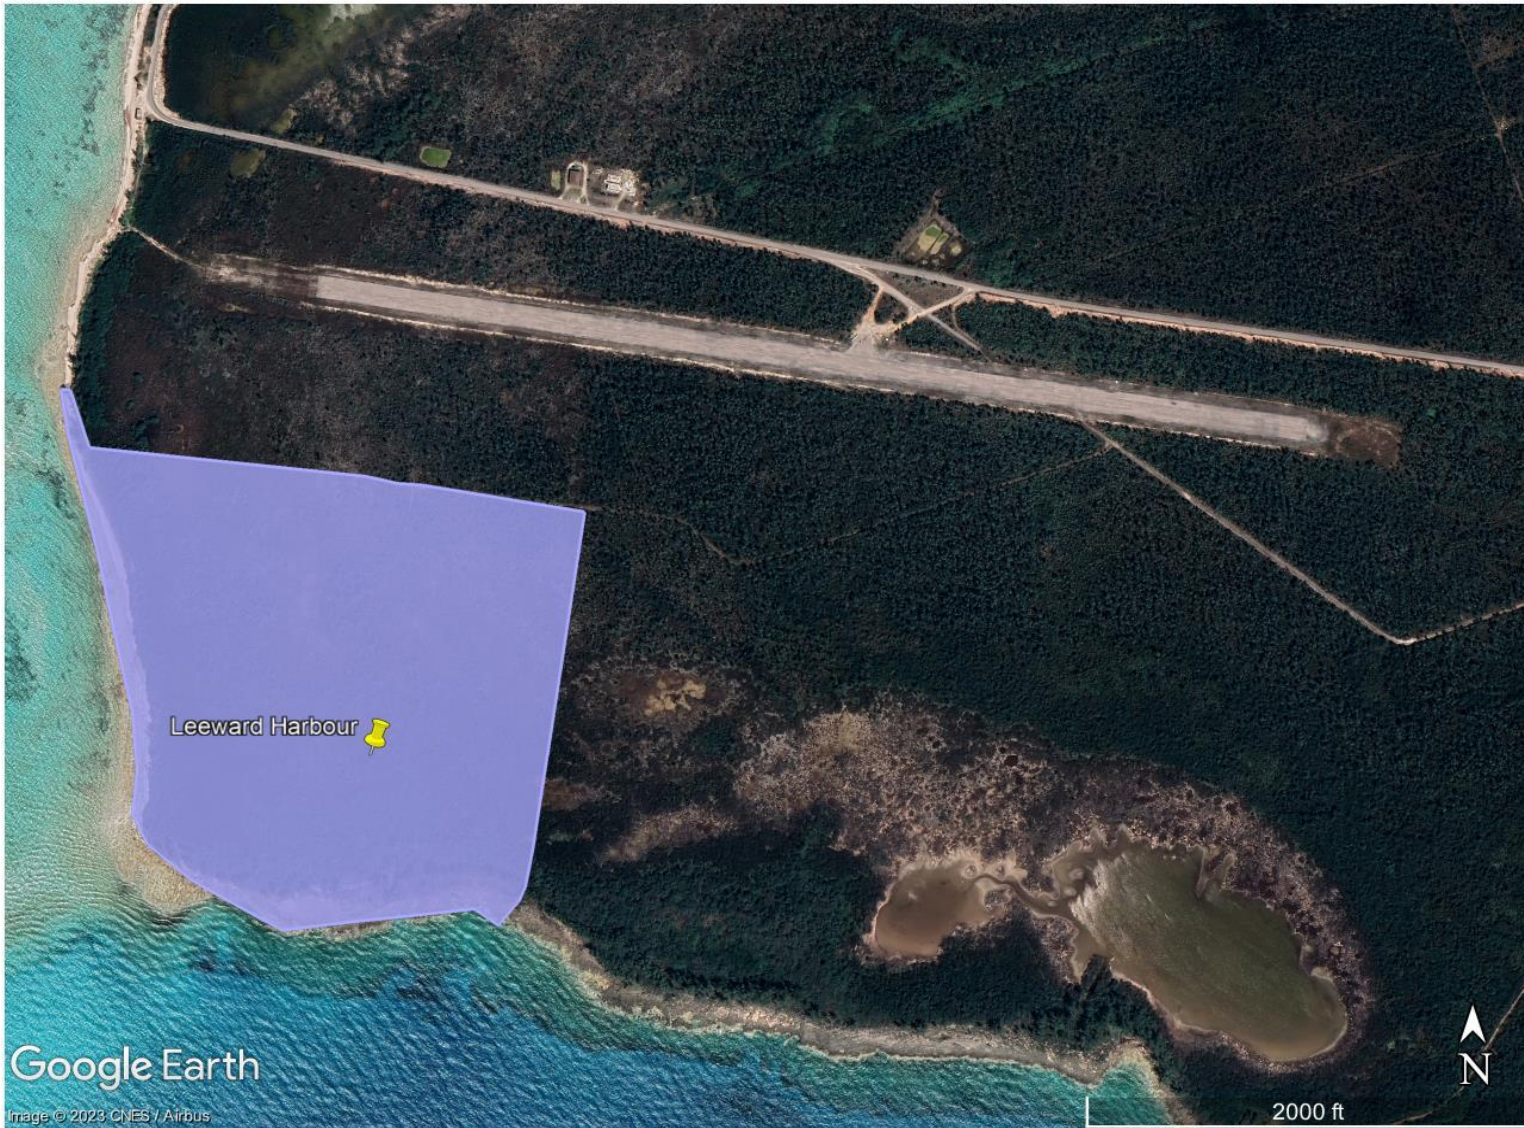
Figure 3.4. Leeward Harbour property boundary (Google Earth, 2023).

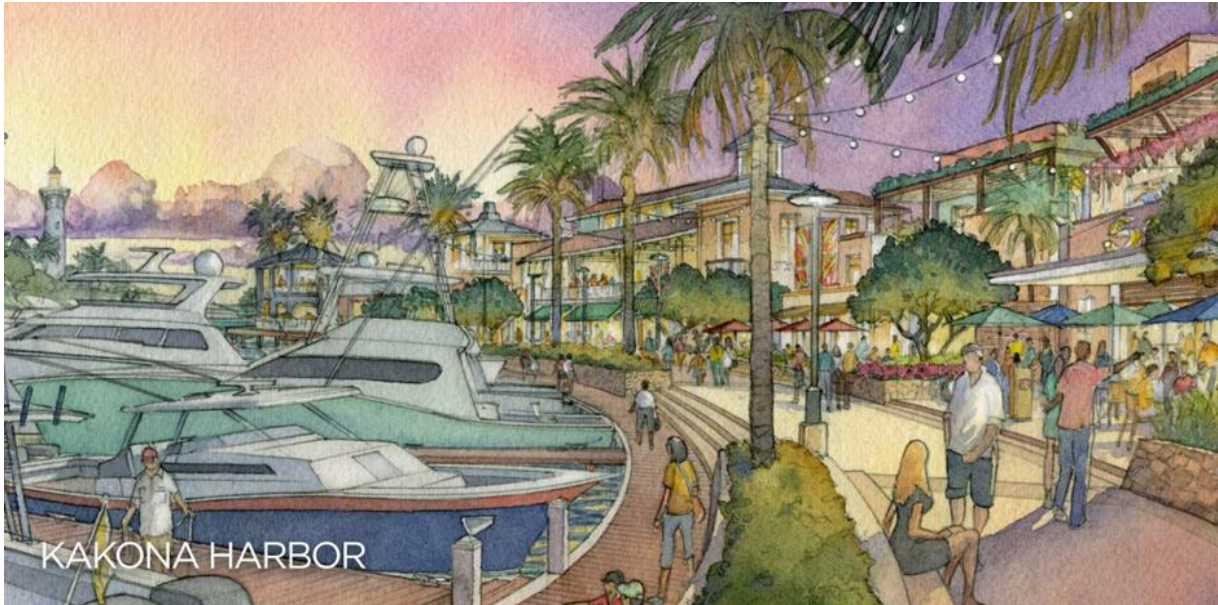
Figure 5.1. Conceptual drawing of the Kakona mixed-use harbor village.

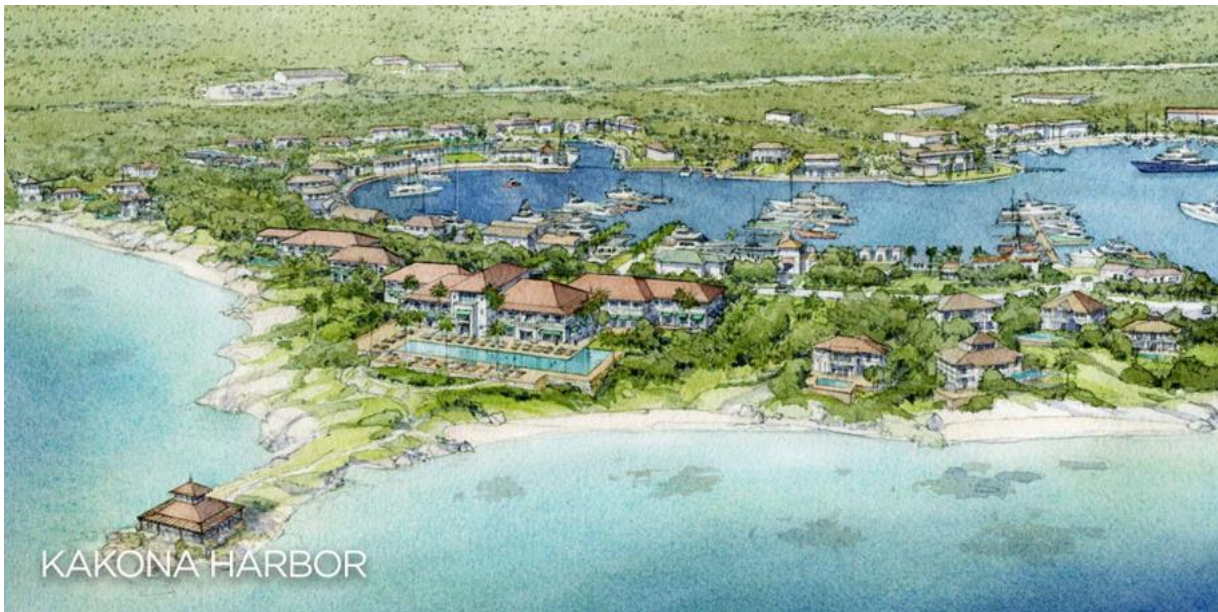
Figure 5.2. Conceptual drawing of Kakona Harbor.

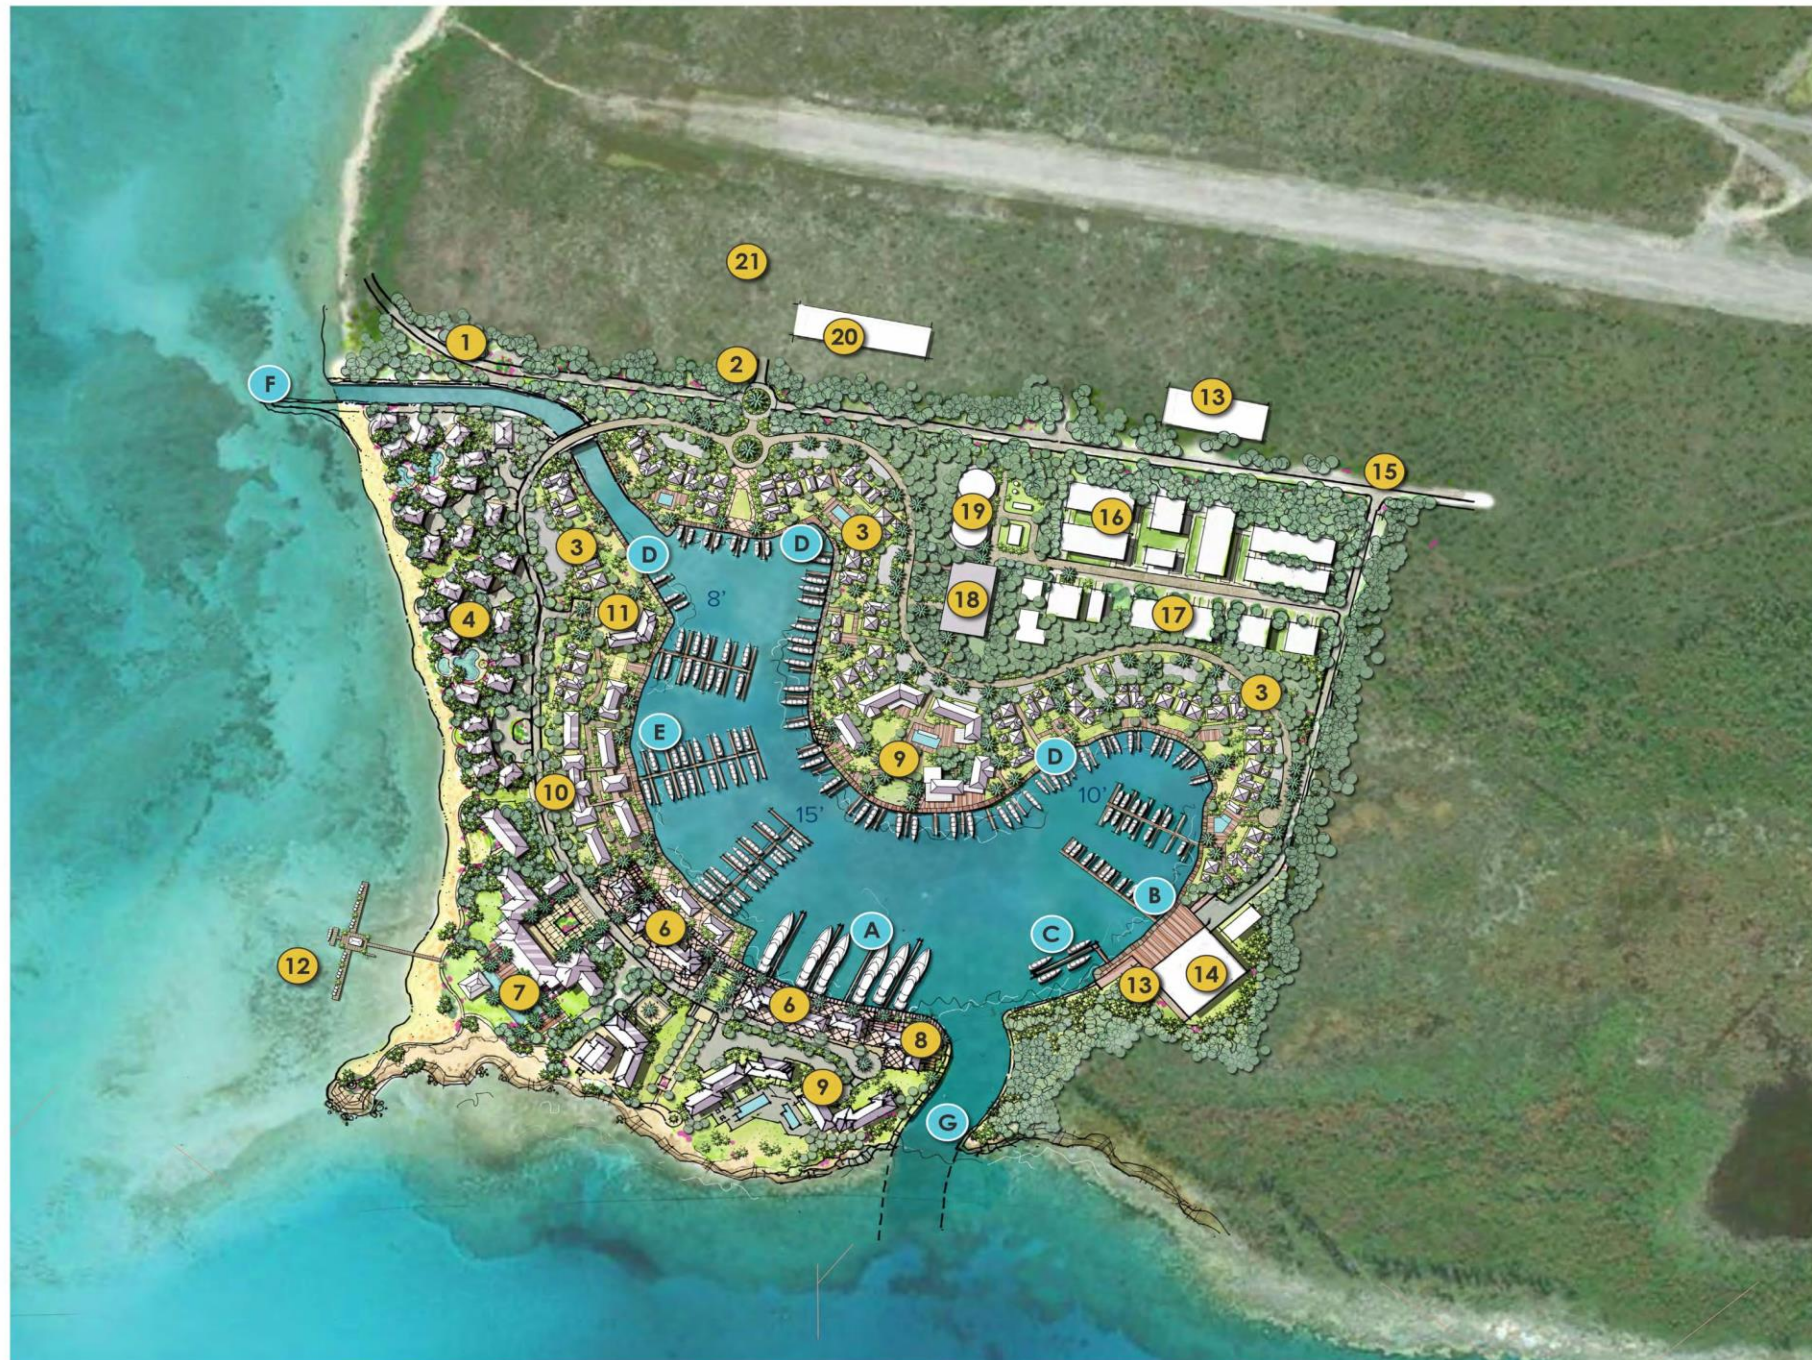
5.3.1 Leeward Harbour Master Plan

- ① CONNECTS TO MAIN HIGHWAY
- ② MAIN ENTRY ROUND ABOUT
- ③ HARBOURSIDE VILLAS
- ④ BEACH FRONT VILLAS
- ⑤ RESTAURANT
- ⑥ HARBOUR VILLAGE
- ⑦ BOUTIQUE HOTEL
- ⑧ CLUB
- ⑨ CONDO
- ⑩ MARINA MULTI-USE PLAZA
- ⑪ SIGNATUR RESTAURANT
- ⑫ ISLAND RETREAT
- ⑬ FUELING
- ⑭ DRY STACK STORAGE
- ⑮ BACK OF HOUSE / MARINE SERVICES GATED ENTRANCE
- ⑯ CENTRAL RECEIVING / BACK OF HOUSE
- ⑰ LIGHT MARINE INDUSTRIAL
- ⑱ PARKING
- ⑲ FACILITIES PLANT
- ⑳ FBO/ CUSTOMS HOUSE
- ㉑ APRON / PLANE PARKING

- Ⓐ SUPER YACHTS
- Ⓑ DRYSTACK & TRANSIENT DOCKS (40' to 100')
- Ⓒ FUEL DOCK
- Ⓓ STERN TO SLIPS (UP TO 80')
- Ⓔ FLOATING DOCK SLIPS (UP TO 100')
- Ⓕ FLUSHING CHANNEL
- Ⓖ ENTRANCE CHANNEL

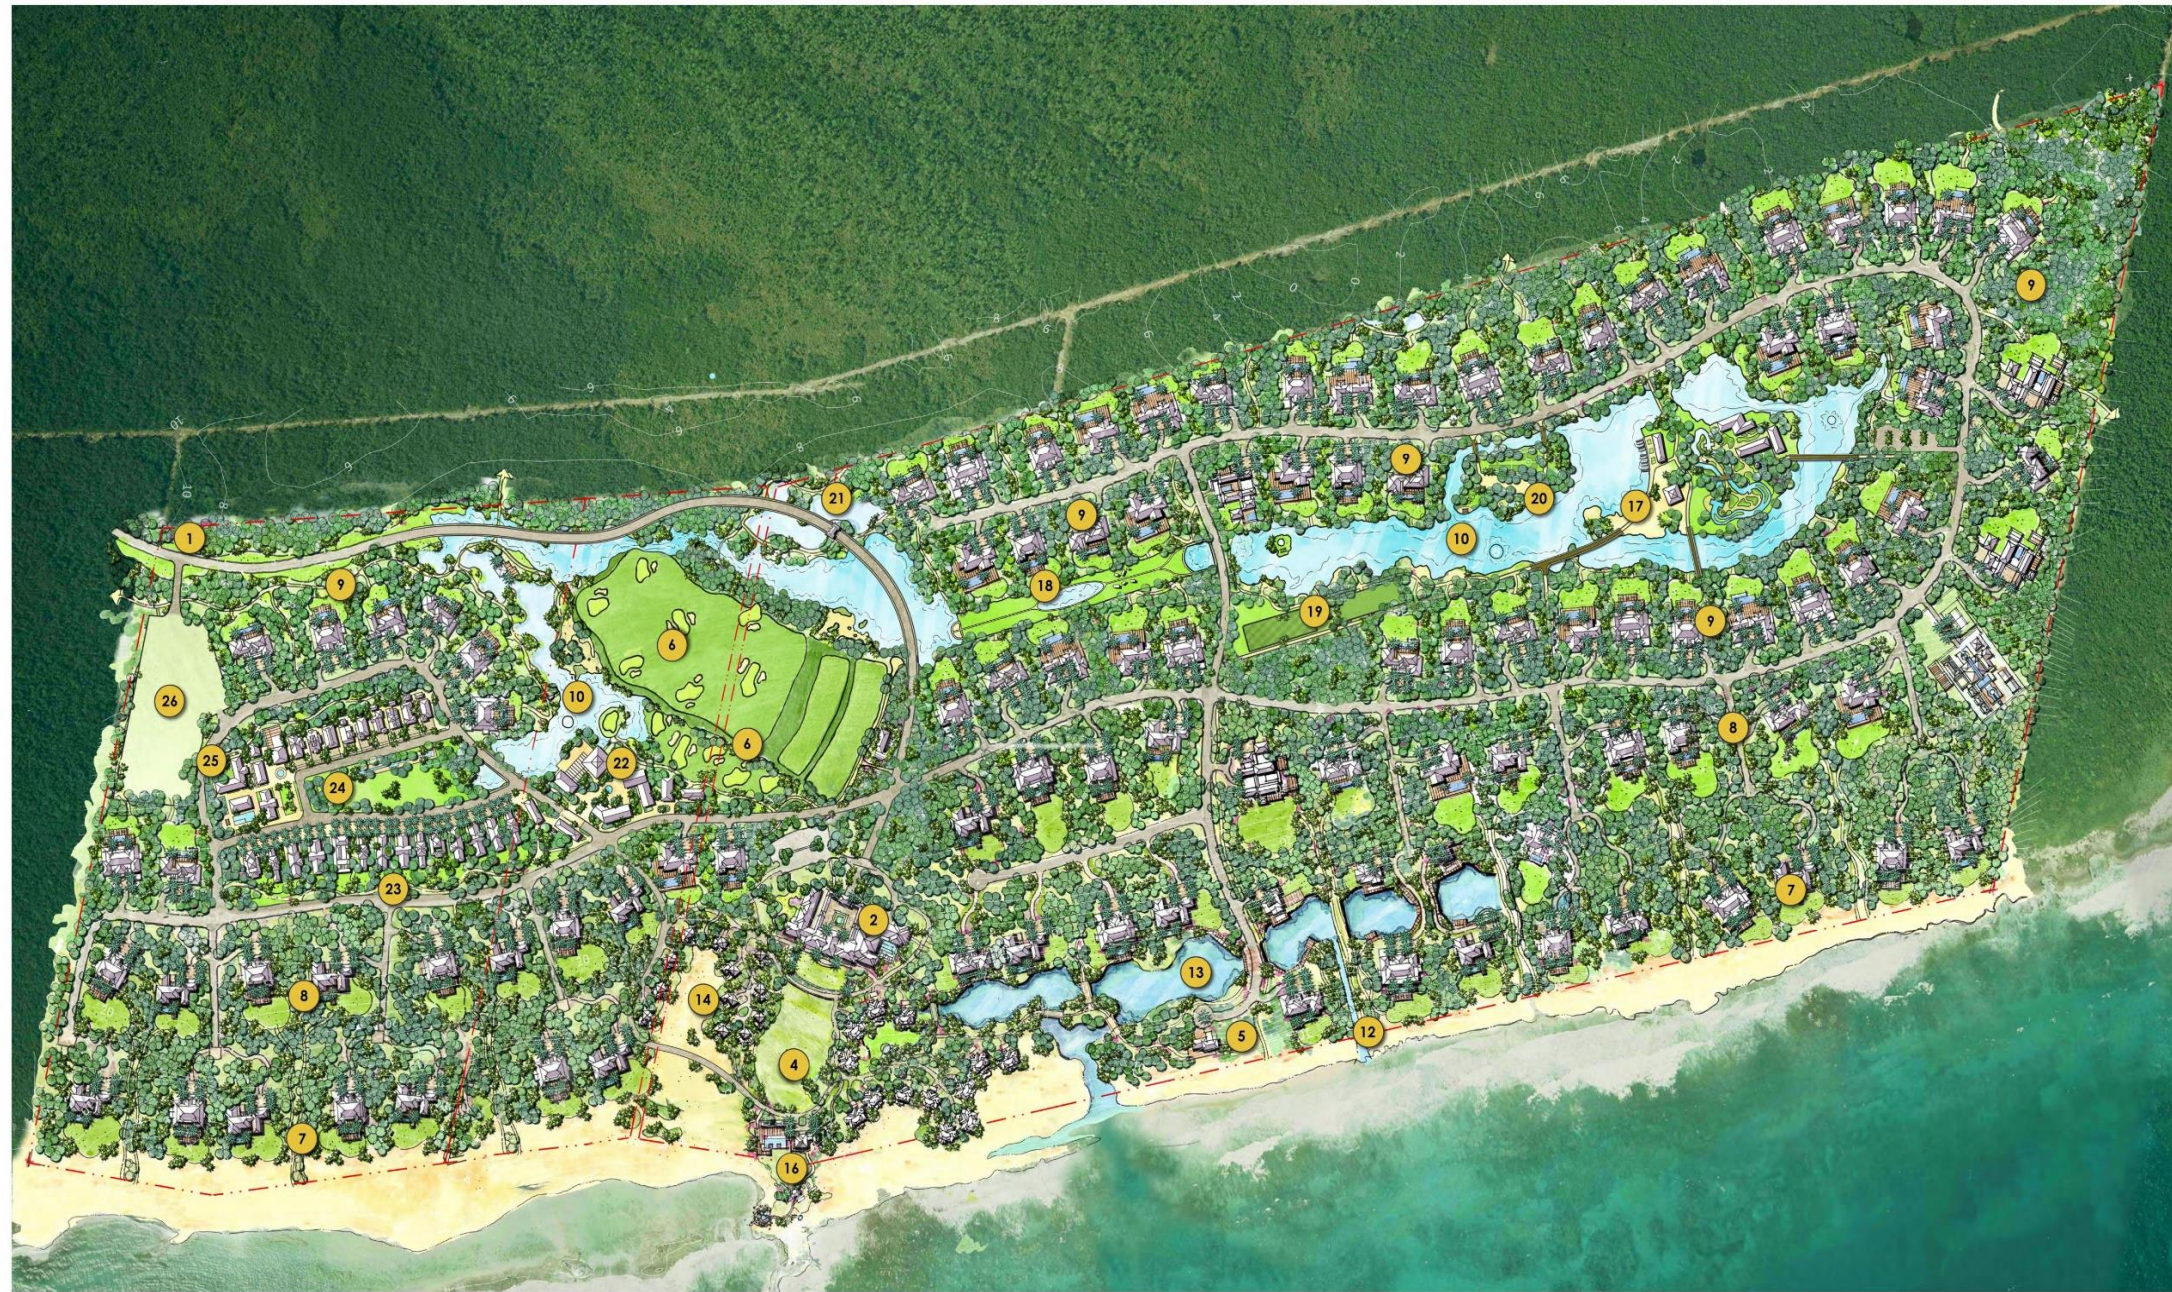
5.3.3 Conch Sound Point Master Plan

- 1 ENTRY DRIVEWAY AND LANDSCAPE STATEMENT
- 2 LODGE
- 3 BEACH
- 4 GRAND LAWN
- 5 GRAND BAR
- 6 PRACTICE & SIGNATURE PUTTING AREA
- 7 OCEAN FRONT ESTATES
- 8 HILL TOP ESTATES
- 9 PRESERVE VIEW ESTATES
- 10 FRESH WATER LAGOON
- 11 PRESERVE TRAILS
- 12 FLUSHING CHANNEL
- 13 SALT WATER LAGOON
- 14 COTTAGE
- 15 BUNGALOW
- 16 CLUB
- 17 ESTATE LAGOON RETREAT, POOL, LAZY RIVER, DOCK, EVENT PAVILION
- 18 FORMAL LAWN
- 19 EVENT LAWNS & MULTI-PURPOSE FIELDS
- 20 BOTANICAL GARDENS RETREAT
- 21 ENTRY GUARD HOUSE & SIGNATURE BRIDGE
- 22 ESTATE VILLAGE
- 23 TOWNHOUSES
- 24 TOWN PLAZA, LAWN, CLUBHOUSE, POOL, RESTAURANT
- 25 DAY CARE FACILITY
- 26 BOH, NURSERY, FACILITY MANAGEMENT

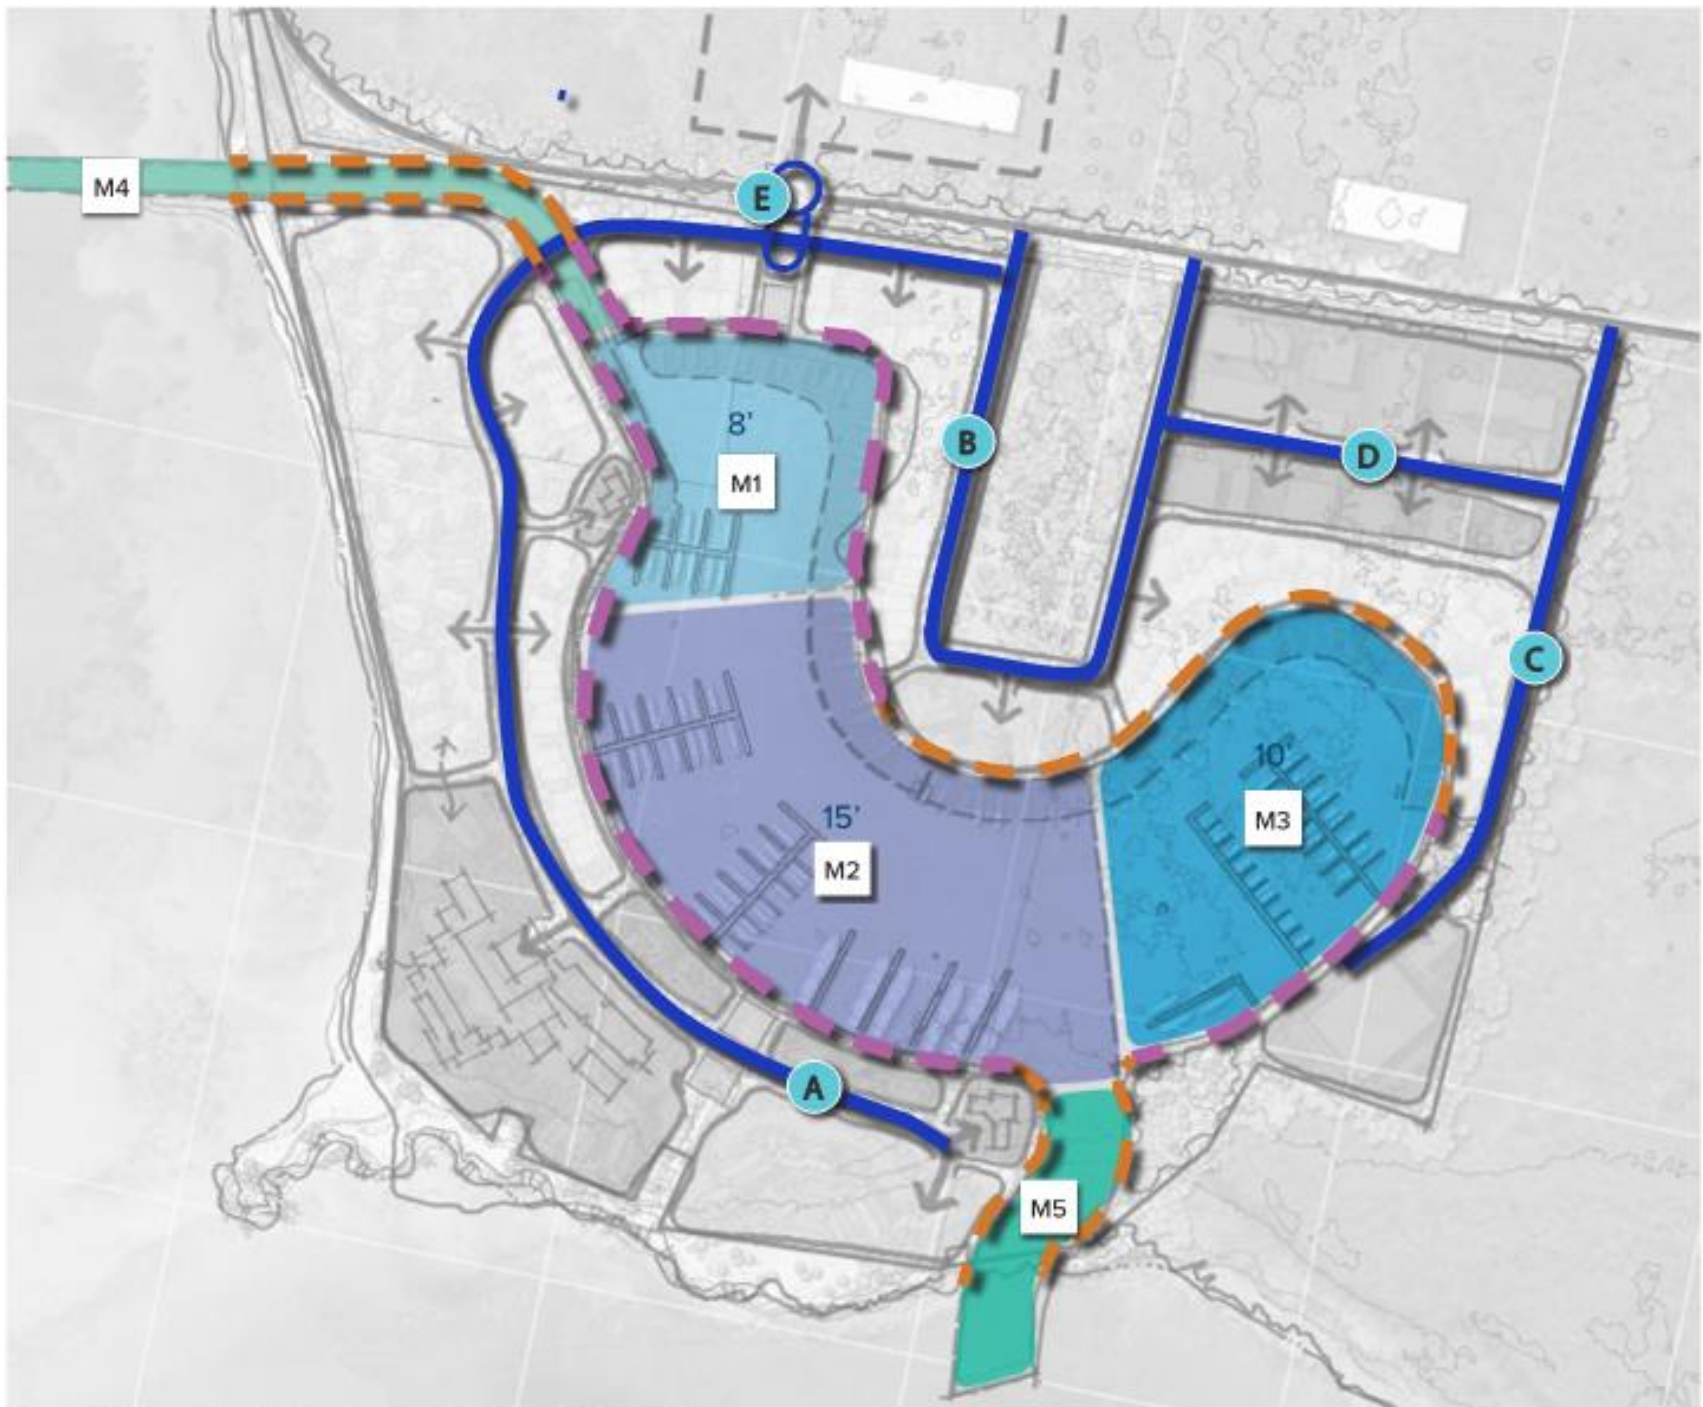
Figure 5.12. Leeward Harbour roadways design plan

Proposed road development for LH allows visitors and staff easy access to building structures and amenities on the site. Five (5) roads will provide access to structures surrounding the harbor (See Figure below).

MARINA & ROAD TAKEOFF DIAGRAM

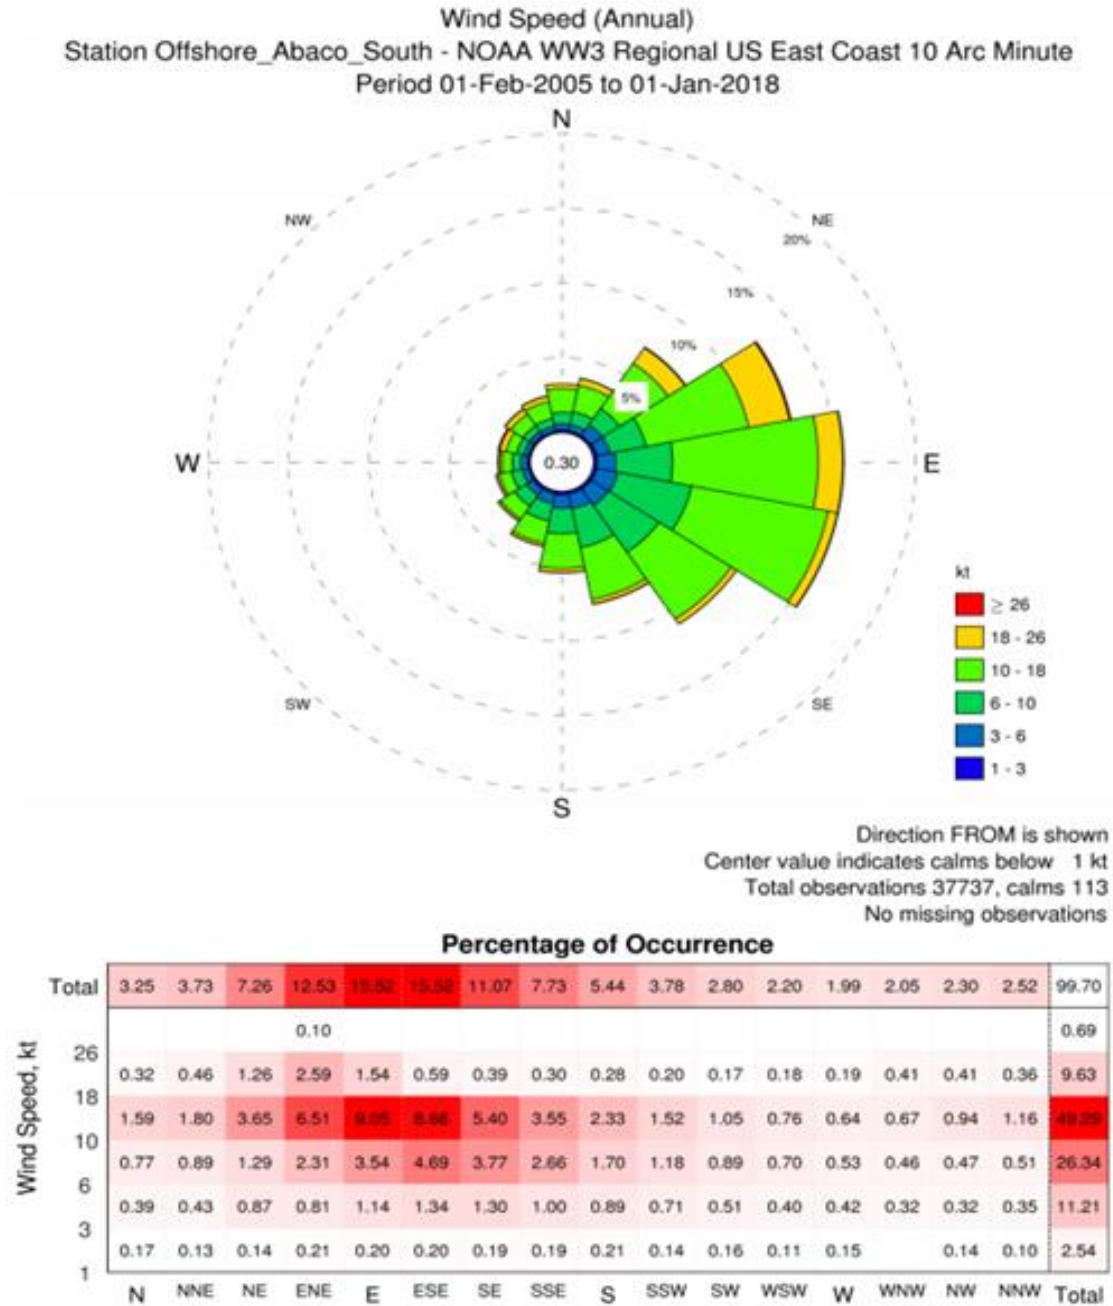
Figure 7.15. Annual wind rose of South Abaco (2018).

The prevailing offshore winds east of the Abaco island are from the east-northeast to the south-southeast directions. Stronger winds are from the east-northeast direction. The 1% annual exceedance wind is approximately 25 knots (kt.).

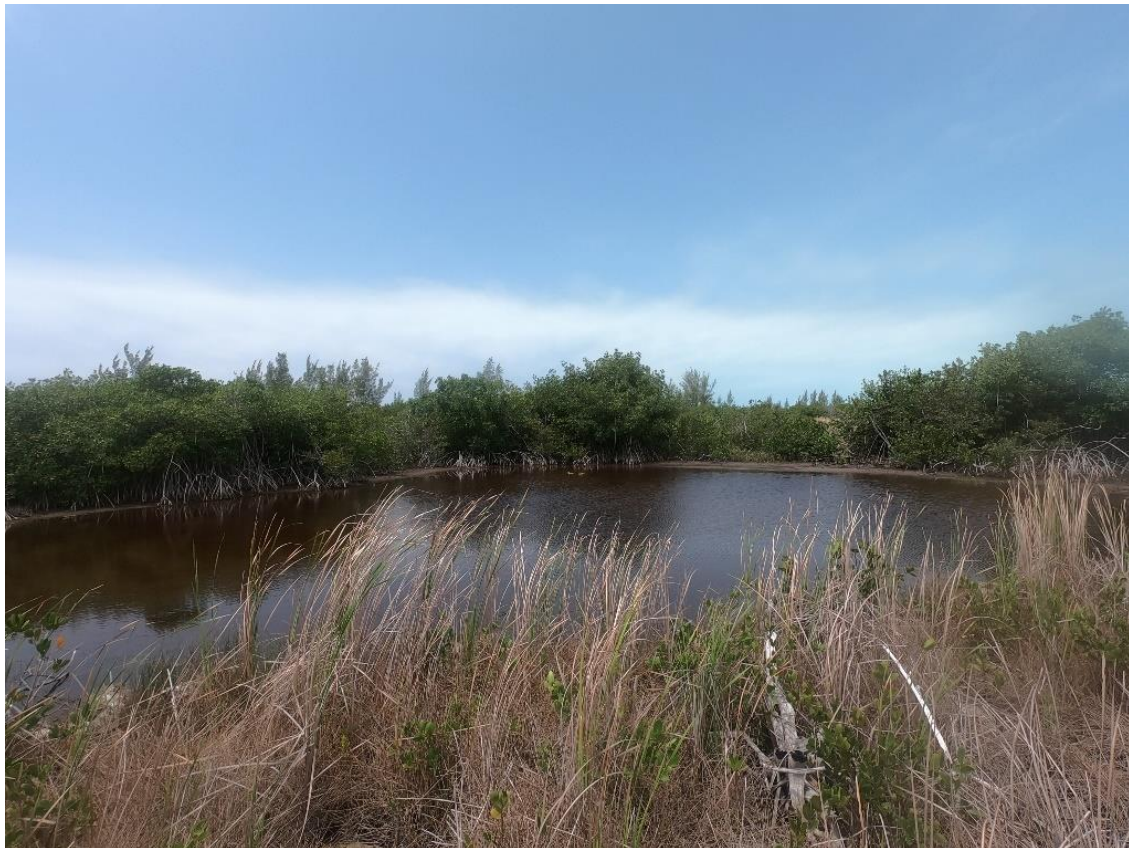
Figure 7.39. Image of sample point.

Average sample temperature in this sample location were recorded at 94.30°F, pH at 8.37, turbidity at 90 NTU, salinity at 6.61 ppt and dissolved oxygen at 8.63mg/L. These results indicate that the sample area is a considerably healthy freshwater environment due to standard levels of dissolved oxygen and pH, as well as the low salinity levels. High temperatures indicate the lack of flushing and stagnant nature susceptible to evaporation. Although this is considered a freshwater habit, it is not recommended for direct consumption of recreation due to high levels of turbidity.

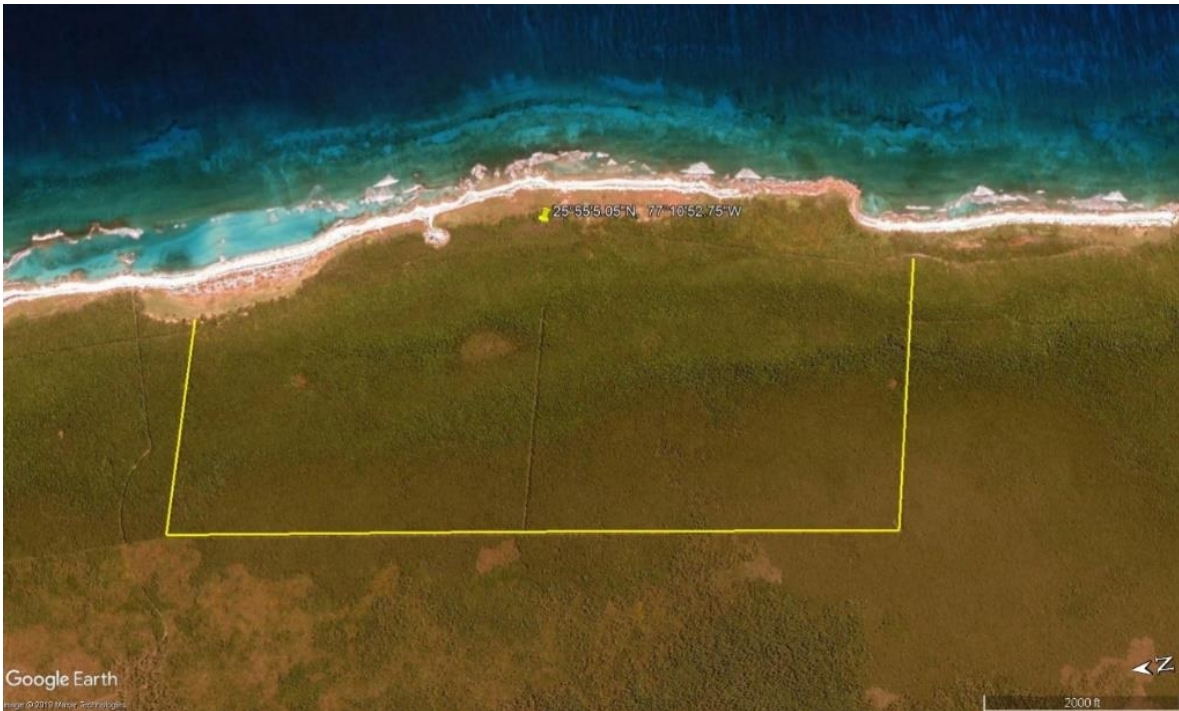
Figure 7.40. Water quality sample point at HBB.

Site	High Bank Bay - Mangrove Overwash		
<u>Description of Water Body</u>	Low lying area behind primary dune system at HBB. Dominated by Black Mangrove in mucky soils		
<u>GPS</u>	25°55'5.05"N, 77°10'52.75"W		
<u>Date</u>	April 16, 2019		
<u>Data #</u>	23	22	21
<u>Time</u>	10:20 a.m.	10:19 a.m.	10:17 a.m.
<u>Temp (°C)</u>	27.7	27.58	27.55
<u>pH</u>	8.87	8.54	8.55
<u>pHmV (mV)</u>	-124	-104	-105
<u>ORP (mV)</u>	-3	-21	-150
<u>Cond (mS/cm)</u>	23.9	54.7	34.8
<u>Turbidity (NTU)</u>	758	111	0
<u>DO (mg/L)</u>	8.09	9.75	5.03
<u>TDS (g/L)</u>	14.9	32.8	21.1
<u>Salinity (ppt)</u>	14.48	36.23	21.88
<u>SG (Sigma t)</u>	7.3	23.6	12.9
<u>Depth (m)</u>	0.15	0.15	0.1

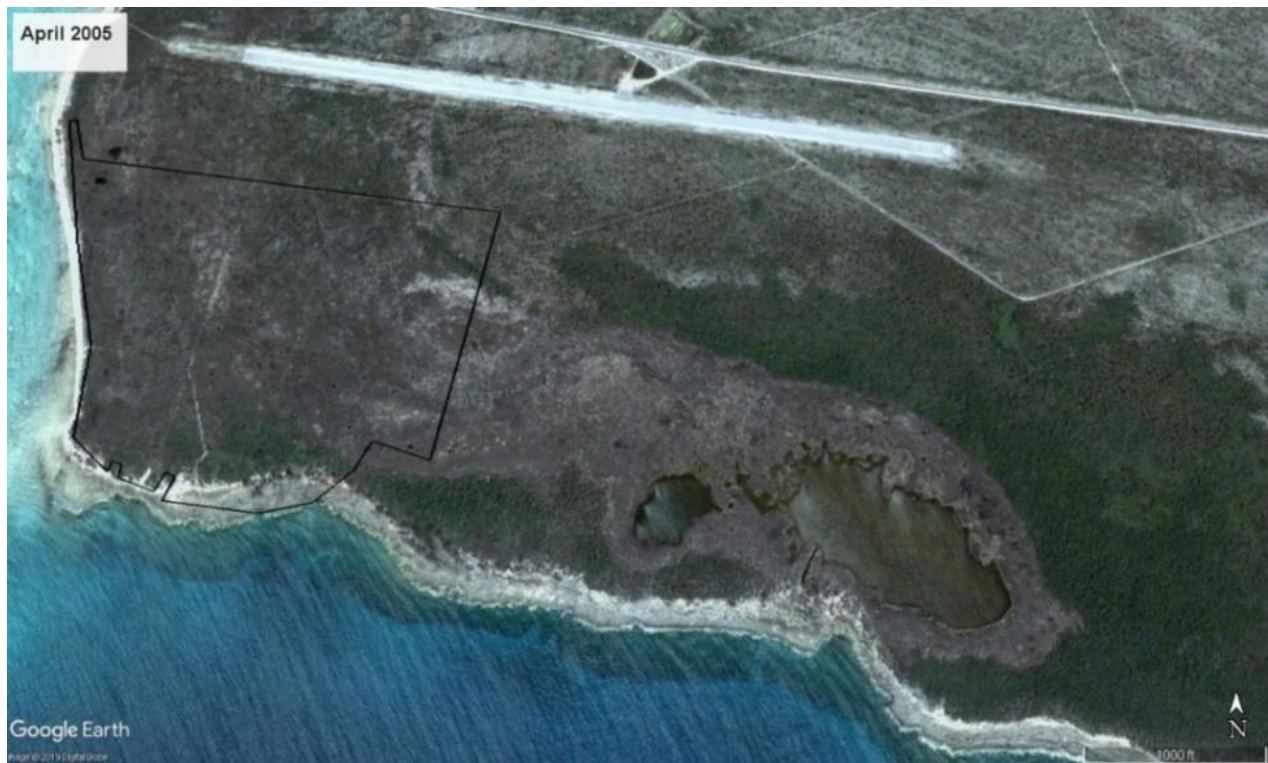
Figure 7.45. Satellite image of wetland fluctuations, April 2005.

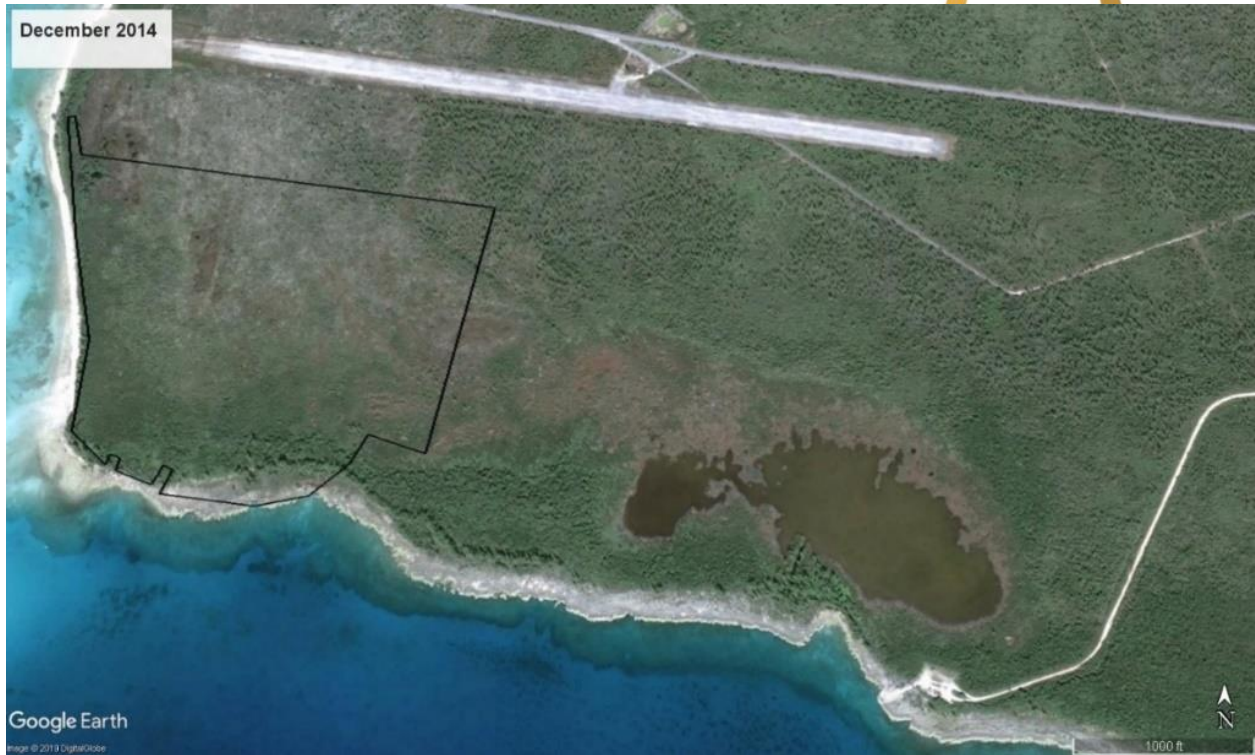
Figure 7.46. Satellite image of wetland fluctuations, December 2014.

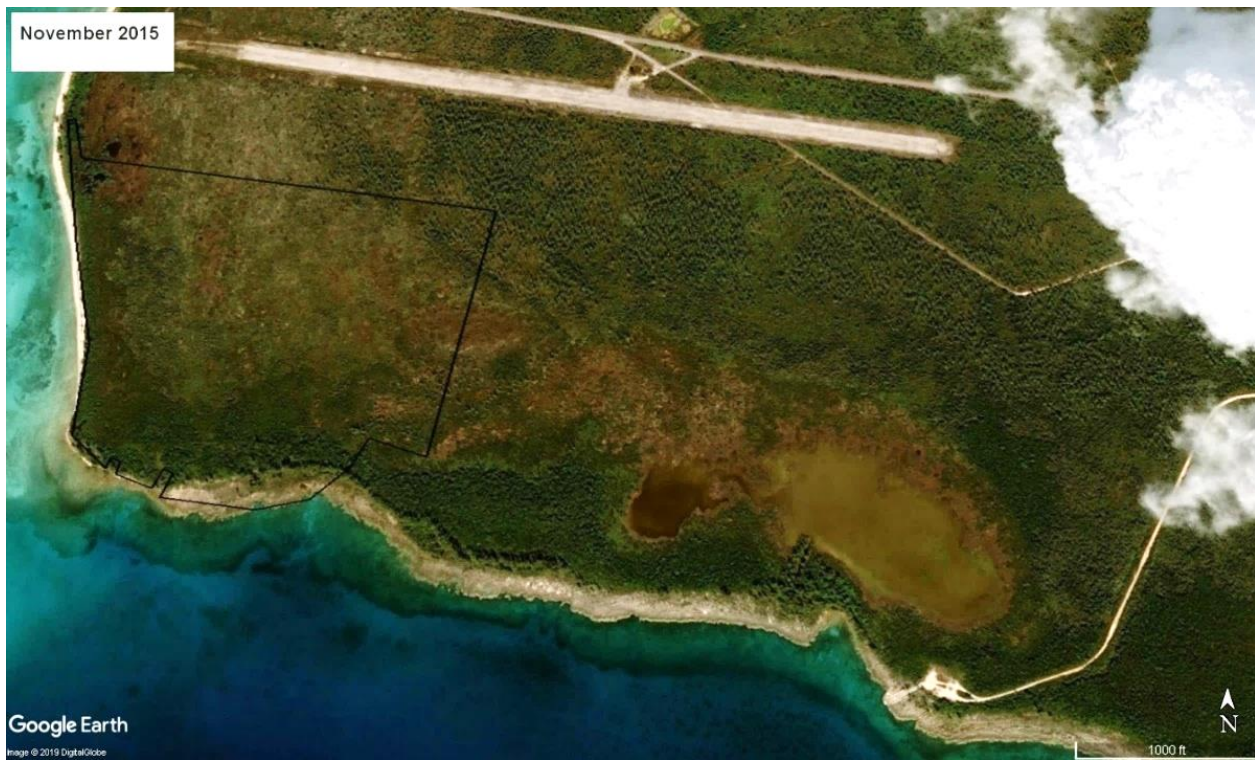
Figure 7.47. Satellite image of wetland fluctuations, November 2015.

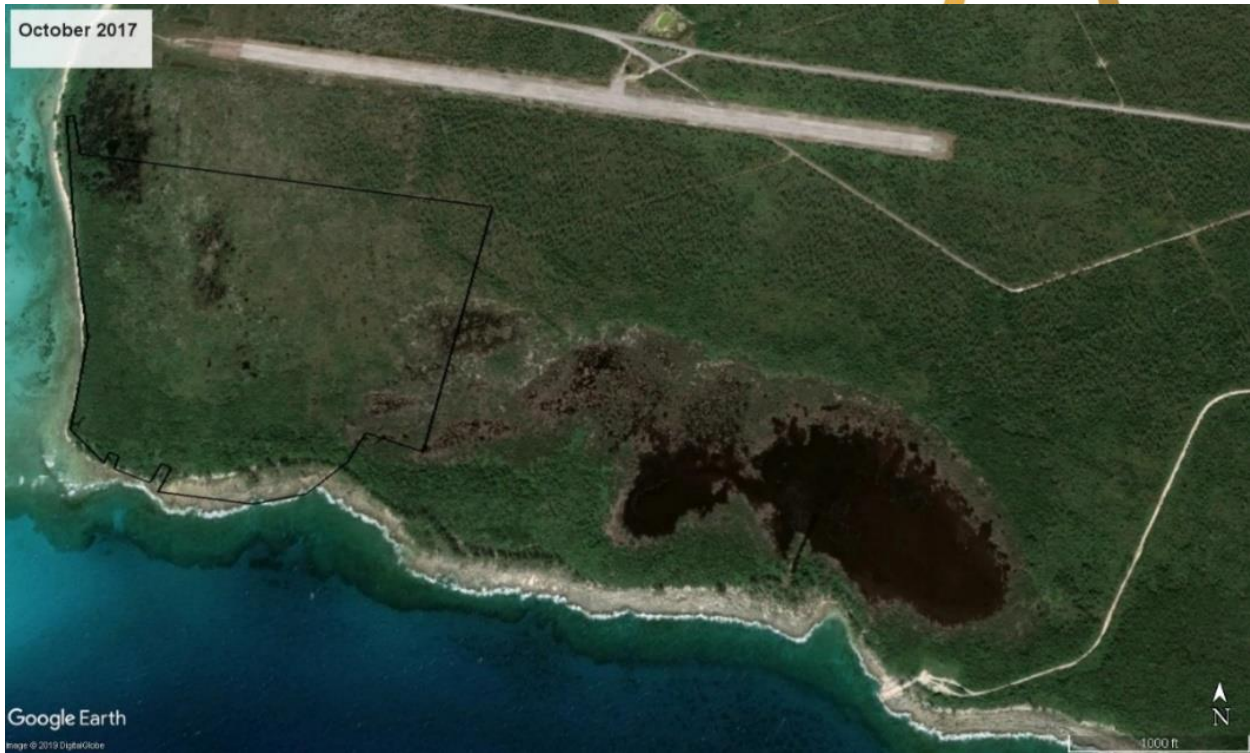
Figure 7.48. Satellite image of wetland fluctuations, October 2017.

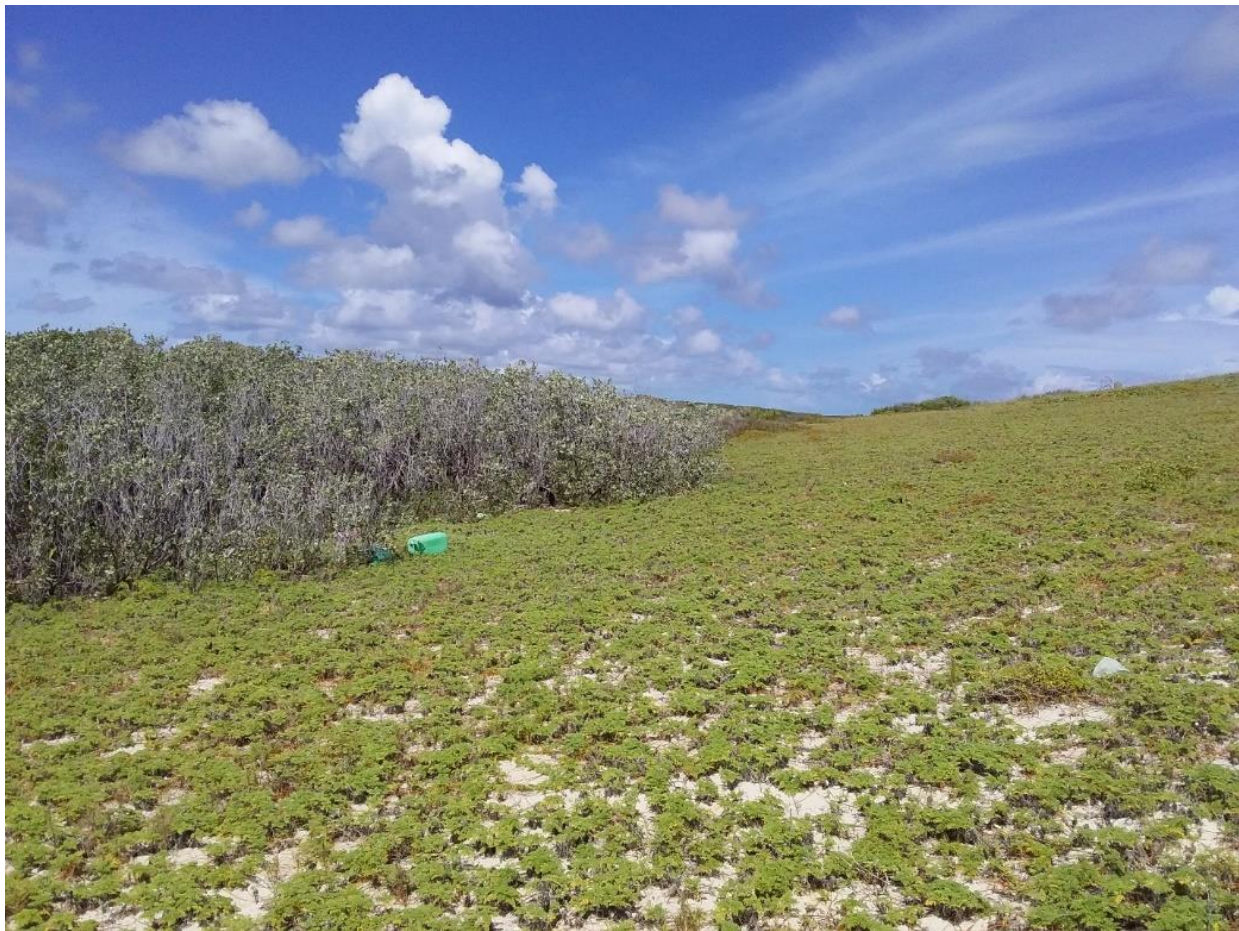
Figure 7.50. Boundary between sandy dune community and Mangrove forests at HBB.

The low-lying areas behind the primary dune systems accumulate water during rainfall and over wash during high storm surges. This habitat runs parallel to the coastline, with a damp mucky substrate along its perimeters and some standing brackish water within the interior of the mangrove system. The dominant vegetation along the perimeter of the wetlands are *Conocarpus erectus*, *Coccoloba uvifera*, *Hymenocallis arenicola*, *Laguncularia racemosa*, *Canavalia rosea*, *Metopium toxiferum*, *Sideroxylon americanum* and *Scaevola taccada*. The wetter interior areas of the wetlands are dominated by the Black Mangrove (*Avicennia germinans*).

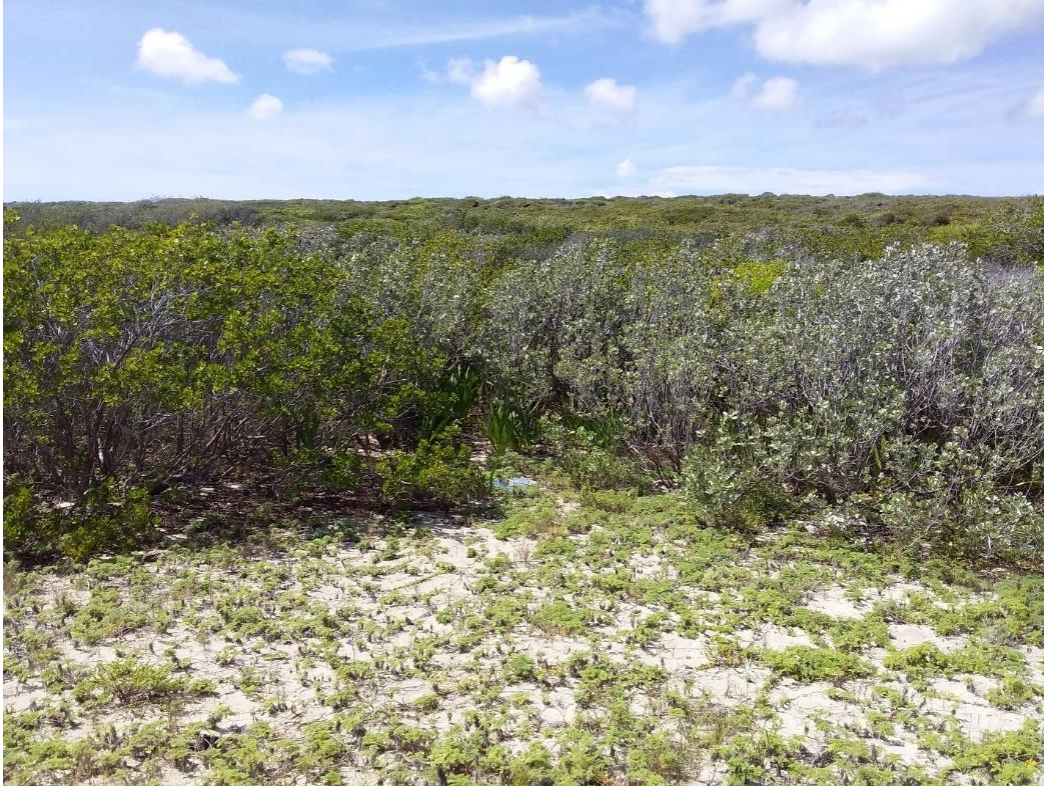
Figure 7.51. Mangrove wetland at HBB, *Conocarpus erectus* in foreground.

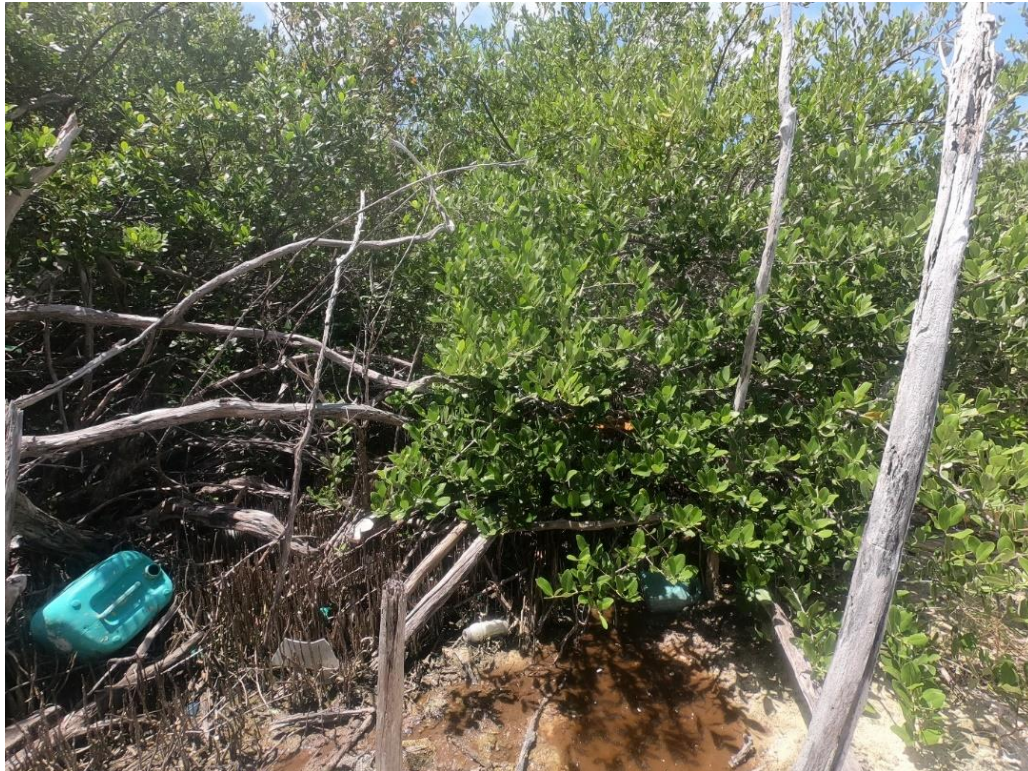
Figure 7.52. *Avicennia germinans* dominating mangrove wetland interior.

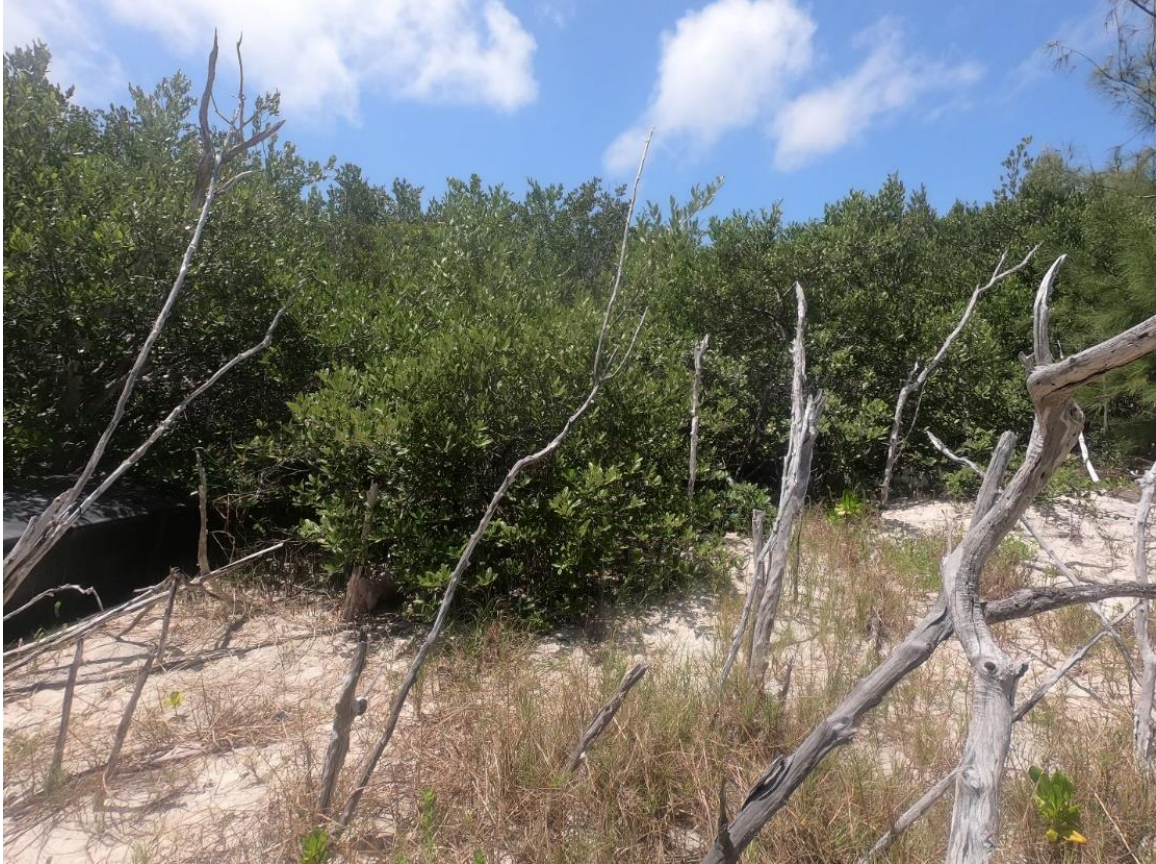
Figure 7.53. Black Mangrove growing along perimeter of mangrove wetland.
