ENVIRONMENTAL IMPACT ASSESSMENT

THE SETAI - KAKONA RESORT DEVELOPMENT

LEEWARD HARBOUR, CONCH SOUND POINT, AND HIGH BANK BAY

SOUTH ABACO, BAHAMAS

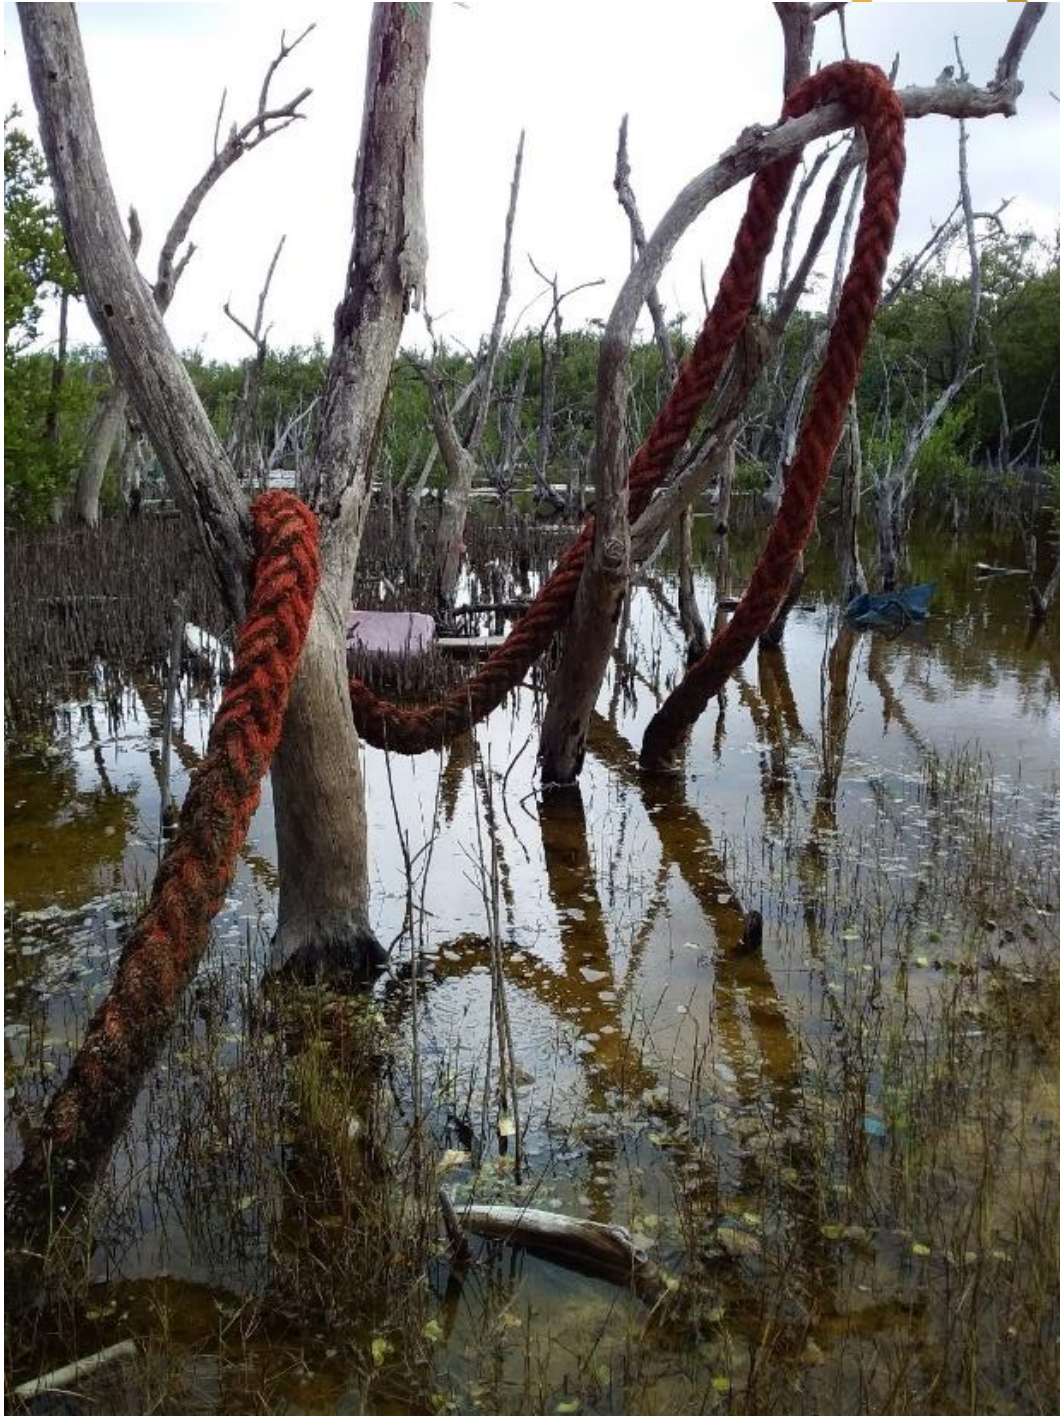
Figure 7.54. Mangrove wetland at CSP.

The low-lying areas behind the primary dune systems accumulate water during rainfall and over wash during high storm surges. This habitat runs parallel to the coastline, with a damp mucky substrate along its perimeters and some standing brackish water within the interior of the mangrove system. The dominant vegetation along the perimeter of the wetlands are *Conocarpus erectus*, *Coccoloba uvifera*, *Hymenocallis arenicola*, *Laguncularia racemosa*, *Canavalia rosea*, *Metopium toxiferum*, *Sideroxylon americanum* and *Scaevola taccada*. The wetter interior areas of the wetlands are dominated by the Black Mangrove (*Avicennia germinans*).

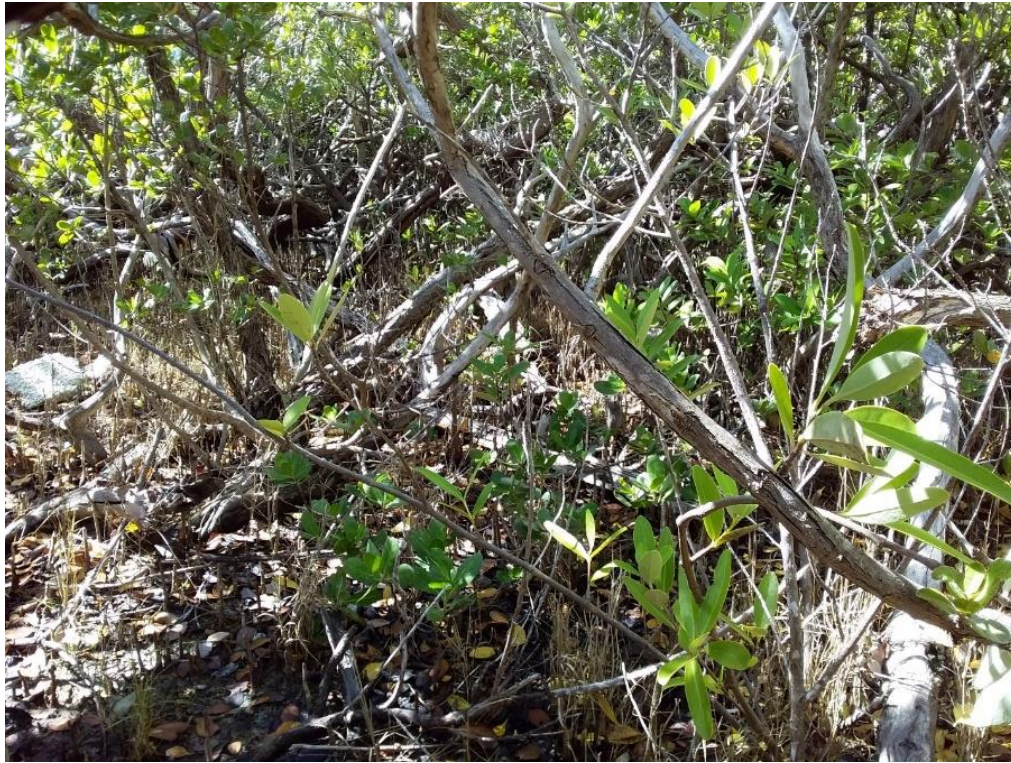
Figure 7.55. Red and Black Mangroves in wetland at CSP.

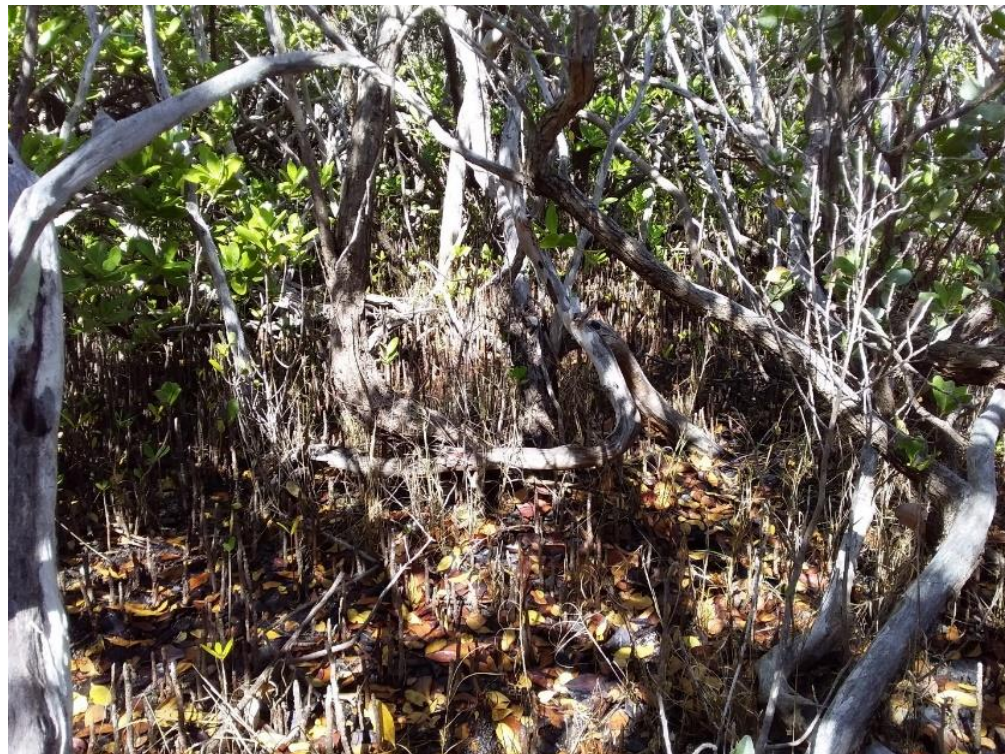
Figure 7.56. Red and Black Mangroves in wetland at CSP.

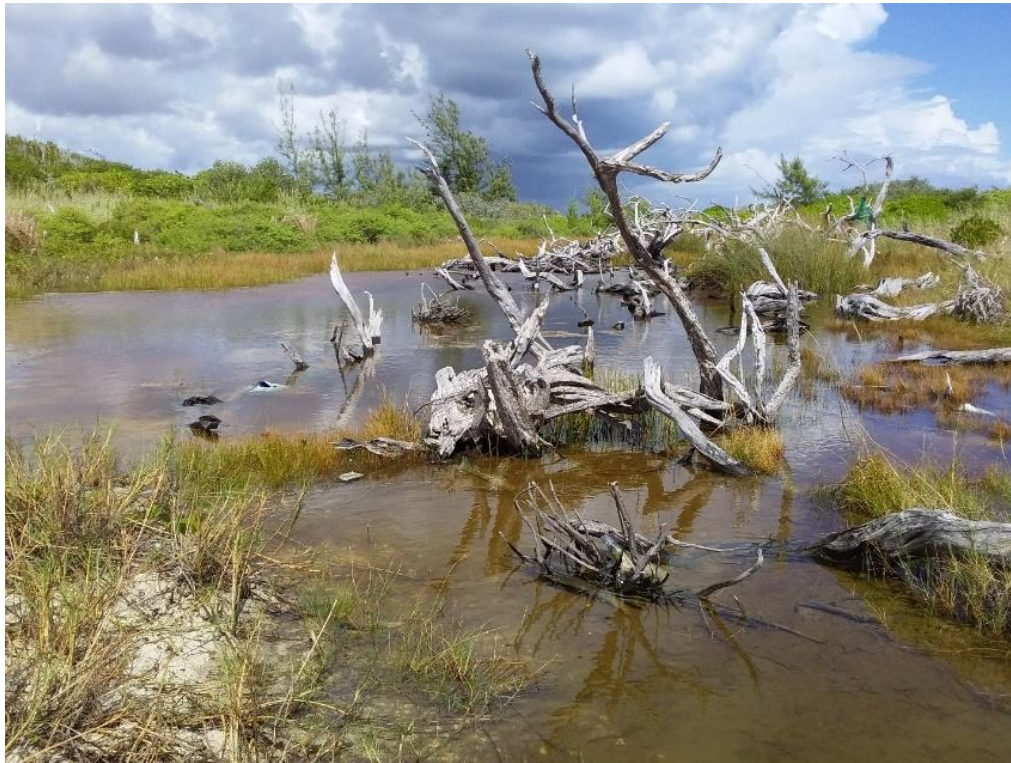
Figure 7.57. Ephemeral wetland at CSP.

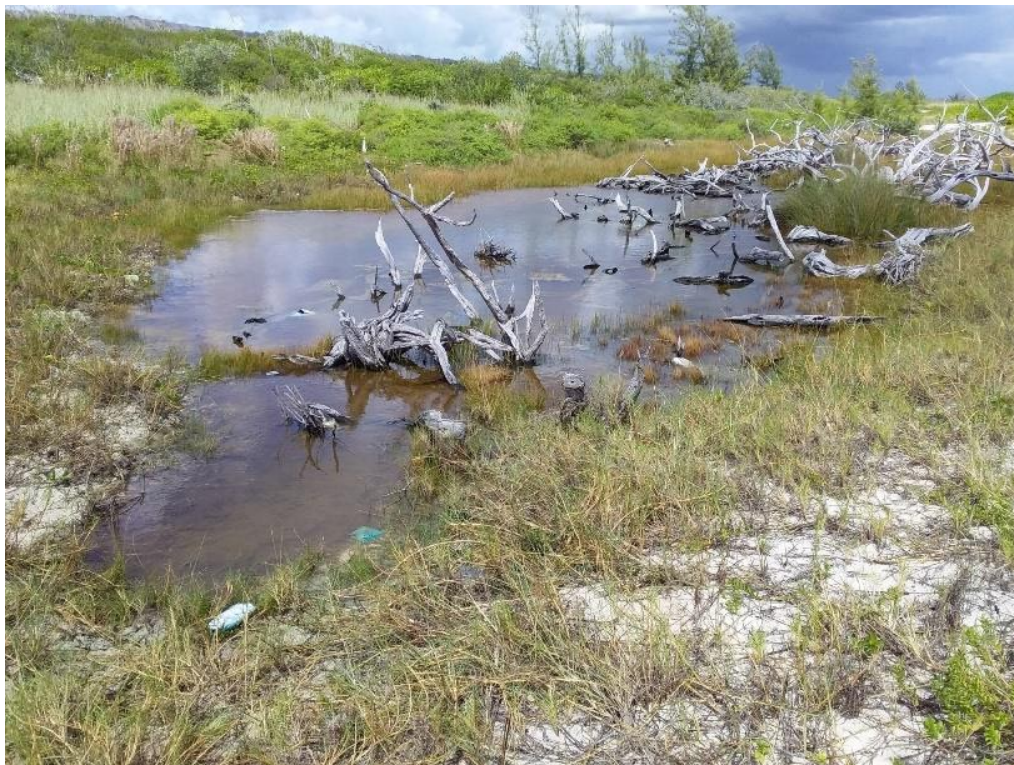
Figure 7.58. Ephemeral wetland at CSP.

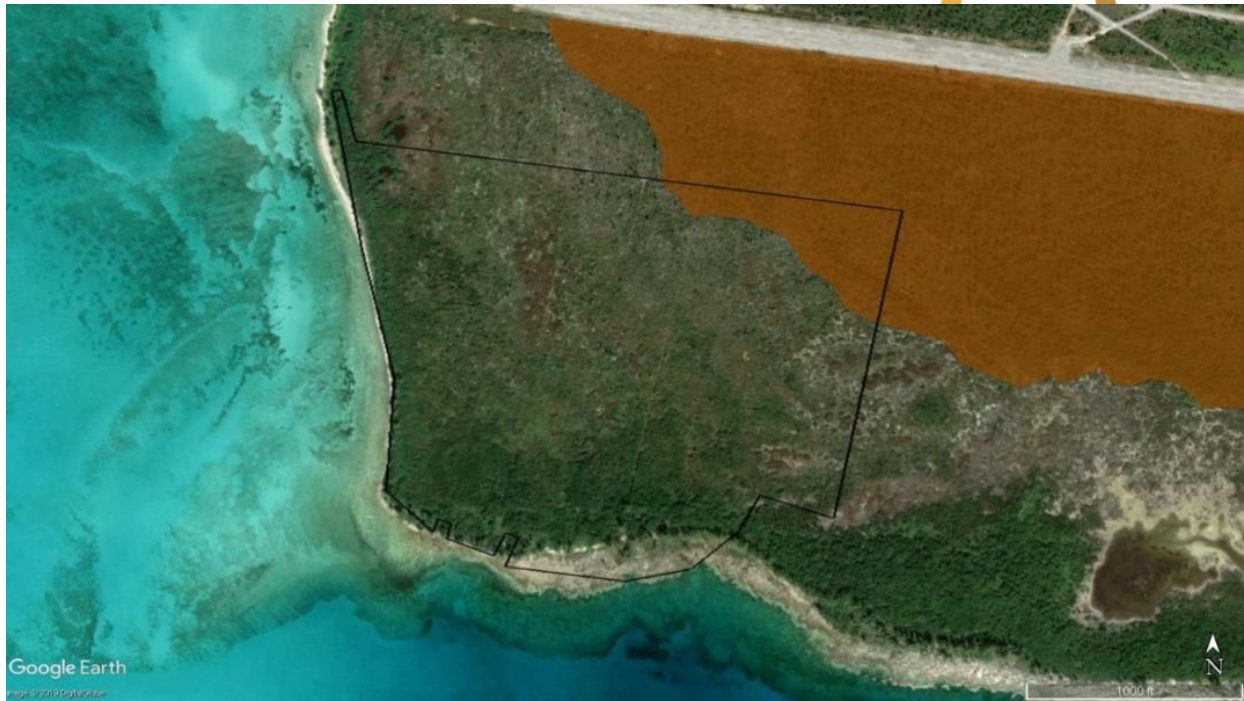
Figure 7.59. Habitat map depicting Pine Woodlands at Leeward Harbour (brown highlighted area).

Pine forests dominate the areas around the LH site, however the *Pinus caribea var. bahamensis* dominant vegetation does not extend throughout the site. Pine dominated woodlands occupy the northwestern area of the LH site, transitioning to a shrubland devoid of *Pinus caribea var. bahamensis* in the canopy. The individuals of *Pinus caribea var. bahamensis* in the woodlands are on average 6-8 m. tall, and do not form a closed canopy. The pinelands grow in a thin soil layer overlaying a pitted limestone surface which collects moist soil in its pockets. In areas where the pitted limestone is exposed, vegetation only grows out of pits with sufficient soil and moisture to support the vegetation there. The understory of the Pine Woodland is on average 1-2 m. tall, supporting a diversity of species, however mostly dominated by *Metopium toxiferum* and *Cassytha filiformis*. Other species occurring in the understory of the Pine Woodlands include *Byrsonima lucida* (Guana Berry), *Lantana involucrate* (White Sage), *Vachellia choriophylla* (Cinnecord), *Smilax havanensis* (Razor Vine), *Morinda royoc* (Rhubarb), *Ardisia escallanoides* (Marlberry), *Varronia bahamensis* (Cat's Tongue, endemic), *Pithecellobium keyense* (Ram's Horn), *Tabebuia bahamensis* (Five Finger), *Corchorus hirsutus* (Wooly Buggar), *Coccothrinax argentata* (Silver Thatch Palm), *Pteridium aquilinum* (Bracken Fern), *Sideroxylon salicifolium* (Willow Busic), *Dichromena floridanum*, *Coccoloba diversifolia* (Pigeon Plum), *Erithalis fruticosa* (Black Torch), *Swietenia mahagoni* (Mahogany, protected), *Trema lamarckianum* (Pain in Back), *Ipomoea indica* (Morning Glory), *Thouinia discolor* (Quicksilver Bush, endemic) and *Cladium jamaicense* (Sawgrass).

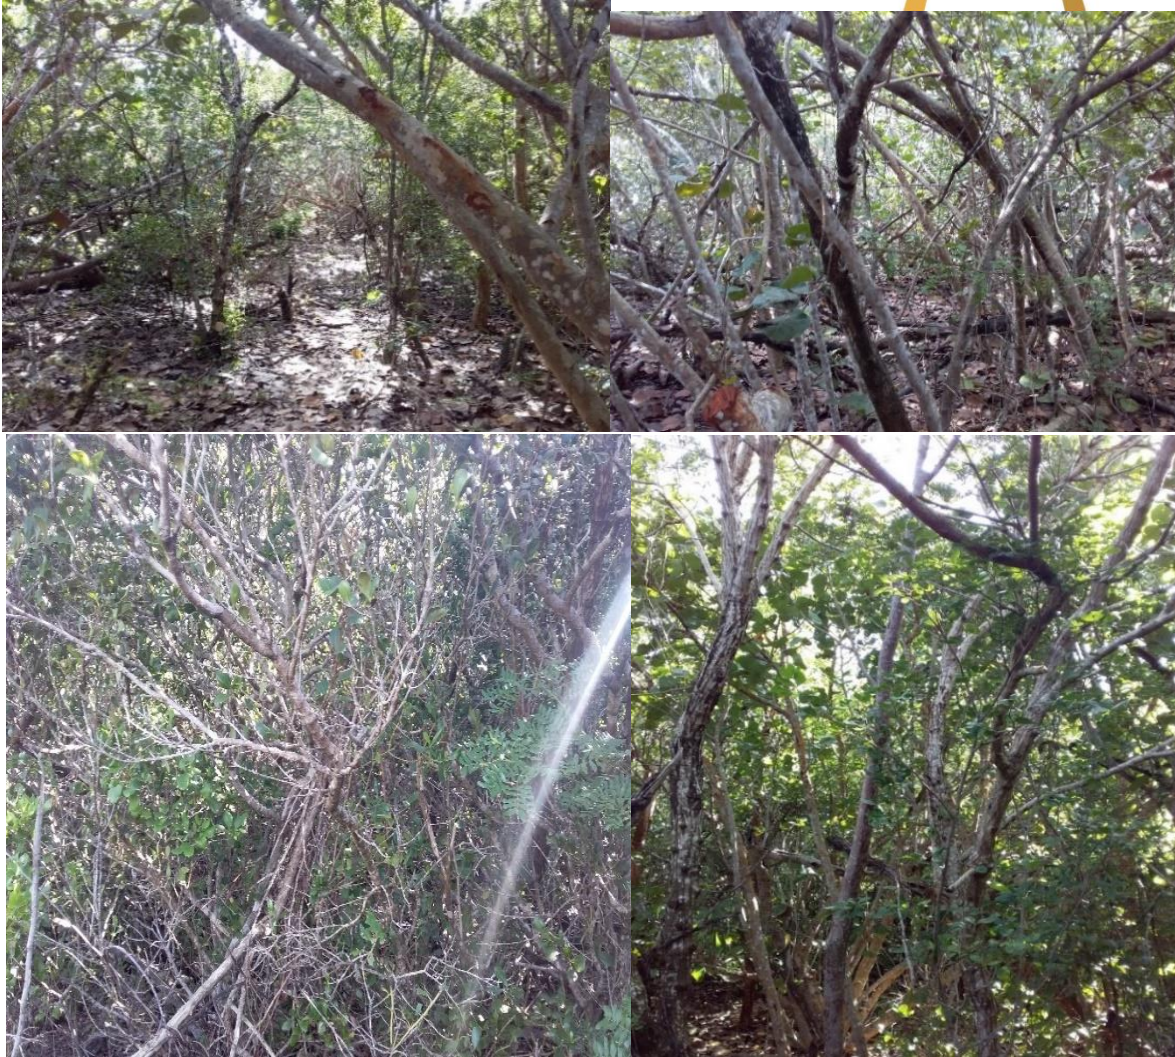
Figure 7.62. Coastal coppice & shrublands at Leeward Harbour.

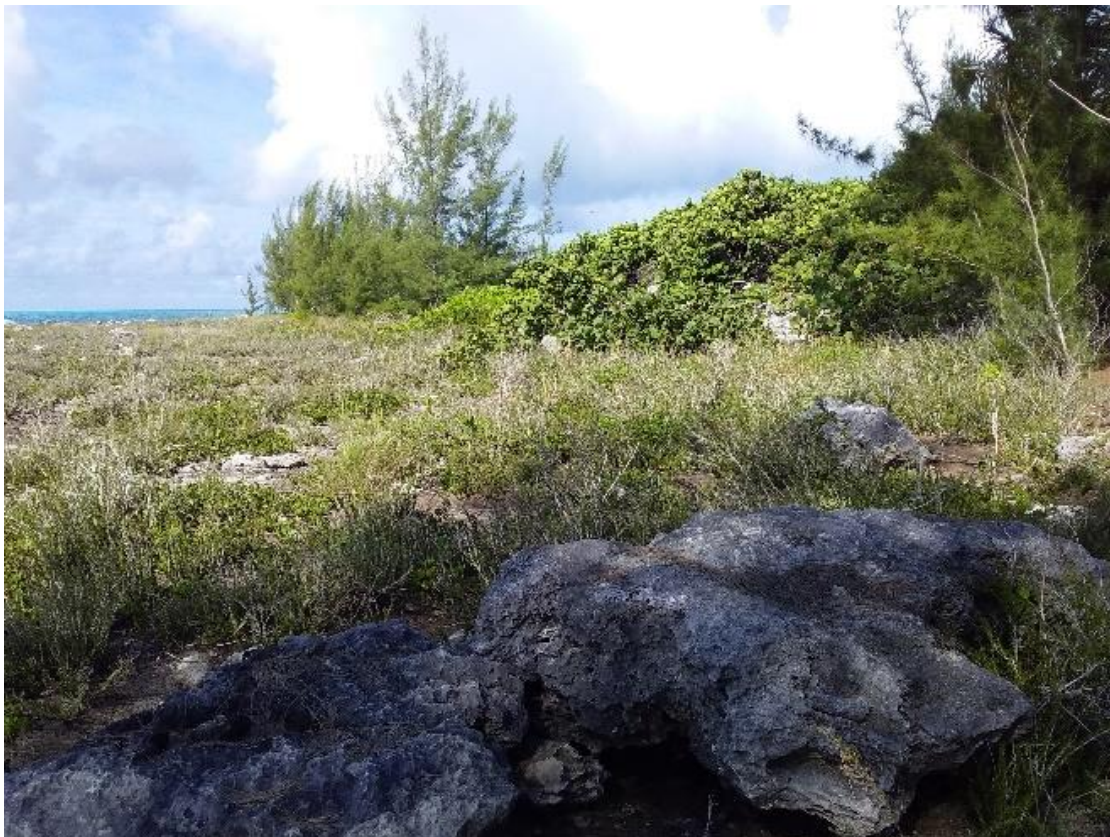
Figure 7.64. Rocky shore habitat at Leeward Harbour.

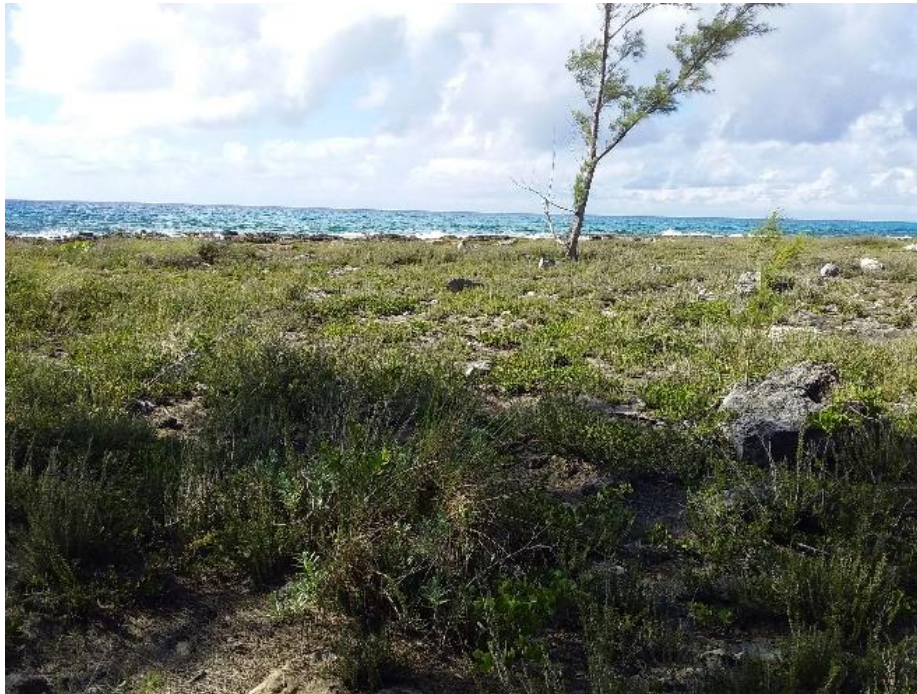
Figure 7.65. Rocky shore habitat at Leeward Harbour

The splash and intertidal zones on the rocky shoreline are devoid of sandy substrate, with tolerant species established in shallow pools which have collected clay-like sediment. Species colonizing this habitat are *Rhizophora mangle* (Red Mangrove), *Avicennia germinans* (Black Mangrove) and *Sesuvium portulacastrum* (Sea Purslane).

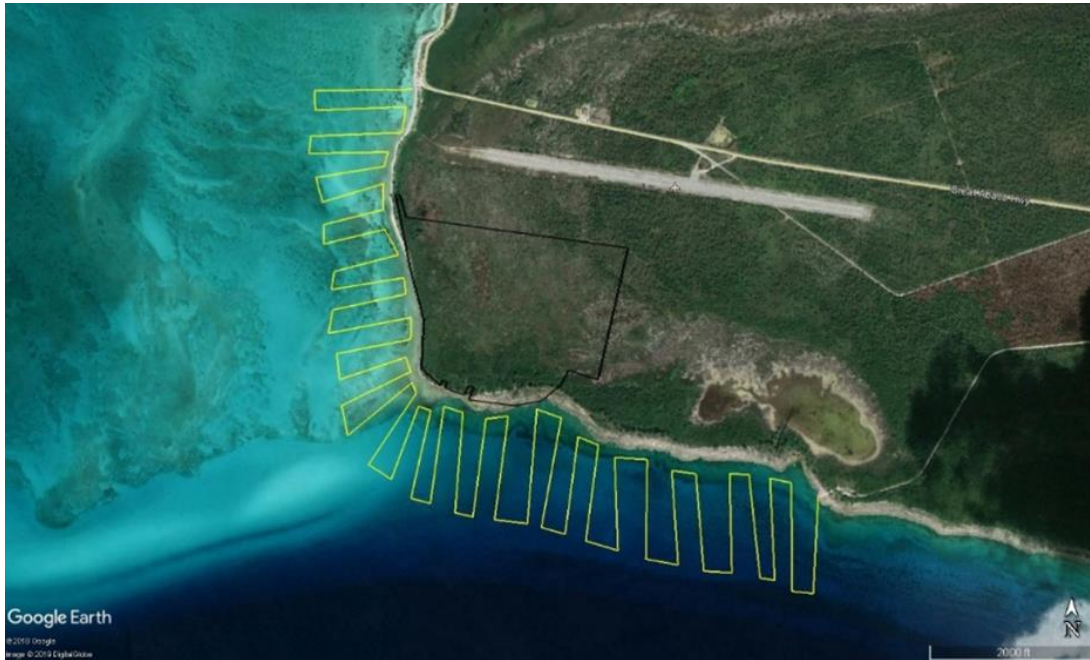
Figure 7.124. Map of benthic survey area at Leeward Harbour depicting survey route. (2018)

The original Benthic surveys were performed at Leeward Harbour on October 10th and 11th, 2018 between the hours of 12:15 p.m. to 3:58 p.m., November 6th and 7th, 2018 between the hours of 12:10 p.m. to 4:12 p.m. and December 18th, 2018, between the hours of 2:05 p.m. to 3:20 p.m. via manta tow and roving techniques. The manta tow technique involves an observer (snorkel diver) attached to a manta board while the diver is towed behind a boat by a 17-meter rope. The diver makes a visual assessment of the existing habitat, organisms, coral reef structures or other notable features while recording data. The benthic survey occurred along the entire shoreline of the proposed site, as well as 1,000 ft. from the shoreline into the sublittoral and pelagic zone (Figure 58). This motion was repeated until the diver arrived at the starting point of the survey, several meters from the boundary shoreline of the proposed site. Furthermore, roving surveys using snorkel equipment were completed within the survey area by swimming parallel and perpendicular to the shore. Fish species were recorded and assigned one of four abundance categories based on their species count within the area (Single = 1, Few = 2 - 11, Many = 11-100, and Abundant = > 100).

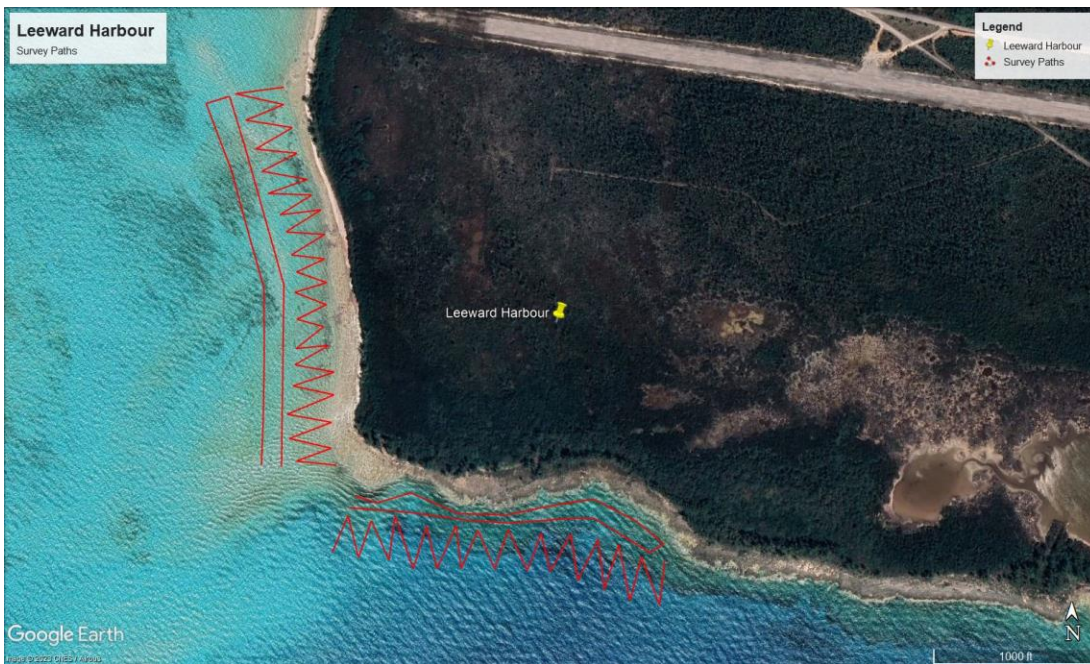
Figure 7.125. Map of benthic survey area at Leeward Harbour depicting survey route. (2023)

Updated marine surveys performed at Leeward Harbour on May 8th and 9th 2023, via manta tow and snorkel survey. The manta tow technique involves an observer (snorkel diver) being towed behind a boat by holding onto a rope. The diver makes a visual assessment of the existing habitat, organisms, coral reef structures or other notable features while taking photos for later assessment. The surveys were similar to the previous surveys completed in 2018. These updated surveys took place to confirm if there were any changes to the general marine habitat. Between 2018 to 2023 a major hurricane, Dorian, had taken place and the surveys were conducted to see if there was damage to the ecosystem and corals within the site.

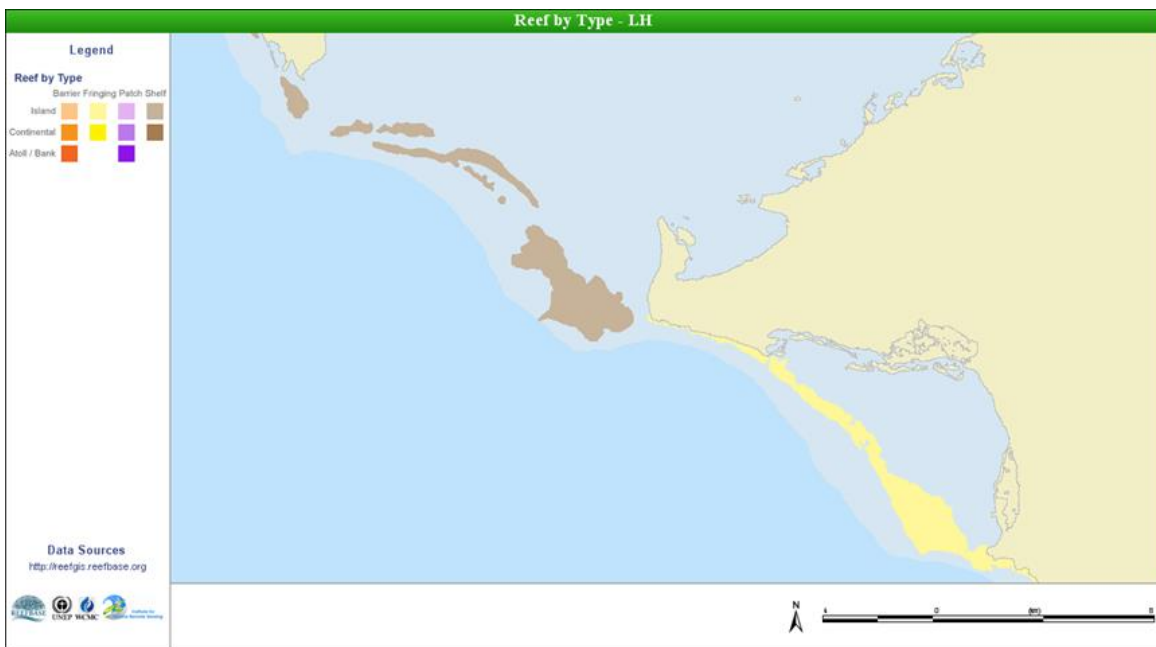
Figure 7.127 Reef type located northwest and southeast of the Leeward Harbour benthic area.

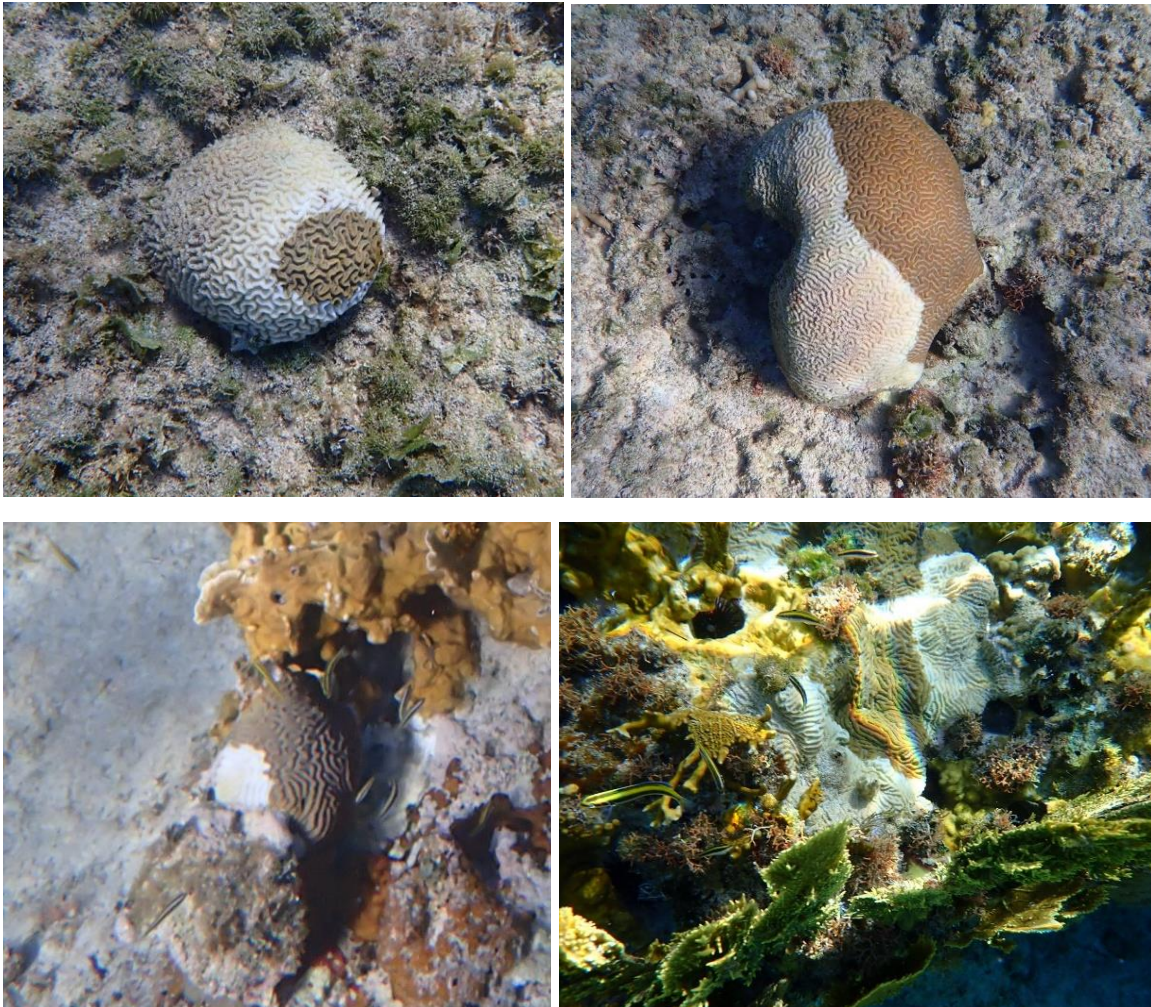
Figure 7.130 Examples of Bleached and Diseased Coral (2023).

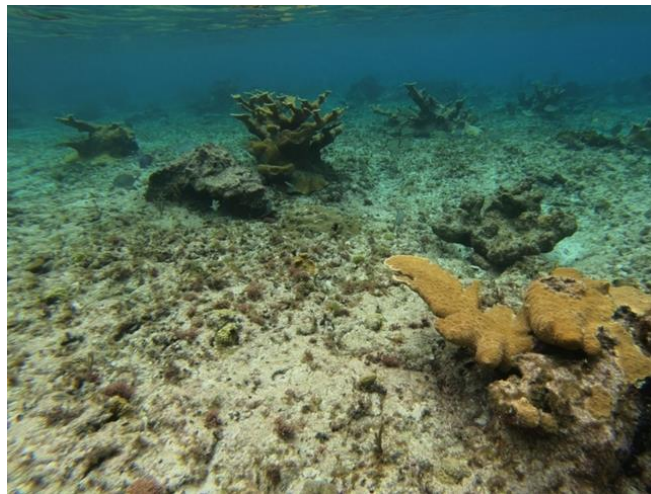
Figure 7.132 Stressed and deceased Elkhorn Coral (2018).

Patch reef systems were observed within the southeast coastal habitat within Leeward Harbour. These systems are composed of rock formations which house well-formed coral species. Numerous patch reefs are located within this survey area; inclusive of coral species such as *Gorgonia flabellum*, *Acropora cervicornis*, *Acropora palmata*, *Millepora complanata* and *Diploria clivosa*. Some patch reef systems showed signs of distress such as discoloration, as well as complete coral deterioration and death.

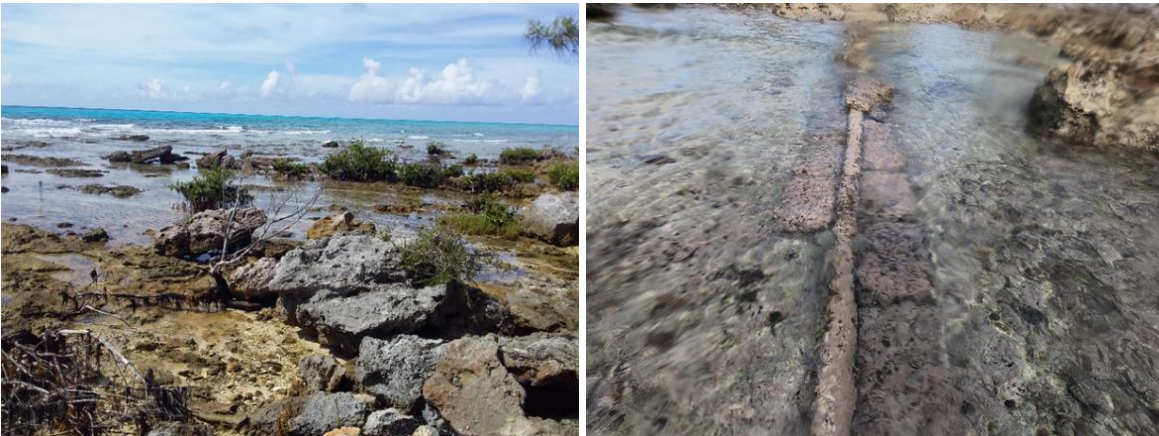
Figure 7.138 Black Mangrove among the rocky intertidal zone, Exposed cable (2018).

The rocky intertidal zone is situated along the north and southeastern coastline of Leeward Harbour. The littoral zone along the northern coastline consists of flat limestone formations which produce tidal pools during tidal fluctuations. This area is mostly covered by water within the foreshore. Some species were observed within this habitat such as *Nerita versicolor*. Few Black Mangrove (*Avicennia germinans*) trees were observed within this area. Some pieces of exposed communications cable lie along the shoreline of this habitat. This cable is partially covered with cement which has worn away over time.

An existing ICT/cable line originating from North Eleuthera emerges ashore at the southwestern tip of the LH site and runs north along the western shoreline and into the Sandy Point settlement. The portions of the line on land were encased with concrete to protect the cable, however the casing has now become exposed due to coastal erosion and broken/damaged in a number of places where it is evident the line has been severed. A replacement cable runs above the high tide mark along the edge of the mangrove wetlands on the western shoreline of the site. Considerations will need to be made for incorporating the cable into the design of the development, or a relocation of the line to a more suitable location.

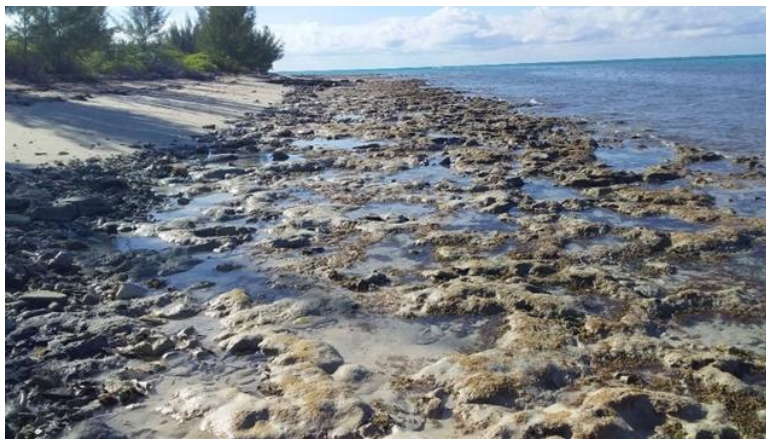
Figure 7.139 Exposed limestone rock formations within the littoral zone at low tide (2018).

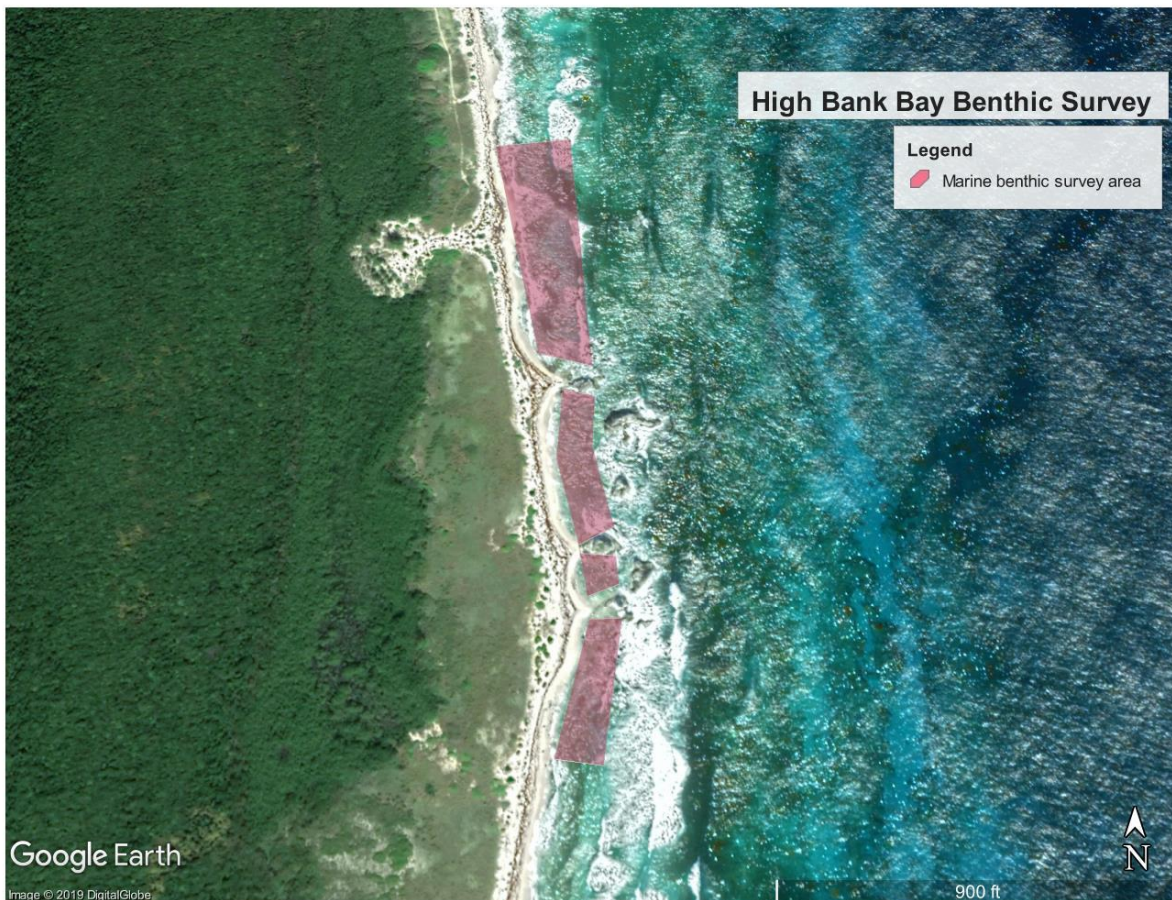
Figure 7.140 High Bank Bay Benthic survey map.

Benthic surveys were completed on April 18, 2019, between the hours of 12:37 p.m. and 1:30 p.m. at low tide. This survey area consists of the northern boundary of High Bank Bay Beach and extends approximately 1-mile toward the southern boundary of the beach (see Figure below). The purpose of the investigation was to record the presence and abundance of marine flora, epifauna and fauna species, as well as assess benthic bottom types and cover. Using snorkel equipment, divers performed a roving survey by swimming parallel and perpendicular to the shore. This method was selected to gain an accurate representation of the marine environment. All observed marine species were recorded. More specifically, fish species were recorded and assigned by one of four abundance categories based on their total species count within the area (Single = 1, Few = 2 - 11, Many = 11- 100, and Abundant = > 100).

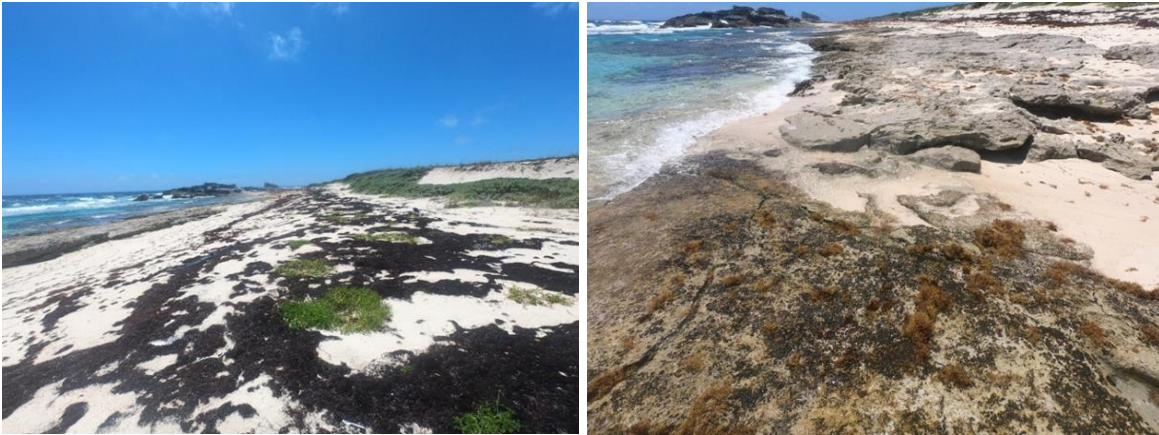
Figure 7.145 Beach face with deceased *Sargassum fluitans*, Limestone rock 'slabs' along the foreshore that extend onto the beach face.

The beach zone consists of sand and limestone features such as beach rock and shell deposits. Deceased *Sargassum fluitans* stretch along the beach face just before the high tide mark and fixed beach vegetation (Figure 75). Large slabs of limestone rock cover the foreshore environment as it extends from the water onto the sand (Figure 76). The hard bottom and rocky intertidal zone serves as a barrier that protects the foreshore from intense wave action from the Atlantic Ocean.

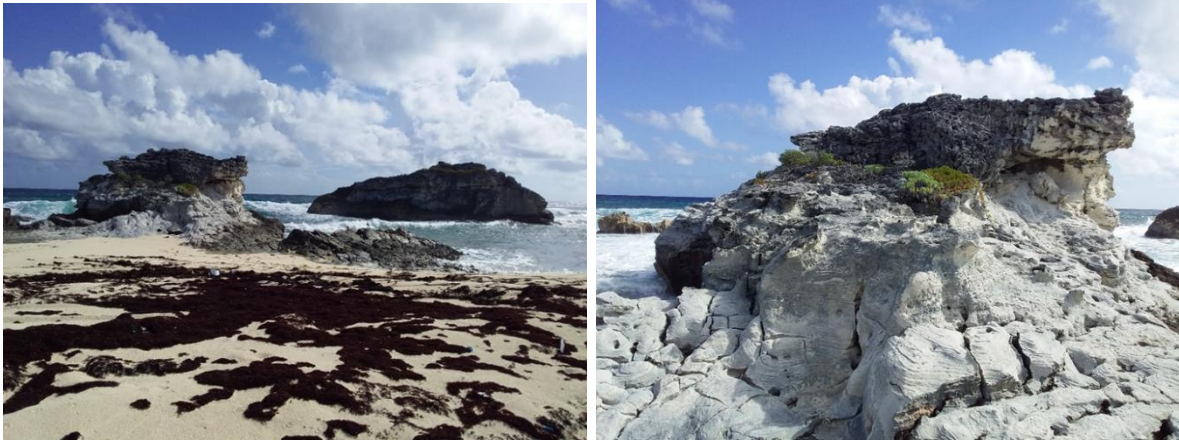
Figure 7.146 Exposed rock formations at High Bank Bay, Exposed supralittoral zone features with salt tolerant vegetation.

The rocky intertidal zone is located along the western end of the High Bank Bay beach. This habitat contains the littoral, sublittoral and supralittoral zones. Multiple rock formations are separated among this coastal environment, allowing wave activity to travel throughout this habitat. These structures are elevated at approximately 9 ft. and compose the supralittoral zone. This zone rarely experiences tidal influences except during major storm activity. Salt tolerant vegetation (*Hymenocallis arenicola*) is located on top of these rock formations. Some gastropods were observed within this area; inclusive of *Nerita tessellata*.

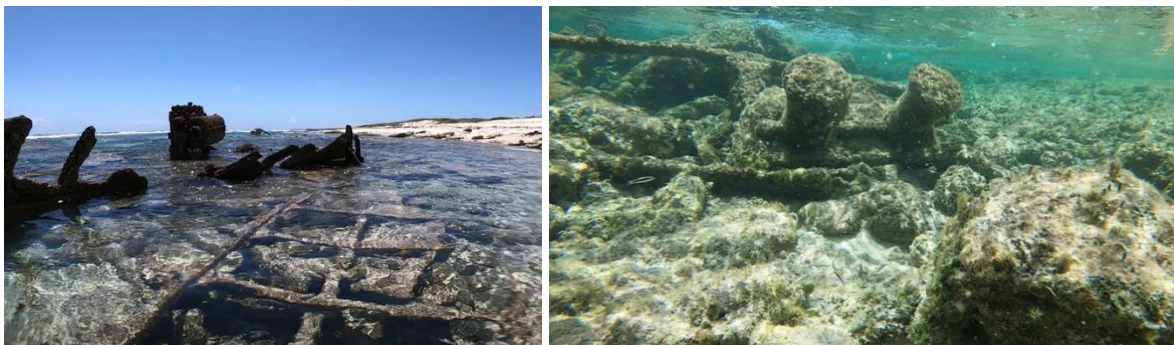
Figure 7.147 Exposed metal debris during low tide, Algae covered shipwreck debris.

Shipwreck debris is present within the beach zone at High Bank Bay. Scattered pieces of the remains are located along the western boundary of the beach along the beach face and within the foreshore. At low tide, pieces of the metal debris are exposed as it rests in this shallow water environment. The metal debris is covered in numerous algae species, subsequently turning what was once debris into an artificial marine environment. Species of coral such as *Porites astreoides*, *Siderastrea radians*, *Gorgonia ventalina* and *Diploria strigose* were observed attached to the metal debris which was also covered in algae. Thus, creating a surface to produce a coral reef environment. Most fish species observed were recorded within this habitat; inclusive of *Abudefdu saxatilis*, *Halichoeres bivittatus*, *Eucinostomus melanopterus*, *Lutjanus apodus*, *Kyphosus sectatrix*, *Kyphosus cinerascens* and *Acanthurus chirurgus*.

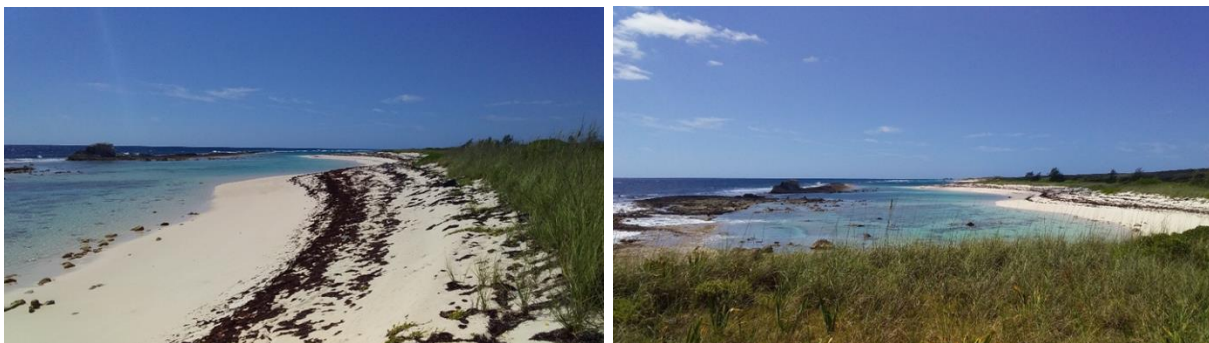
Figure 7.156 Southern view of the beach face at low tide with deceased *Sargassum* Seaweed onshore, Foreshore beach environment at low tide.

The beach foreshore consists of fine sand deposits that extend along the entire beach face. Rock features enclose the beach's nearshore environment forming a lagoon. This rock formation acts as a barrier protecting this environment from intense wave action of the Atlantic Ocean that lies parallel to the foreshore and provides a shallow water habitat. There are openings in the barrier rock formation which allows water to move in and out of the foreshore environment. These openings act as a natural flushing channel to support nutrient and sand deposits throughout the entire beach zone. Mounds of deceased *Sargassum fluitans* accumulate along the entire beach face just before the high tide mark and fixed vegetation.

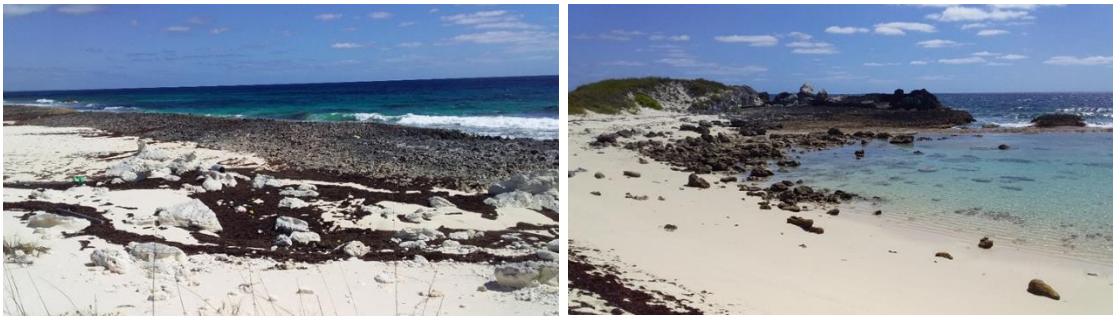
Figure 7.159 Exposed littoral zone limestone feature, Fixed beach vegetation and exposed supralittoral zone with iron shore features.

The rocky intertidal zone is situated along the northern boundary of the survey area. This habitat is categorized in zones due to its tidal ranges. The sublittoral zone was exposed during observation, displaying its tidal pools which contained marine invertebrate species such as *Acanthopleura granulate*. Ironshore limestone features within the littoral and supralittoral zone are elevated at approximately 4 ft. - 6 ft. This zone is connected to beach vegetation which is located a few feet to the west of this rocky shore environment.

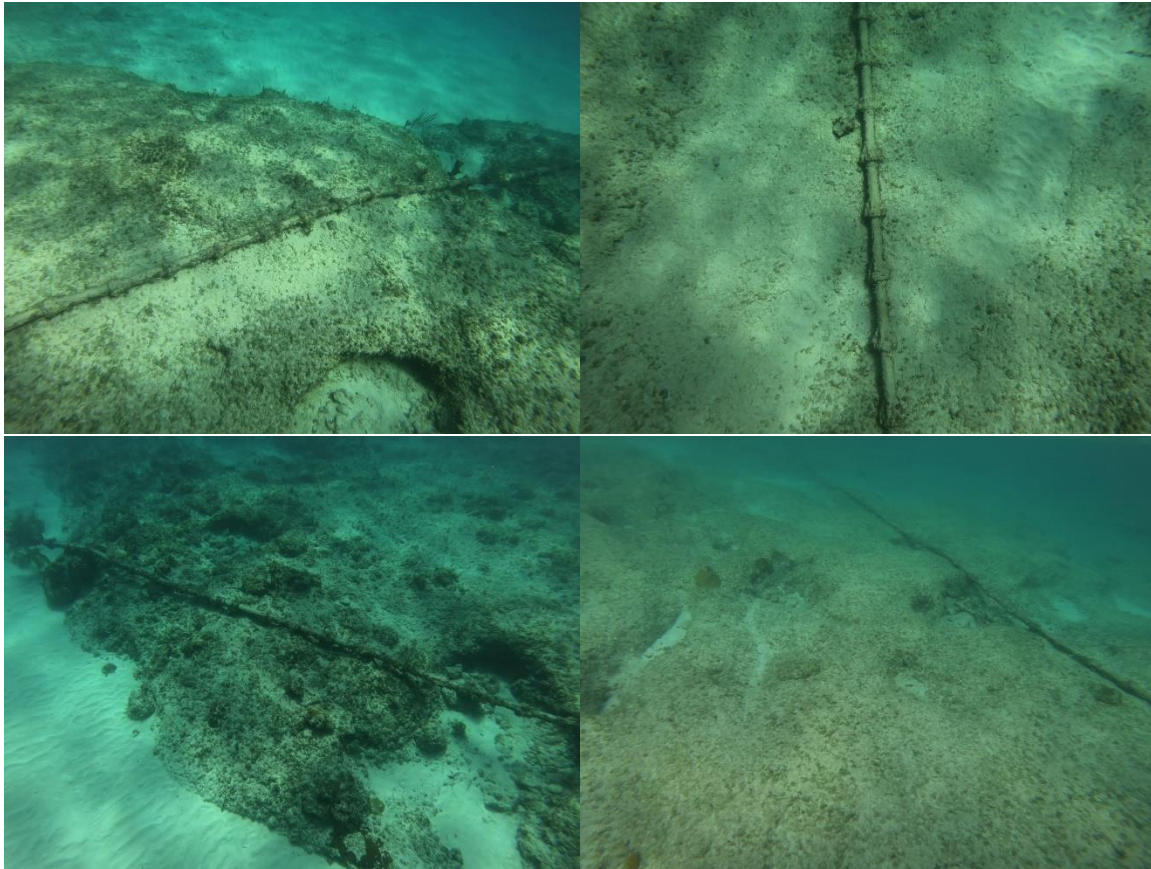
Figure 7.162. Images of subaqueous ICT cable off the southern shore of Leeward Harbour (2018).

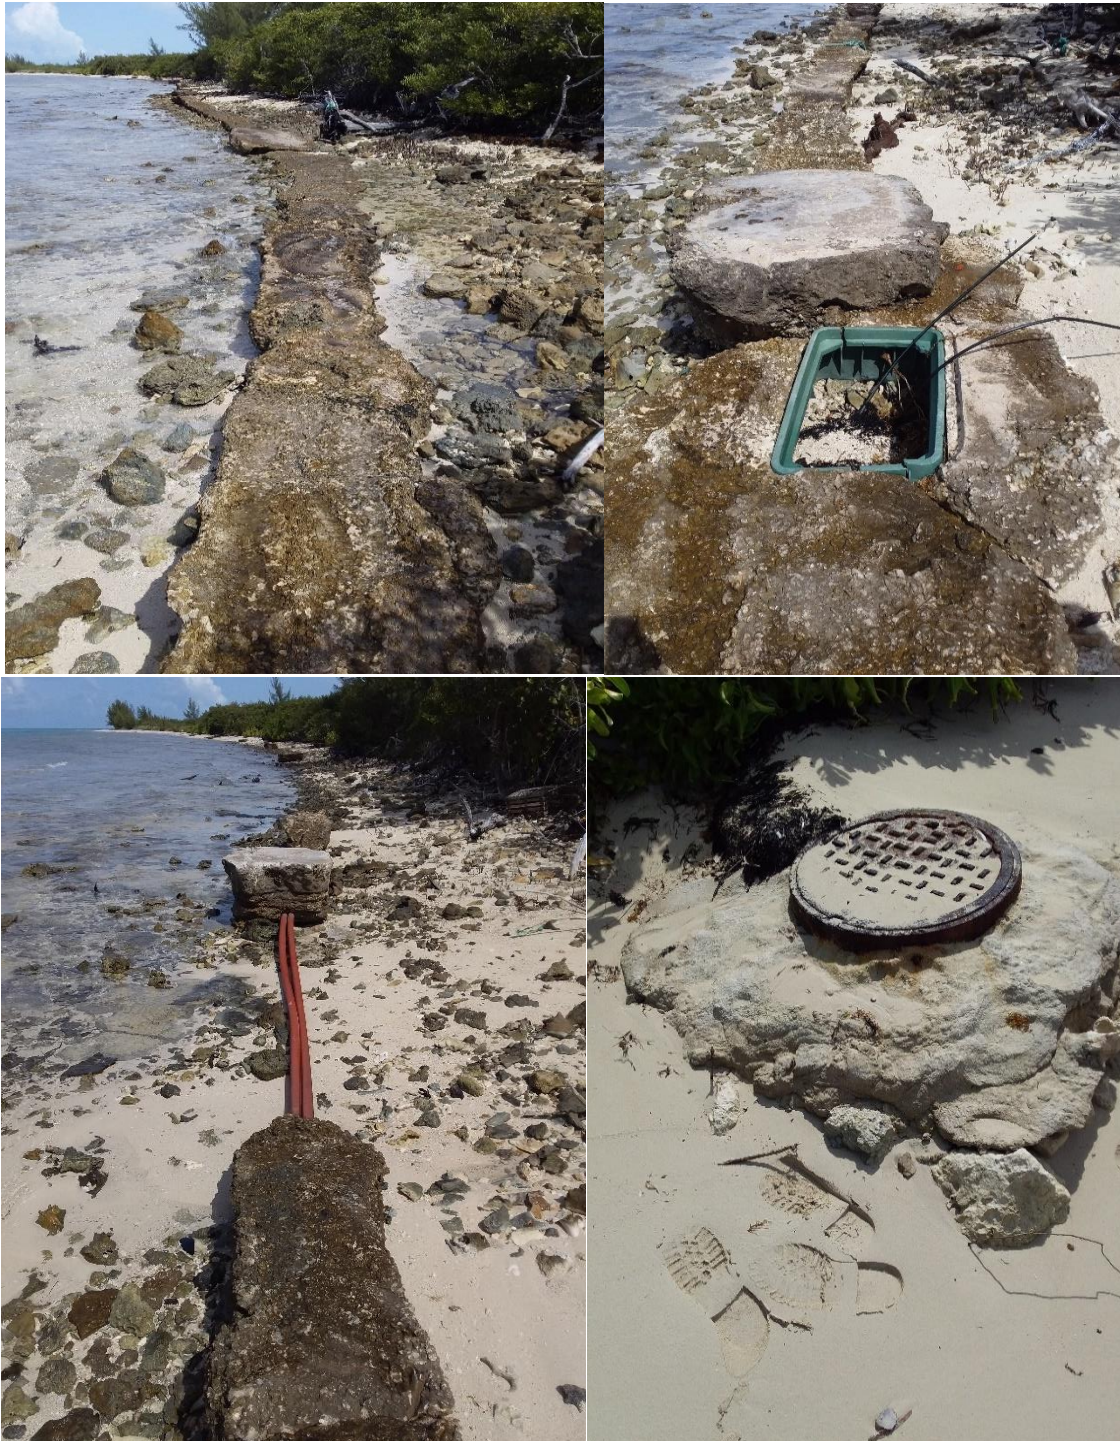
Figure 7.163. Exposed ICT cable infrastructure along western shoreline of Leeward Harbour (2018).

The property at LH is currently undeveloped and free from infrastructure aside from the ICT cable and relic lighthouse at Rocky Point. The proposed project will have to incorporate the ICT cable into the project's design to facilitate continued communication capabilities for South Abaco. The small defunct lighthouse at Rocky Point will be replaced with a functional light warning system for mariners traversing waters near the shallow Rocky Point.
