ENVIRONMENTAL IMPACT ASSESSMENT

THE SETAI - KAKONA RESORT DEVELOPMENT

LEEWARD HARBOUR, CONCH SOUND POINT, AND HIGH BANK BAY

SOUTH ABACO, BAHAMAS

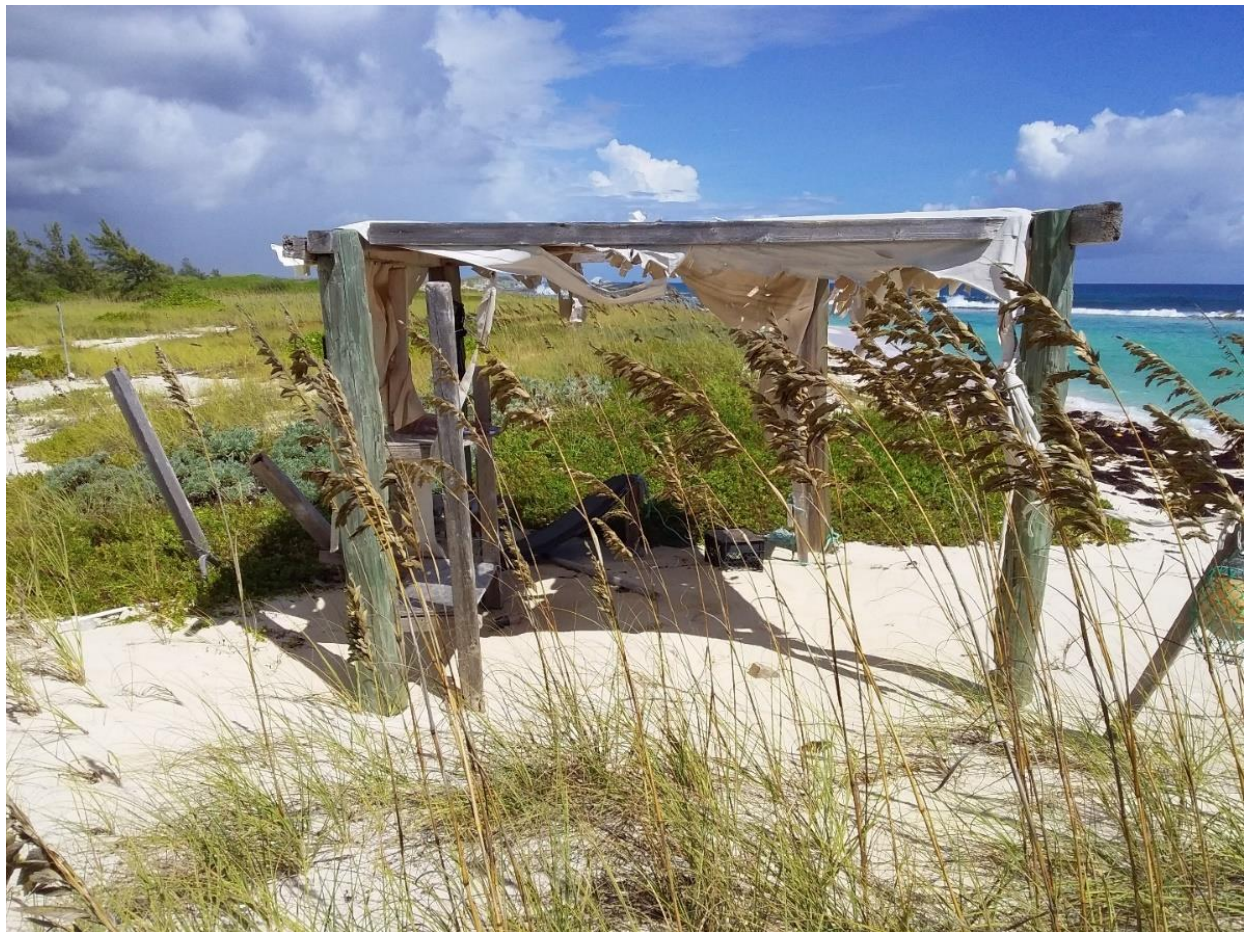
Figure 7.164. Improvised shelter structure .

No human activity was observed during this survey. However, marine debris was observed; inclusive of twisted boat rope, cooking oil containers and plastic water bottles. Furthermore, a small makeshift shelter was constructed of wood and tarp, which is located at the high tide mark and point of fixed vegetation.

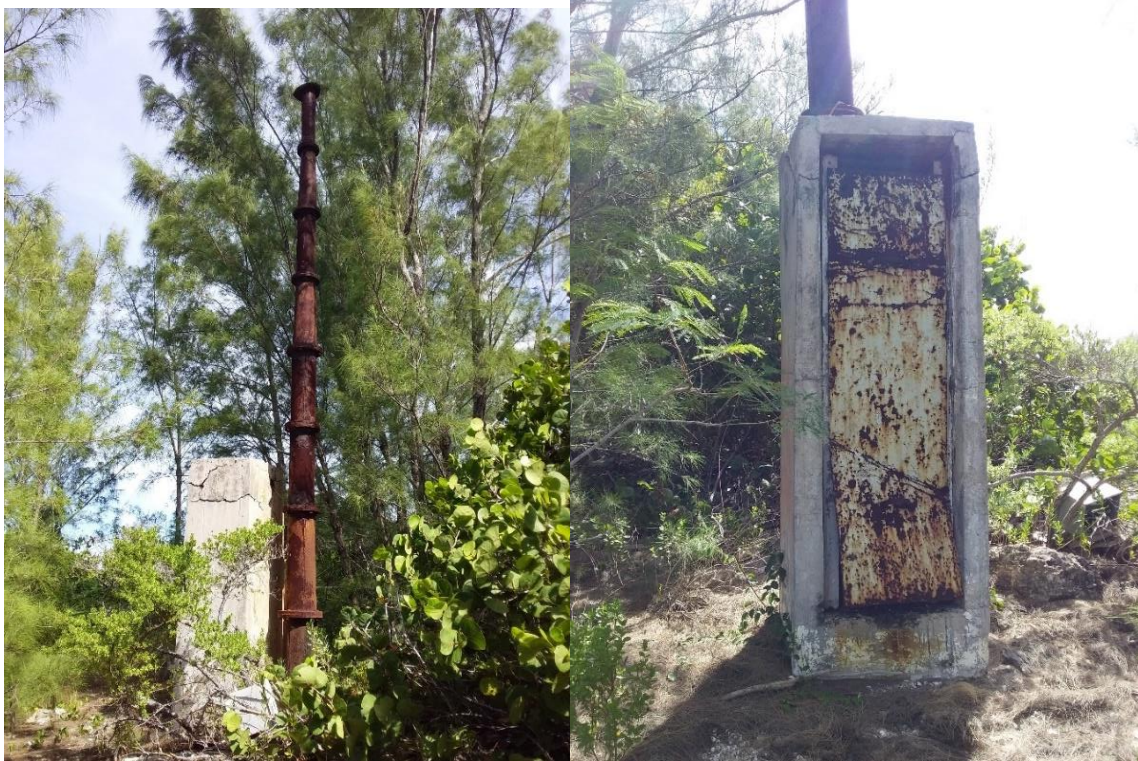
Figure 7.167. Remnants of Rocky Point 'lighthouse

The remains of a stone wall have been found in the Leeward Harbour site indicating historic usage of the area although it is not known at this time the extent of any activities. Defunct infrastructure for the ICT cable and lighthouse are found along the southern and western shoreline of the Leeward harbor property.

The property at LH is currently undeveloped and free from infrastructure aside from the ICT cable and relic lighthouse at Rocky Point. The proposed project will have to incorporate the ICT cable into the project's design to facilitate continued communication capabilities for South Abaco. The small defunct lighthouse at Rocky Point will be replaced with a functional light warning system for mariners traversing waters near the shallow Rocky Point.

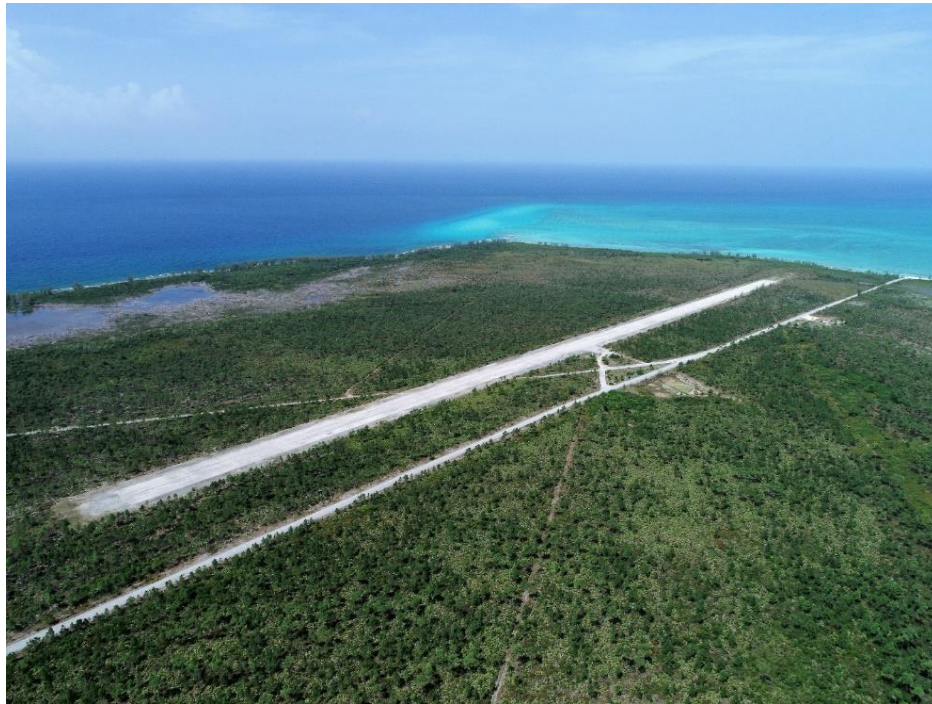
Figure 7.176. Sandy Point Airstrip with access road and Great Abaco Highway

The Sandy Point airstrip exists 1-mile south of Sandy Point and serves to accommodate small aircraft. However, there is no FOB facility to support the airstrip. Therefore, leaving the airstrip unmanaged due to the lack of Bahamas Customs and Immigration regulation. This airstrip is void of a control tower and lacks communication services directly into South Abaco; although, pilots can communicate with radio frequencies in New Providence. Fire extinguishers are available. Its runway is constructed of 4,500 ft. x 100 ft. of asphalt.

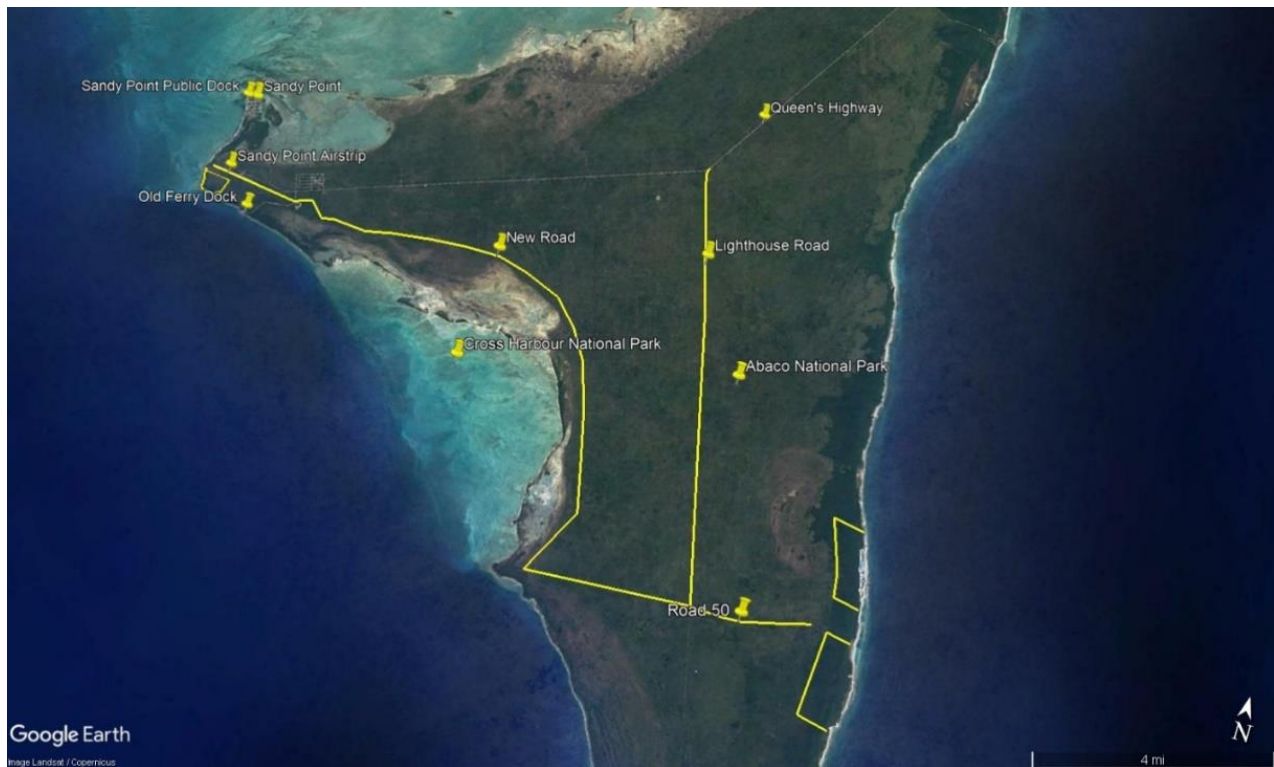
Figure 7.178. Proposed South Abaco road improvements as part of the Kakona development.

Access to the HBB property is accessible through use of the Great Abaco Highway, The Lighthouse Road, and Road 50. The Lighthouse Road runs approximately 8.5 miles to the junction with Road 50, which is approximately 2.5 miles to the nearest junction to the HBB and CSP properties. Both Lighthouse Road and Road 50 are unpaved surfaces and become rocky at points.

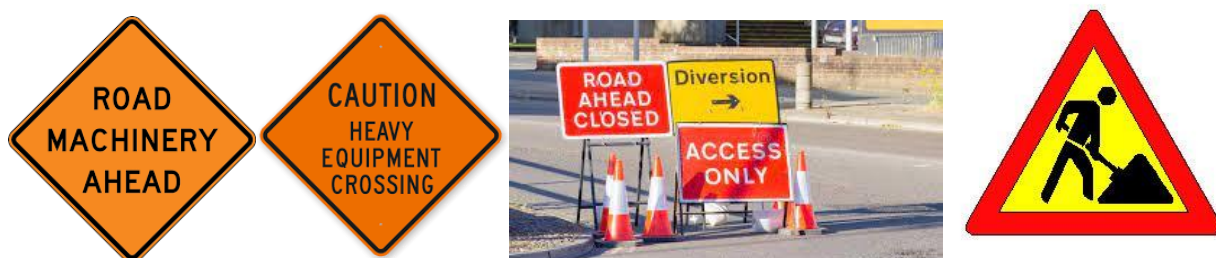
Figure 13.3. Examples of road construction signage.

To mitigate possible traffic impacts it is recommended that visible signage is erected along the access route to assist with traffic diversion where necessary (see figure below).

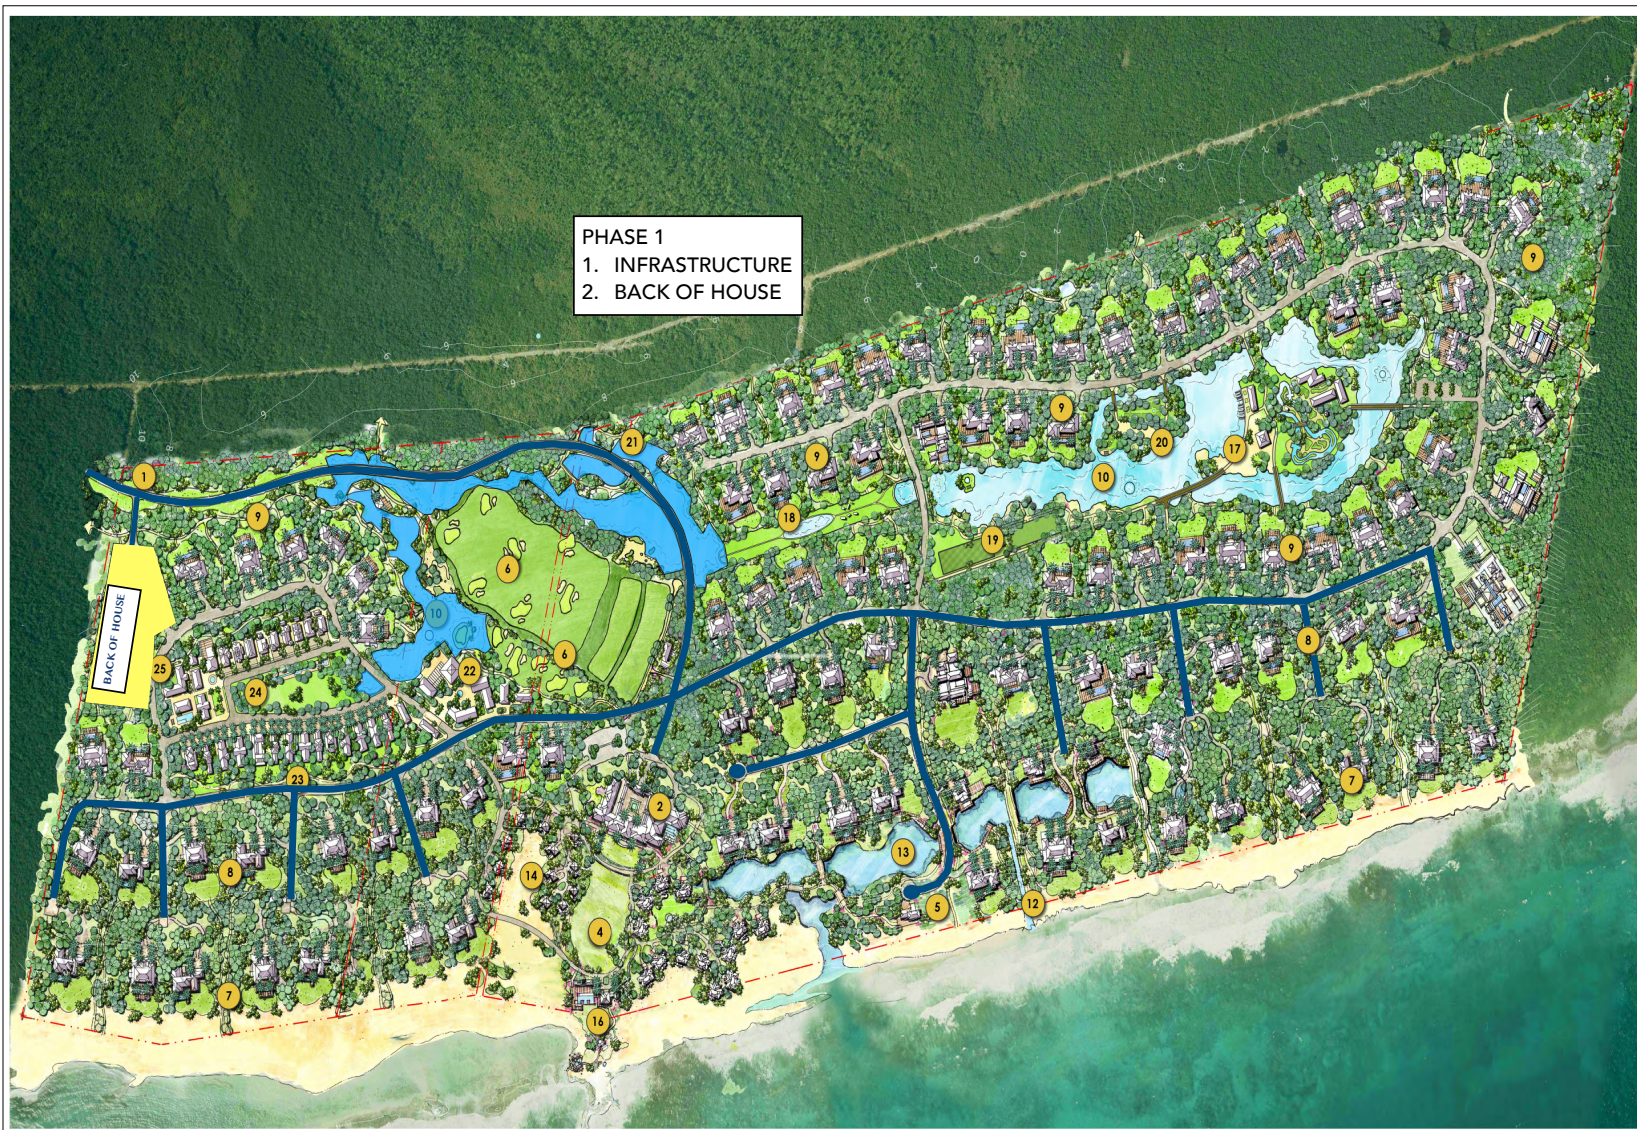
PHASE 1
1. INFRASTRUCTURE
2. BACK OF HOUSE

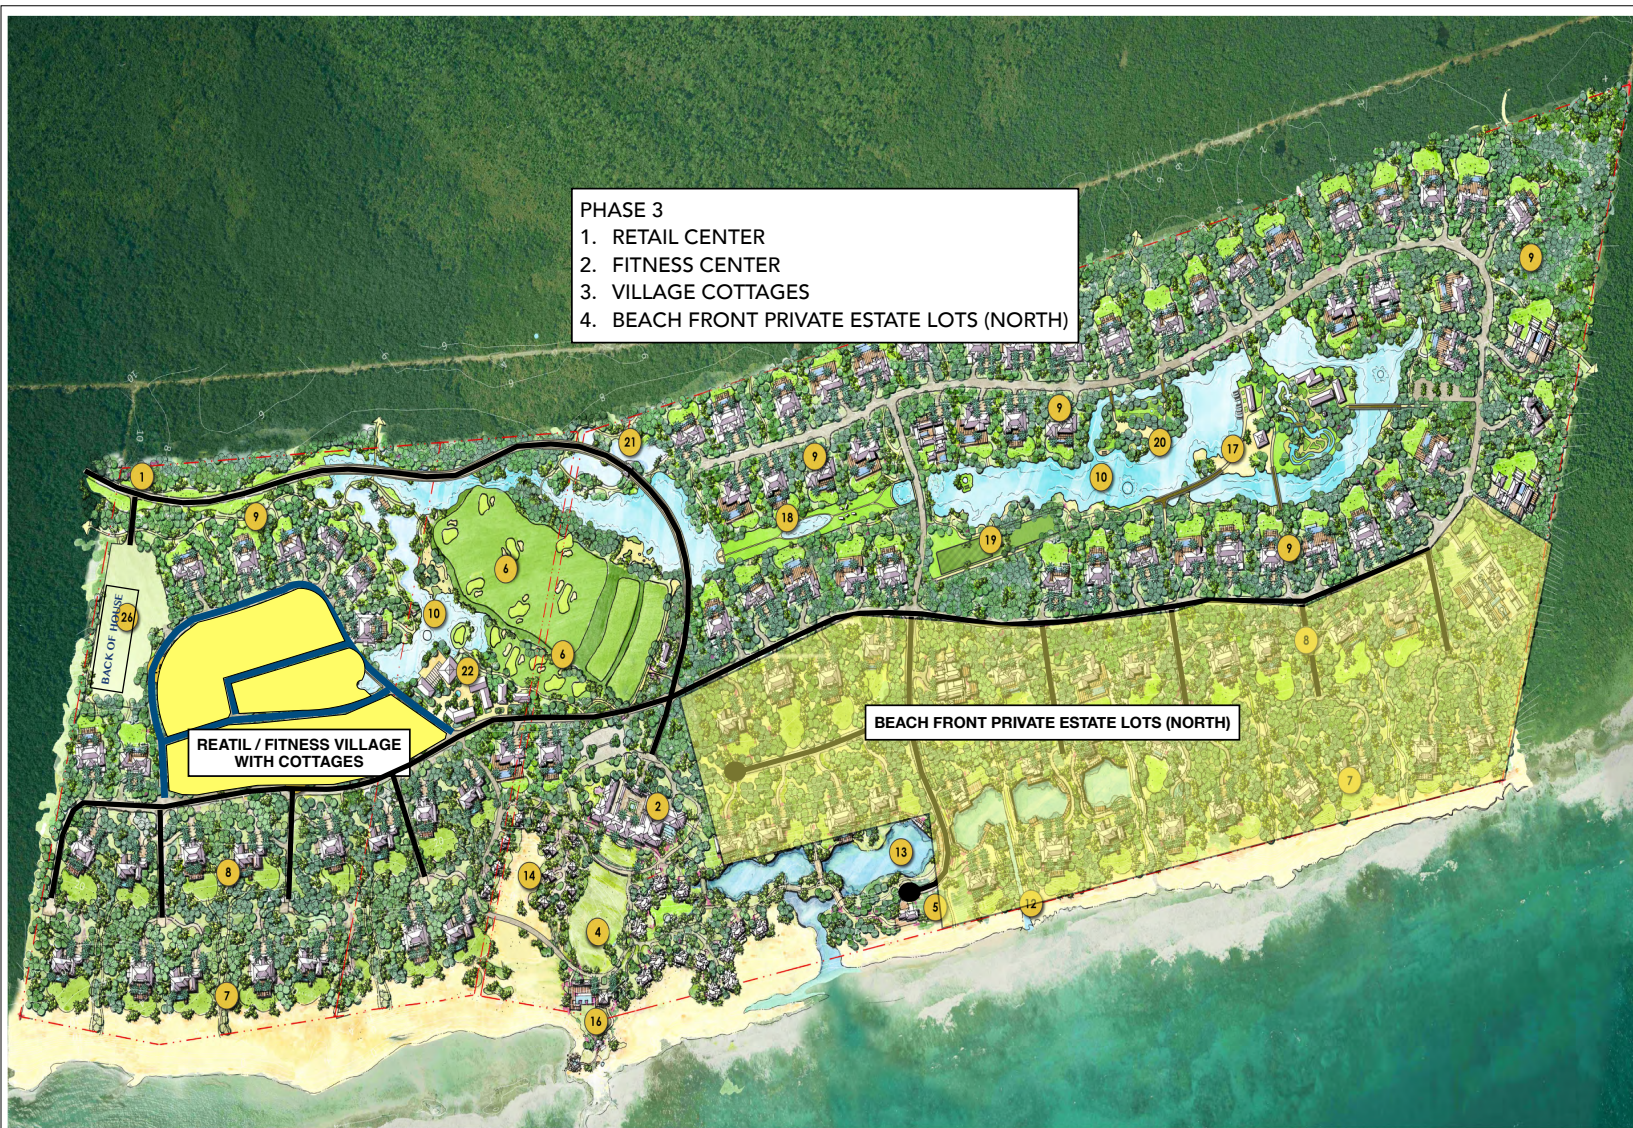
PHASE 3
 1. RETAIL CENTER
 2. FITNESS CENTER
 3. VILLAGE COTTAGES
 4. BEACH FRONT PRIVATE ESTATE LOTS (NORTH)

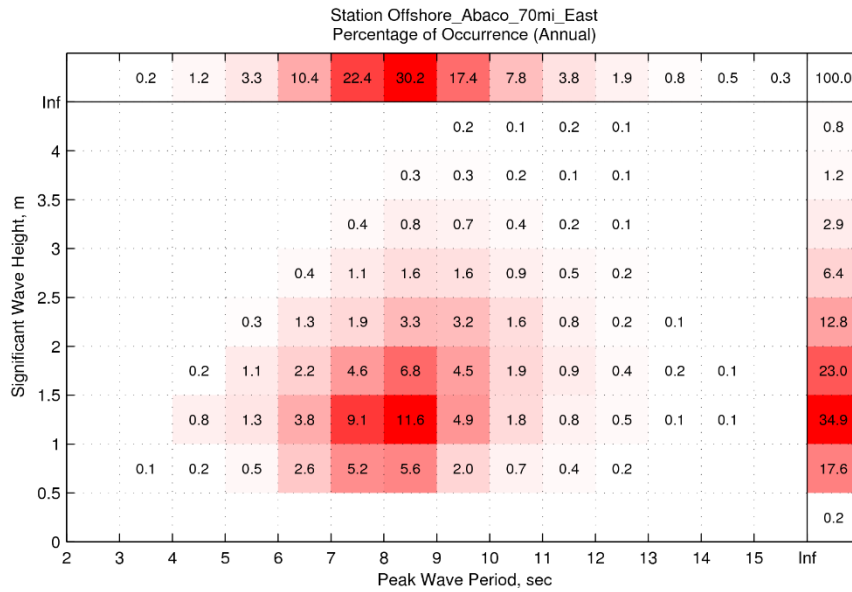
The significant wave heights and associated peak wave periods were analyzed, and the annual joint histogram is presented in Figure 2-9. The majority of the waves range from 1 to 2 m with a period between 7 and 9 seconds.

Figure 2-9: Joint Histogram – Offshore Significant Wave Height and Period

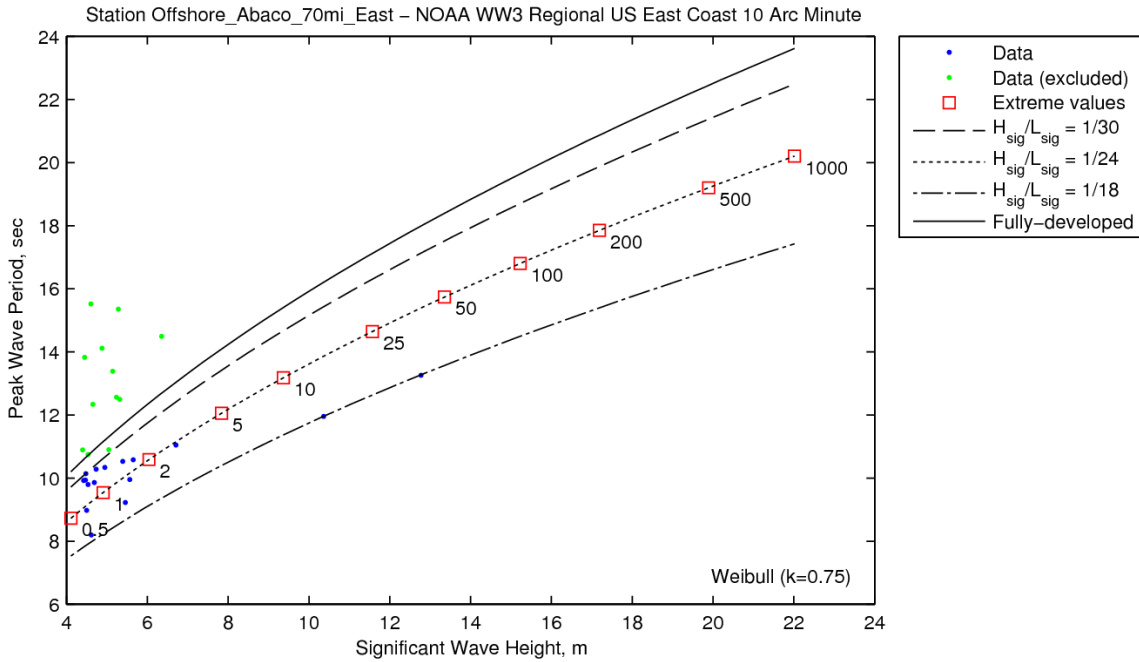
The peak period was estimated based on a fitted Weibull (k=0.75) distribution between the extreme significant wave heights and peak wave periods, which is presented in Figure 2-11.

Figure 2-11: Joint Extreme Significant Wave Height and Peak Wave Period Curves

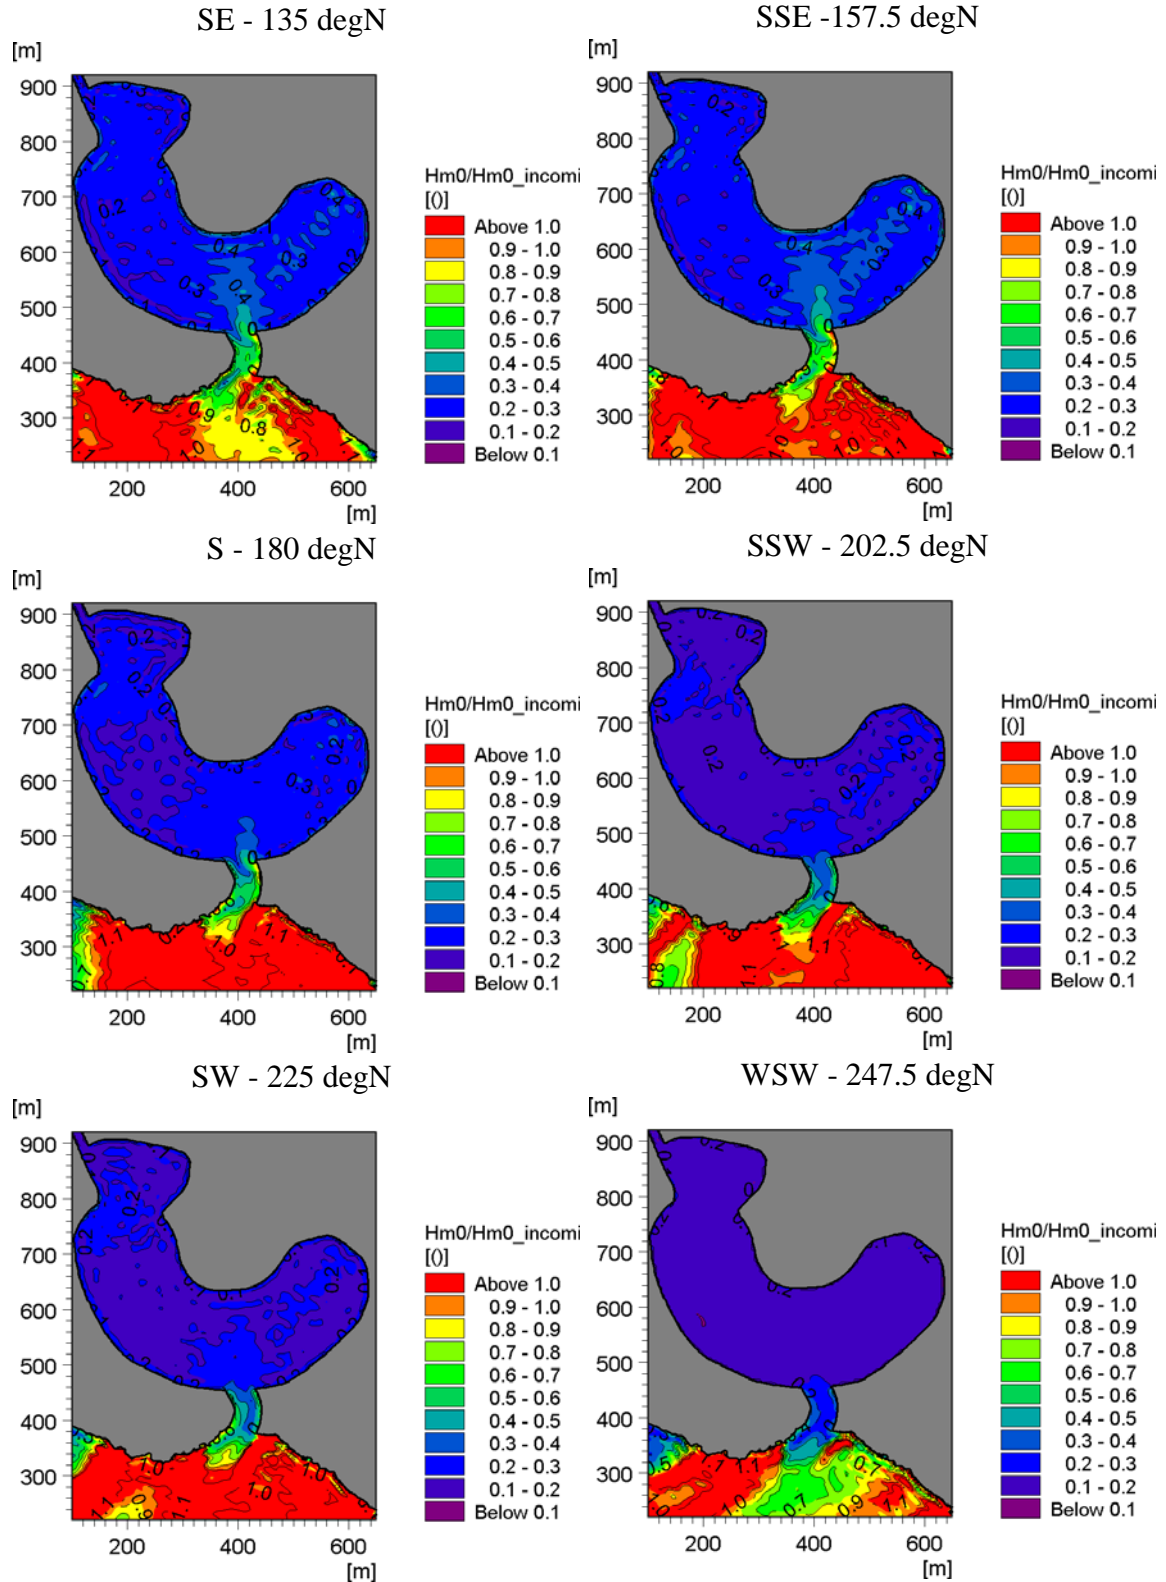
Base Case – Peak Period = 8 seconds

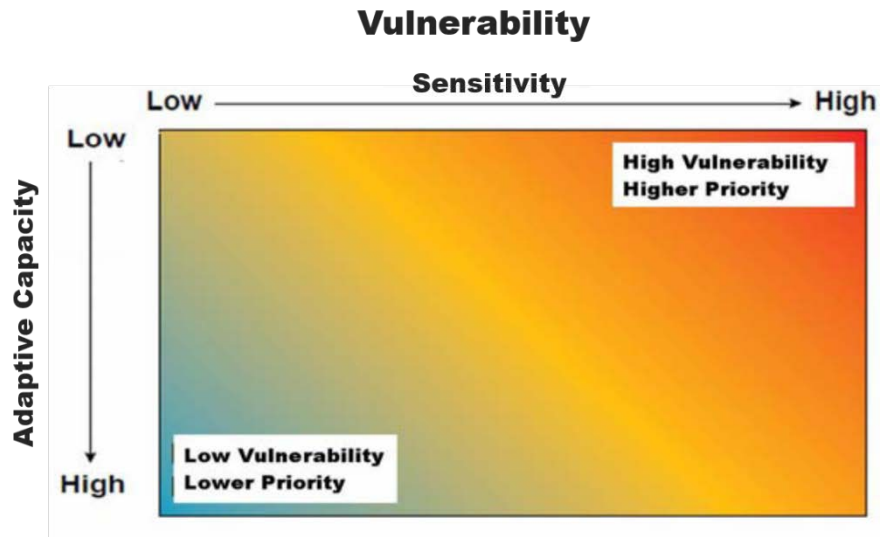
Figure G-3: Relationship Between Sensitivity, Adaptive Capacity, and Vulnerability (ICLEI 2012)

The vulnerability of an asset increases as the sensitivity increases. Adaptive capacity is inversely related to vulnerability in that as the adaptive capacity increases, the vulnerability decreases. For example, beaches along the coastline are sensitive to small changes in sea level but would be assigned a moderate vulnerability because of their relatively high adaptive capacity. These relationships are shown graphically in Figure G-3.

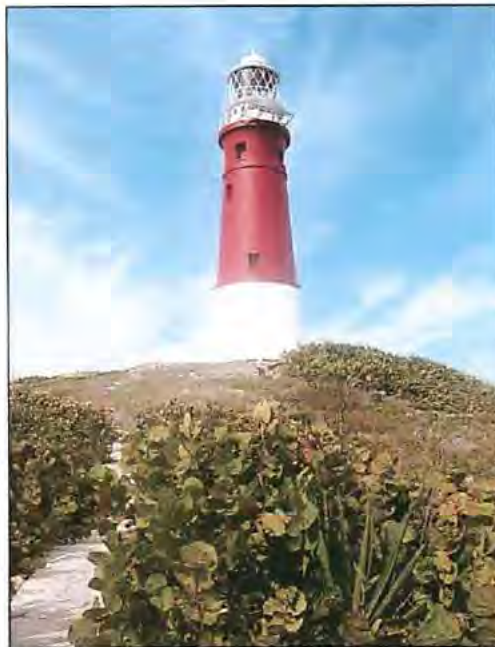
Figure 5, Hole-in-the-Wall Lighthouse, completed 1836

Constructed of imported, pre-cut stone blocks, the present structure is about 85 feet (25.9 m) high and stands at an elevation of approximately 124 feet above a rocky promontory which must have presented nearly insuperable difficulties to the builders as they tried to land heavy equipment and massive amounts of construction material when heavy seas were running.⁵ To alleviate this situation, it appears that a staging area was developed several miles to the west, on Great Abaco's opposite shore where the coast was somewhat sheltered from prevailing winds by high ground known as Fishers Hill. The anchorage here could never have been very safe but was probably more accessible and safer than any other, coasts north of the light being dominated by high limestone cliffs with few beaches, jagged rocks occurring to the west.

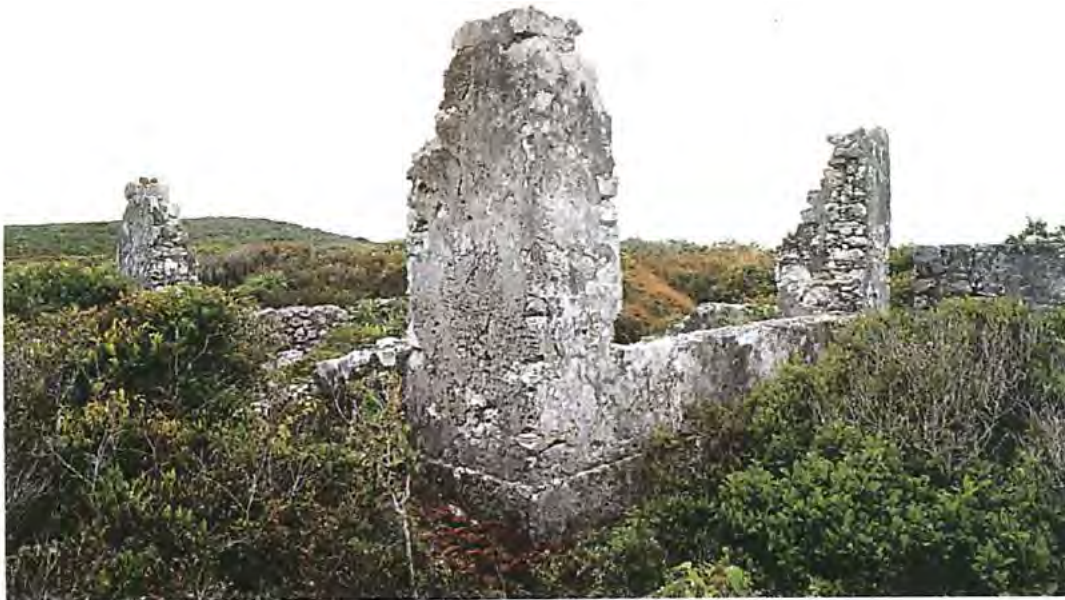
Figure 19, Lantern Head Structure 1 toward southwest from front yard.
Southeast corner of Structure 2 is visible at far right.

Within the enclosure stands a ruined steading, elements of which are arranged in an "L" shaped configuration. Built to face the sea, the largest and most imposing structure (LH Structure 1) incorporated (insofar as can be determined from present condition), one principal floor raised on a stone plinth 2'-0" above grade. Measuring 27'-1 1/2" x 21'-3" in plan at first floor level, this building features cut stone and rubble external walls (measuring 1'-6" in width above plinth level) stuccoed on outer faces and plastered internally. Barely visible traces of doorways (measuring 3'-4" in width) centered on east and west facades indicate a through hall or central passage plan, there being no visible evidence for further subdivision of the interior space.

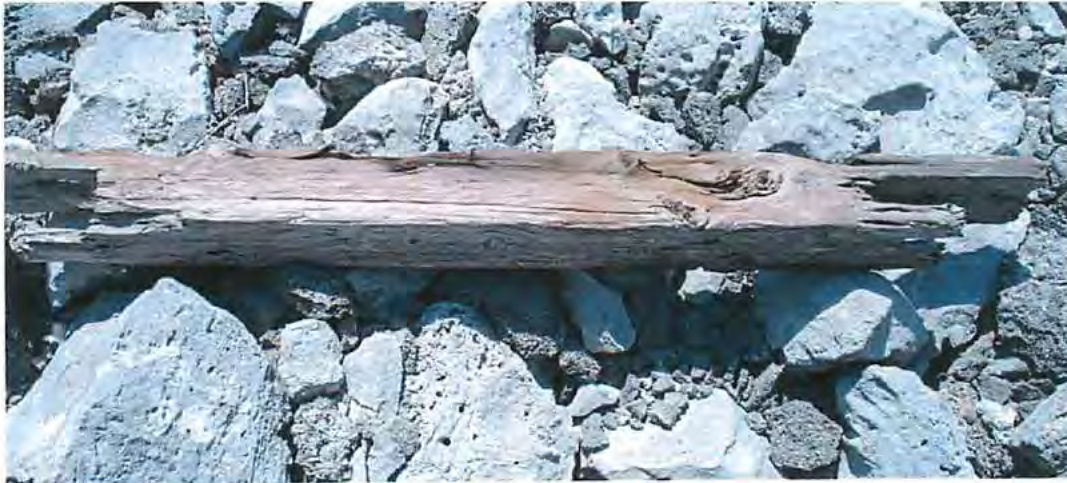
Figure 24, Lantern Head Structure 1, Head of window frame found loose in ruin

All facades have disassociated, only portions of three corners still standing to a maximum height of 10'-0" above plinth level. Nevertheless, careful examination of wall falls on the interior and fallen timbers derived from wall openings allows at least partial reconstruction, it being likely that north and south elevations each featured three relatively large window openings of equal dimension arranged symmetrically. As already mentioned, east and west facades were each punctured by a central doorway, the doorways being flanked right and left by one or possibly two window openings matching those of north and south facades in size. Loose frames and an intact lintel found inside the building indicate that window openings were 4'-10" high (excluding lintels) x 2'-10 1/2" wide, the frames, set flush with the outer building face, being fabricated from 3 3/8" square timbers. Joints were tenoned and carefully pegged at corners.

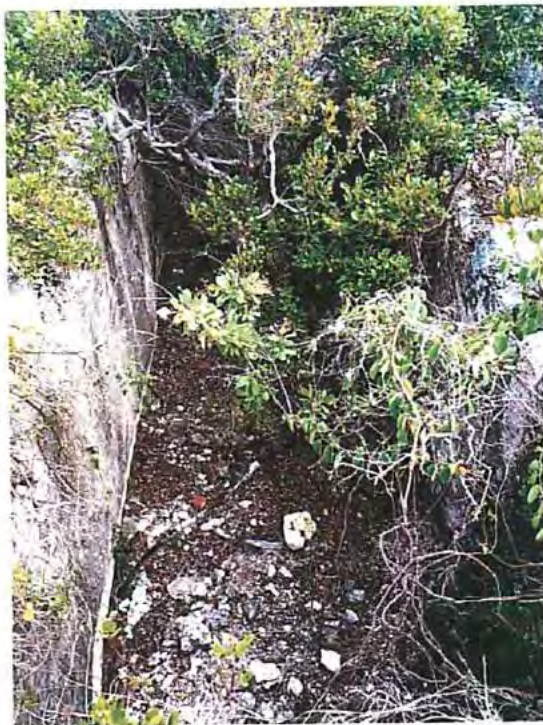
Figure 25, Cistern, Lantern Head Structure 3, showing south and north walls and bottom

Separated by a narrow (4'-0" wide) pathway, the main house is flanked on its northern side by a deep rock-cut cistern (measuring about 6'-3" x 20'-0" in plan).

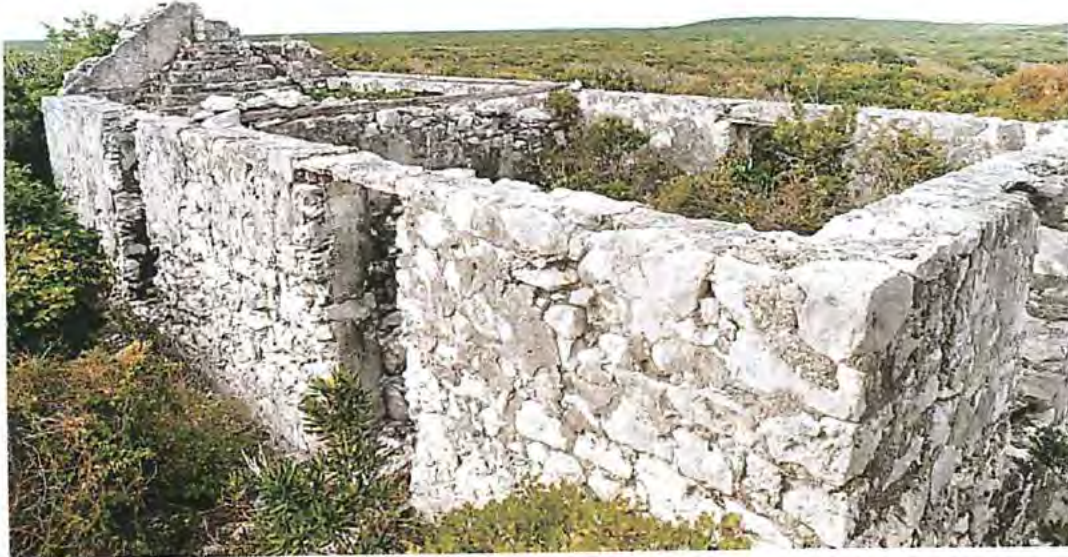
Figure 27, Kitchen, Lantern Head Structure 2 viewed toward northwest from Structure 1.

Immediately west of the cistern stands a long, narrow, single storey building, measuring 36'-3" x 15'-8" overall. Now roofless but otherwise well preserved, this building is enclosed by mortared rubble walls (measuring 1'-6" in width) which, following the sloping ground stand between 7'-0" and 8'-10" high. Inside there are few architectural refinements except at the gabled west end where the enclosed space is dominated by a massive (7'-10" wide) internal fireplace, a bread oven flanking the fireplace on its north side. Here, the hearth is raised about 2'-0" above floor level, a zone of transition between hearth and chimney featuring corbeled construction in cut stone, the large, carefully finished blocks used being supported on a single timber beam measuring 5" x 6" in cross section. Originally, the hearth and fire box were lined in red brick. The same brick was employed to construct an arched opening to the bake oven.

Elevational treatment is simple, incorporating two doorways (3'-1" and 3'-3" wide) on the long southern side and two windows on the corresponding northern facade, the window openings measuring 2'-10" wide x 4'-7" high. Another, similar window is centered on the eastern facade. Each door and window opening is spanned by an exceptionally thin (1" thick) timber lintel. Some window frames survive. Set flush with facades these are made up from 3" x 3" pine sections, morticed, tenoned and pegged at corners.

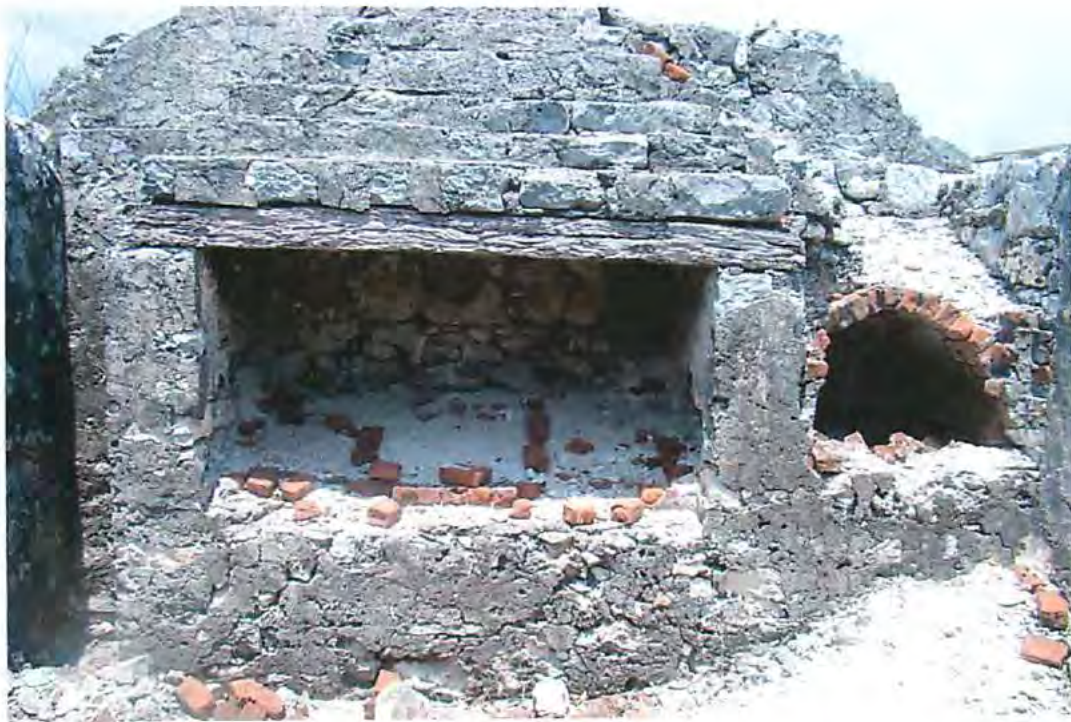
Figure 28, Hearth and oven, west interior wall of kitchen, Lantern Head Structure 2

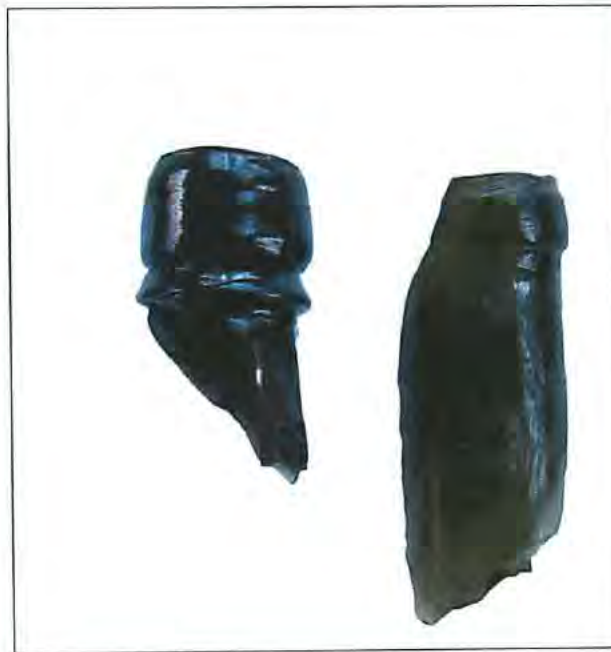
Figure 34, ART1, Lantern Head, Mineral finish and tooled finish bottle necks.
Height of specimen on right is 3 inches

ART1, collected from outside the northeast corner of the kitchen, near the cistern, included unglazed earthenware, whiteware and spatterware pottery fragments. Glass was represented by square-shaped case gin and standard cylindrical bottles in green, black and clear. All fragments appeared to be from mold-blown rather than free-blown bottles. One example showed a prominent push-up base with no manual pontil scar. Two lip pieces appear to have a tooled finish and a mineral finish (Figure 34).

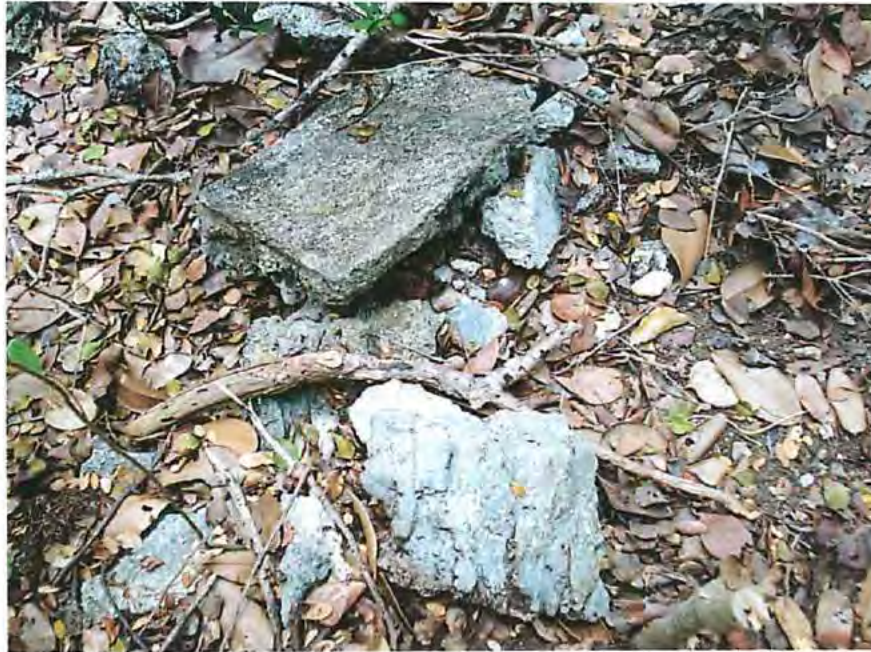
Figure 40, Wall fragments with smooth mortar on exterior face and wattle impressions inside

Nevertheless, remnants of exterior house walls are distinctive, including numerous chunks of lime mortar finished smooth on one face and bearing impressions of interwoven timber strips on the other. These fragments attest walls fabricated using wattle and daub, a vernacular construction technique which in variant forms has been used in The Bahamas since at least the early Loyalist Period. In the present instance, it seems likely that construction involved erection of woven hurdles (wattles), the hurdles being secured to timber uprights which besides strengthening walls, supported roofing materials such as palm thatch. The hurdles themselves were stuccoed with lime mortar on the outer face, this technique producing more or less weather-proof surfaces.

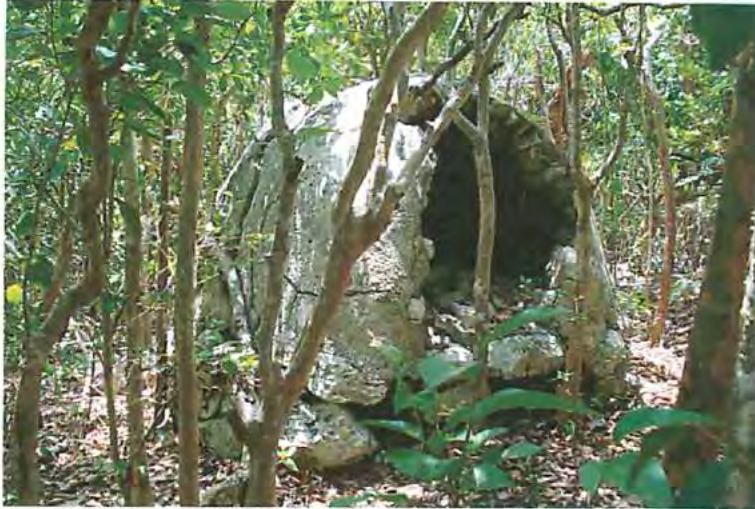
Figure 41, Oven of limestone rubble with stucco exterior

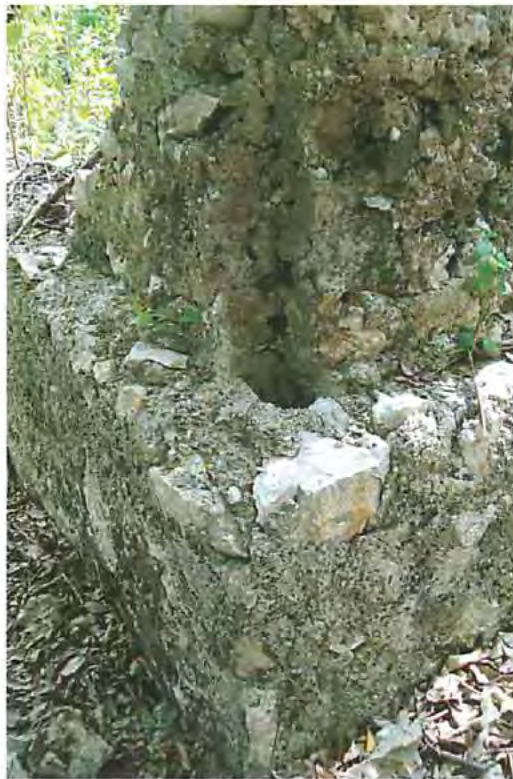
Figure 42, Detail showing impression of corner post at building occupying Lot 4

The structure occupying Lot 4 is different, its size and construction providing firm links to buildings standing on Lot 1. Despite poor preservation, we were able to determine it originally measured 17'-10" east/west x 21'-0" north/south in plan, with a least one entrance centered on the east facade. External walls measure 16" at base, this dimension being reduced by an external chamfer to 8" approximately 18" above grade.

Upper wall levels are lost but it can be seen from impressions that these were most likely of lime mortar cast in place about a series of rounded vertical timber posts placed 4'-0" on center, building corners being defined by 5 1/2" x 5 1/2" uprights of wrought timber. This technique is similar if not identical to techniques used to fabricate exterior walls of Structure 2 standing on Lot #1.

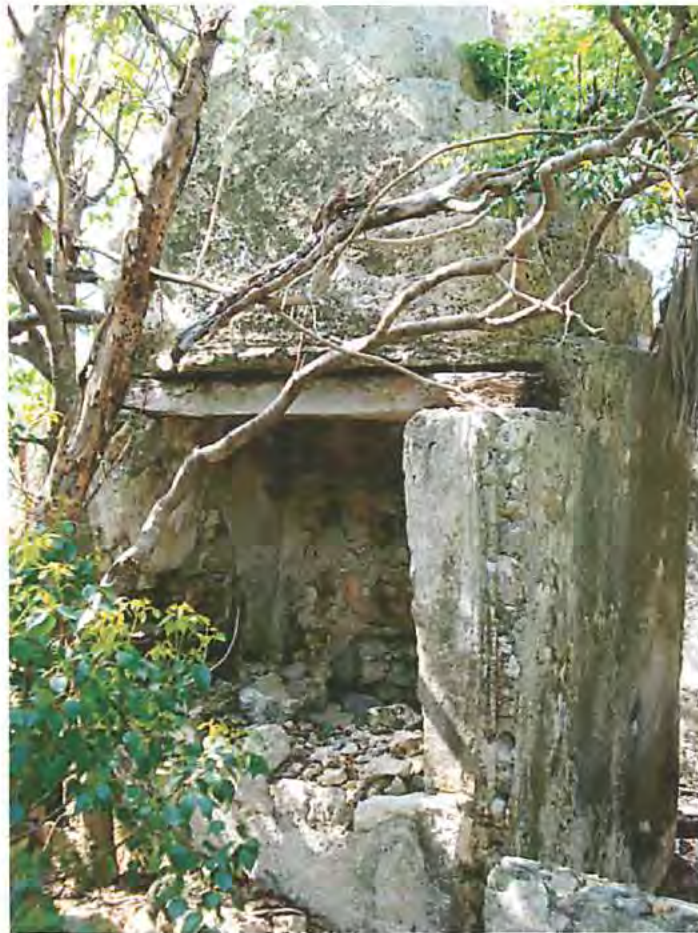
Figure 43, Barque Bay Structure 2, detail of chimney and hearth, from interior of building toward southeast

Measuring 6'-1" x 4'-7" in plan, the fireplace is fabricated of stone, rubble and lime mortar. Spanned by a 4 1/2" x 5" timber lintel, the fireplace opening (measuring 4'-0" wide x 3'-10" high including the lintel) appears to have incorporated a hearth slightly raised above floor level. The chimney is lost, except for a small stump, but corbeled stonework above the opening, which served to support it, remains in excellent condition.

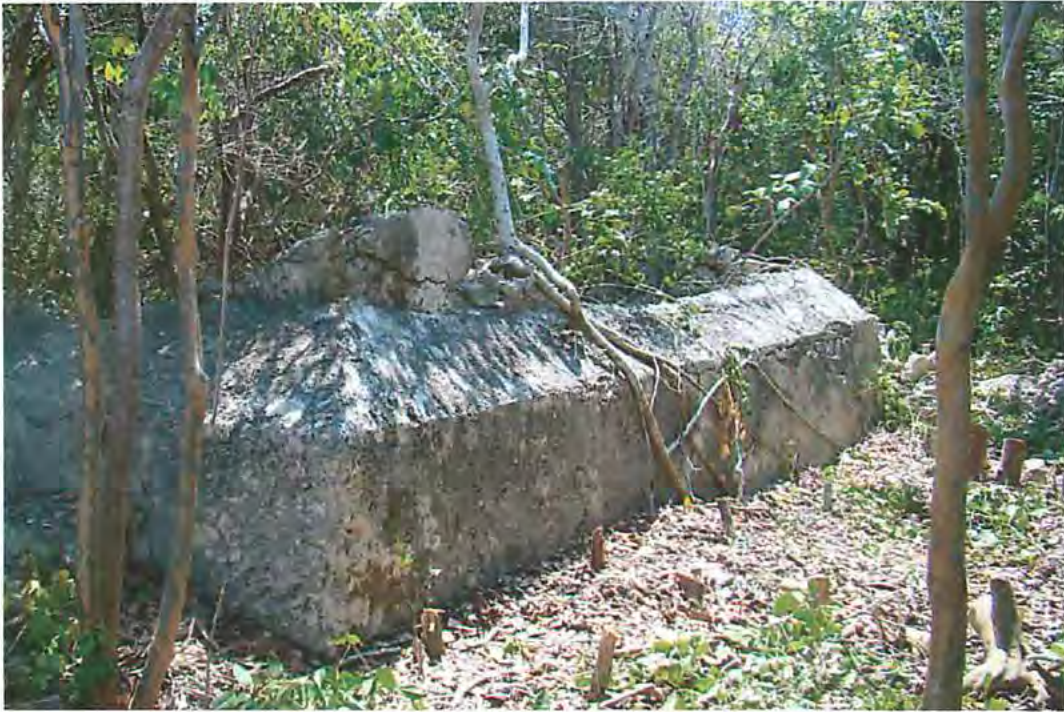
Figure 47, Barque Bay Structure 2, wide base with chamfer on exterior faces, toward southwest

How exactly mortar constituting the relatively thin upper walls was supported or applied is uncertain. Possibly, thin horizontal timber strips were fixed between the timber uprights, mortar then being daubed over posts and strips until the required wall thickness was achieved. More likely, mortar was cast between form boards fixed to or positioned around the vertical posts, using techniques familiar in tabby construction.³⁸ Either way, the resulting walls lacked strength, ratios between length and thickness being such as to almost guarantee early cracking or disassociation especially as timber posts buried in the fabric (but otherwise barely protected from penetrating moisture) decayed.

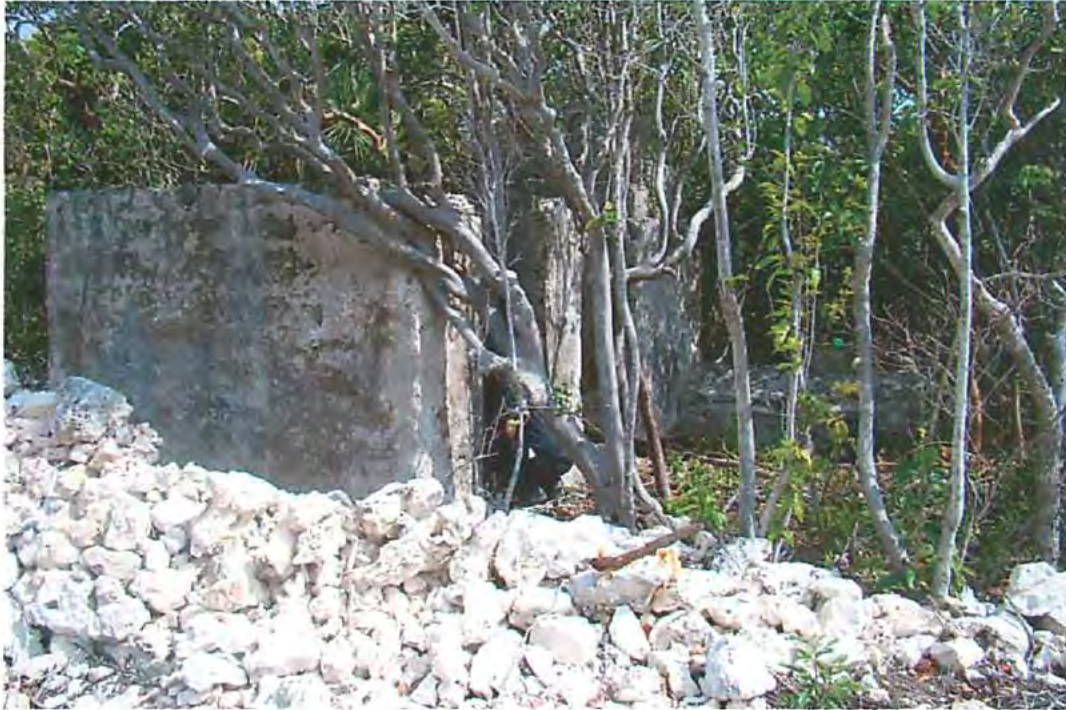
Figure 48, Barque Bay Structure 1 behind disturbed section of south wall of enclosure, toward northwest.

Located immediately behind (south of) Structure 2, Structure 1 is a rock-cut well (excavated to a depth in excess of 5'-0"), enclosed within rubble walls (typically 1'-4 1/2" wide) standing to a height of 6'-6". The well proper is accessed by openings (each 2'-11" wide) positioned opposite one another east and west. Overall the structure measures 10'-0" east/west x 6'-10" north/south. No evidence survives for roofing or other structural details but the south wall is of considerable interest since it is incised with at least two ship drawings and what may be a monogram or Masonic emblem. The better preserved ship drawing represents a schooner under sail (Figure 49).

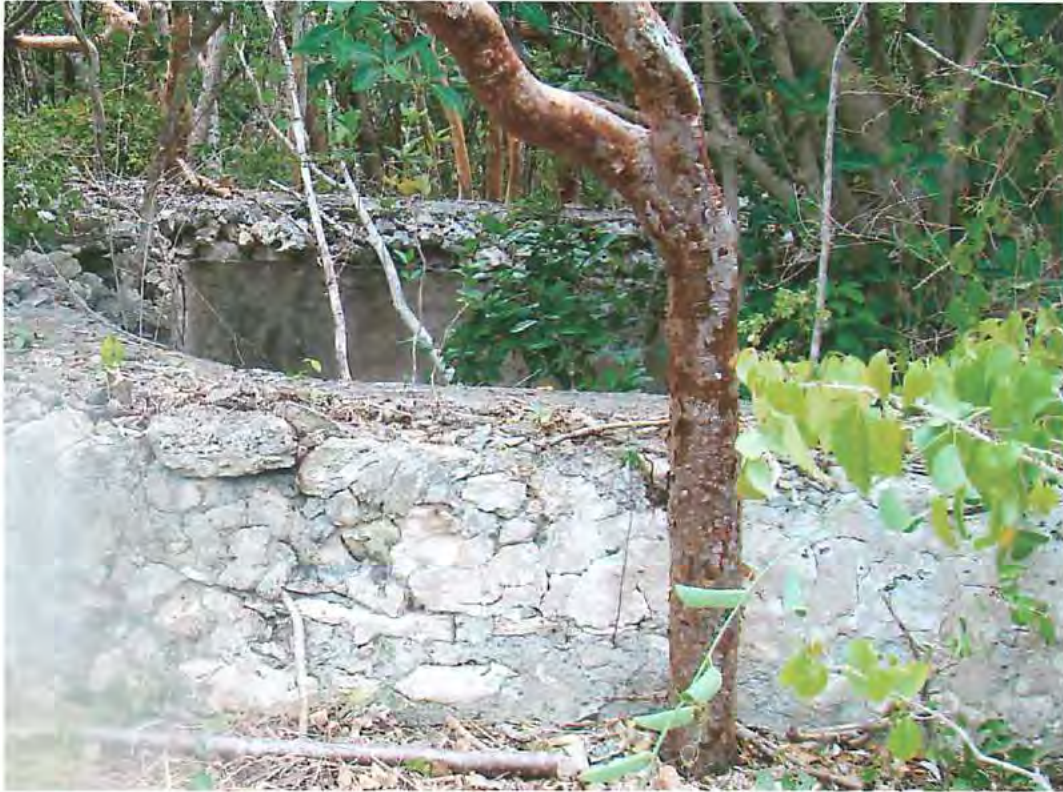
Figure 50, Barque Bay Structure 3, cistern, toward north

Aligned parallel to Structure 2 on its east side, Structure 3 is a rectangular rock-cut cistern excavated to a depth of at least 5'-0" below present grade. The feature is enclosed by a 2'-10" wide curb or dwarf wall standing 2 feet high and measures (including curbs) 23'-7" north/south x 15'-5" east/west. Originally, this cistern was roofed, closely spaced 4" to 6" diameter logs spanning east/west supporting a 5" thick slab cast in lime mortar, of which only fragments survive.
