ENVIRONMENTAL IMPACT ASSESSMENT

THE SETAI - KAKONA RESORT DEVELOPMENT

LEEWARD HARBOUR, CONCH SOUND POINT, AND HIGH BANK BAY

SOUTH ABACO, BAHAMAS

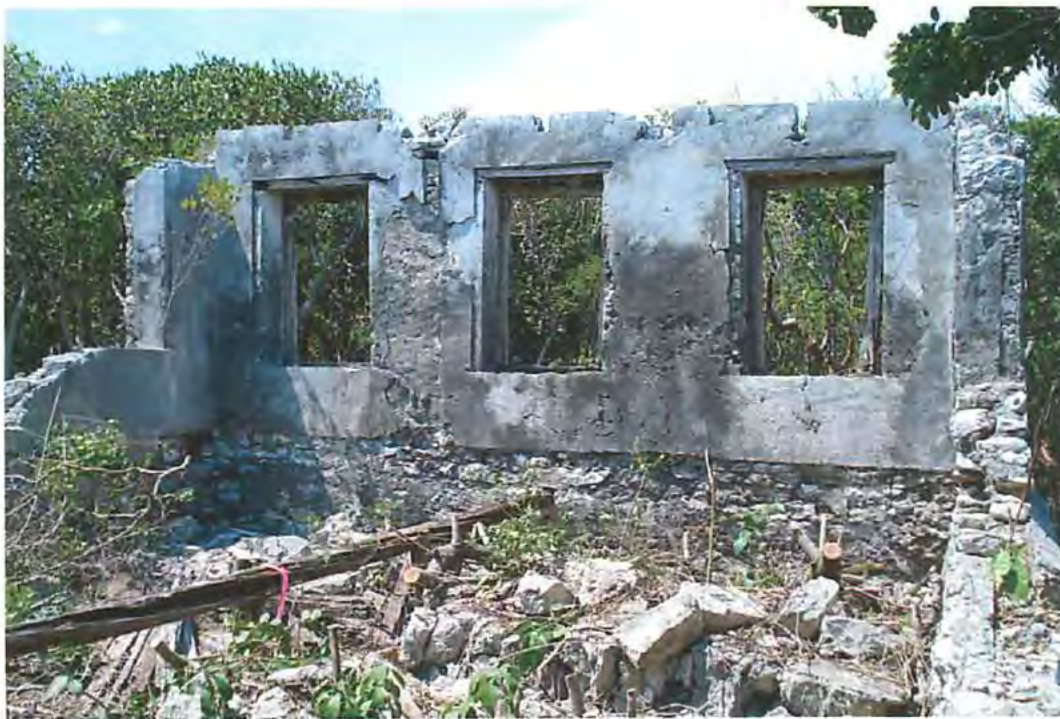
Figure 54, Barque Bay Structure 4, interior view showing beam for joists supported by cedar posts and slots at top of north wall for rafters, toward northwest

It is certain that floor joists measuring 5" x 5 1/2" distanced about 3'-4" on center were set in place as the plinth neared completion, the joists, running east/west being supported half way across the building by an intermediate cross beam of pine, measuring 4 1/2" x 4" in section. The beam itself was supported on untrimmed cedar posts, these (like the cross beam) still remaining *in situ*.

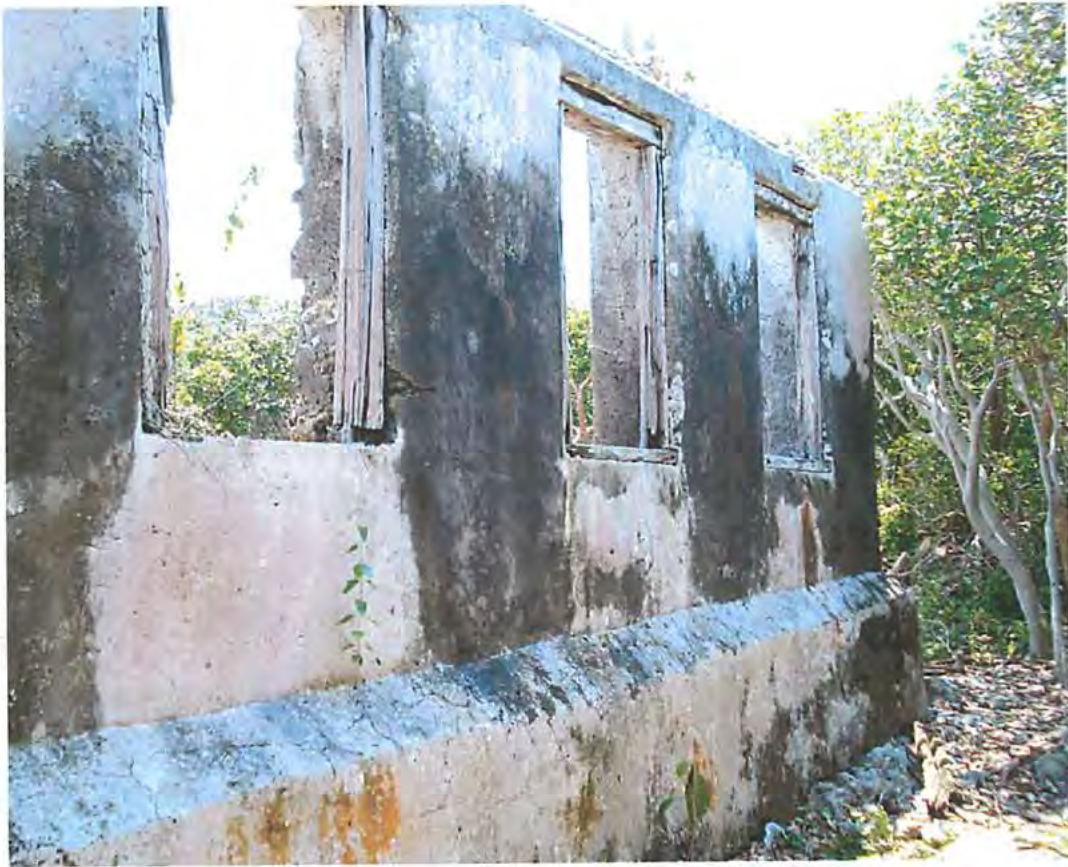
Figure 56, Barque Bay Structure 4, detail of north facade, toward southwest

Elevational treatment is imperfectly known. The north facade featured three symmetrically spaced windows, each window opening measuring 3'-2" wide x 4'-8" high including a 3" deep timber lintel spanning across the opening. Frames (typically measuring 3 1/2" x 3 3/4" in section) still extant are set flush with exterior building faces. Enough remains of the south facade to indicate its organization was similar except that the most easterly opening here was a door rather than a window. East and west facades are too far gone for any certain reconstruction although it is evident that each featured a central doorway flanked right and left by one, or possibly two, windows.

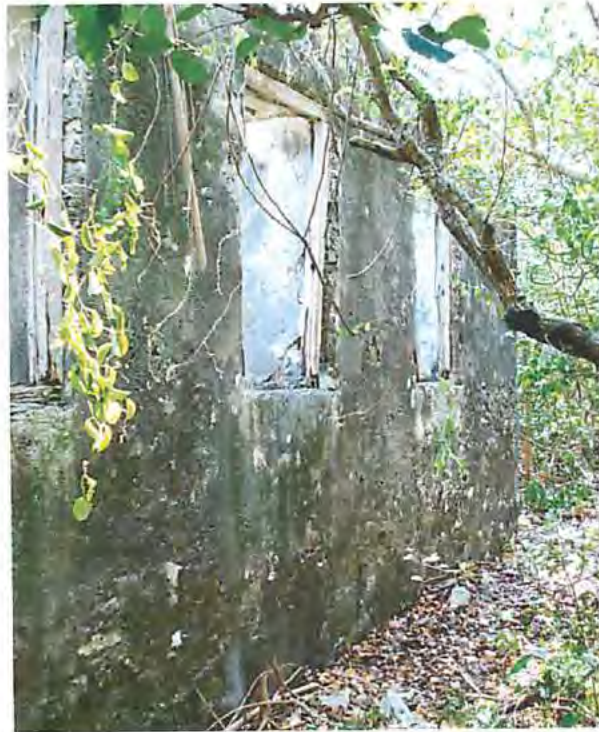
Figure 59, Barque Bay Structure 5, detail of north façade

collapsed and upper portions of north and south facades are heavily damaged, enough fabric remains to attest a single story masonry building defined by 1'-10" thick exterior walls with perhaps end gables carried up in stone. It can also be determined that east and west elevations each featured three door openings (typically measuring 3'-4 1/2" wide x 7'-0") disposed more or less symmetrically, these doorways giving access to the interior space or spaces via exterior stone steps. Window openings were probably positioned between each doorway, one surviving example measuring 2'-9 1/2" wide x 4'-5 1/2" high. Three similar window openings puncture the north facade. The south facade was probably similar but now stands incomplete and heavily overgrown.

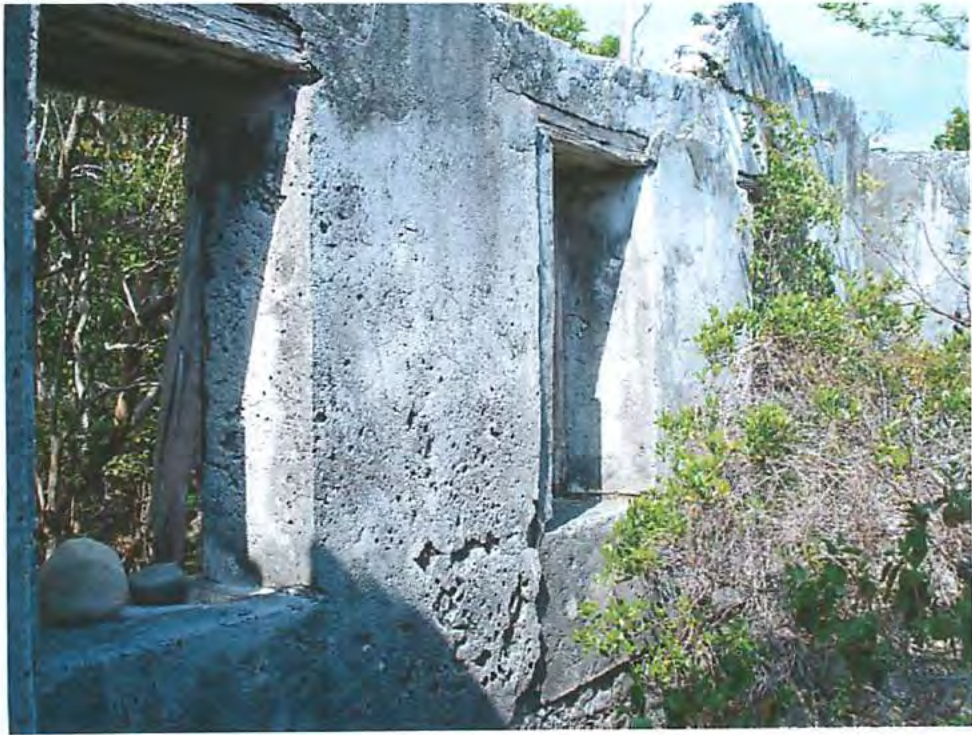
Figure 60, Barque Bay Structure 5, interior of north wall toward northeast

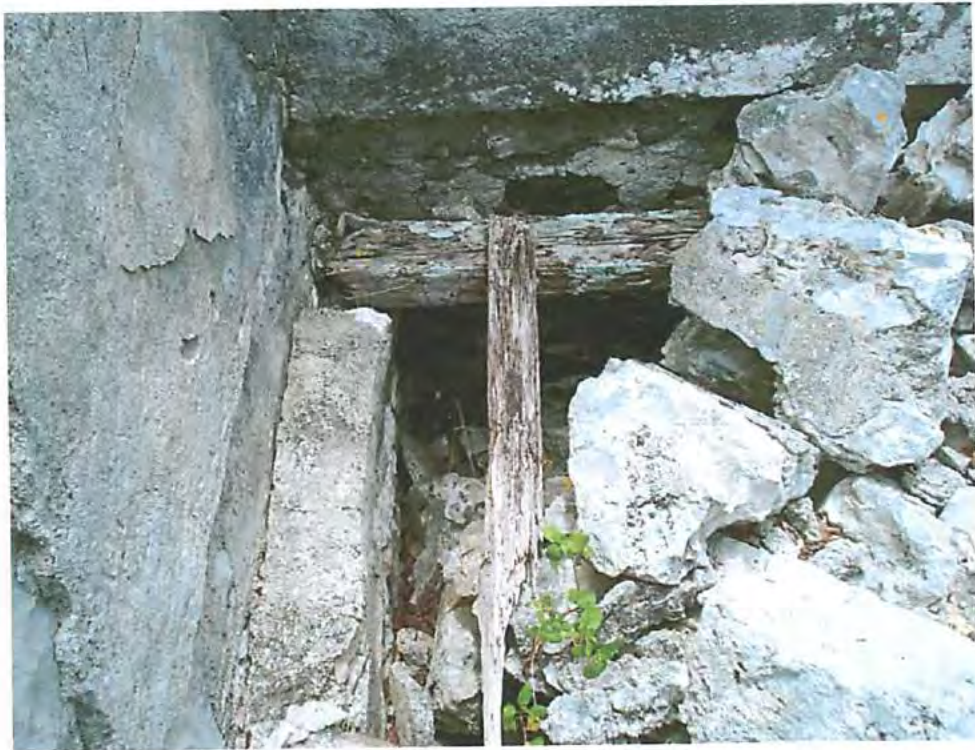
Figure 61, Barque Bay Structure 5, detail of floor joists

Inside, we found no evidence for interior partition making it impossible to be sure if doorways gave onto three separate units or one large space. However remnants in situ show the principal floor was raised about 2'-9" above grade and designed for heavy loads. Stone sleeper walls (distanced 5'-9" off the interior face of both east and west exterior wall) which originally received floor joists, extended along the building's entire length. Floor joists themselves appear to have been untrimmed timbers of varying dimension.

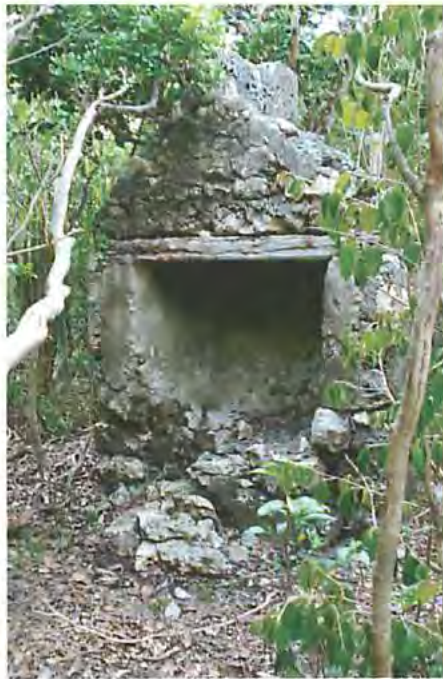
Figure 64, Fireplace west of Barque Bay Structure 5

Structure 2, suggests one of these buildings was a kitchen, but if so, an oven of traditional beehive form, rather roughly fabricated of stone rubble located nearby seems out of place. A depression just north of the chimney is also enigmatic, suggesting either a cistern or some kind of cellar. Either way, it remains to be determined if Building Group C is a coherent one, or indeed what kind of purpose it was built to serve.

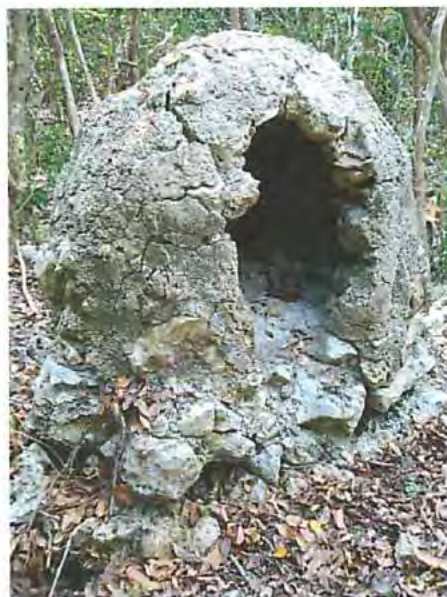
Figure 65, Oven of limestone rubble with stucco exterior west of Barque Bay Structure 5
